PT status and planning

Michael Pešek
Charles University, Prague

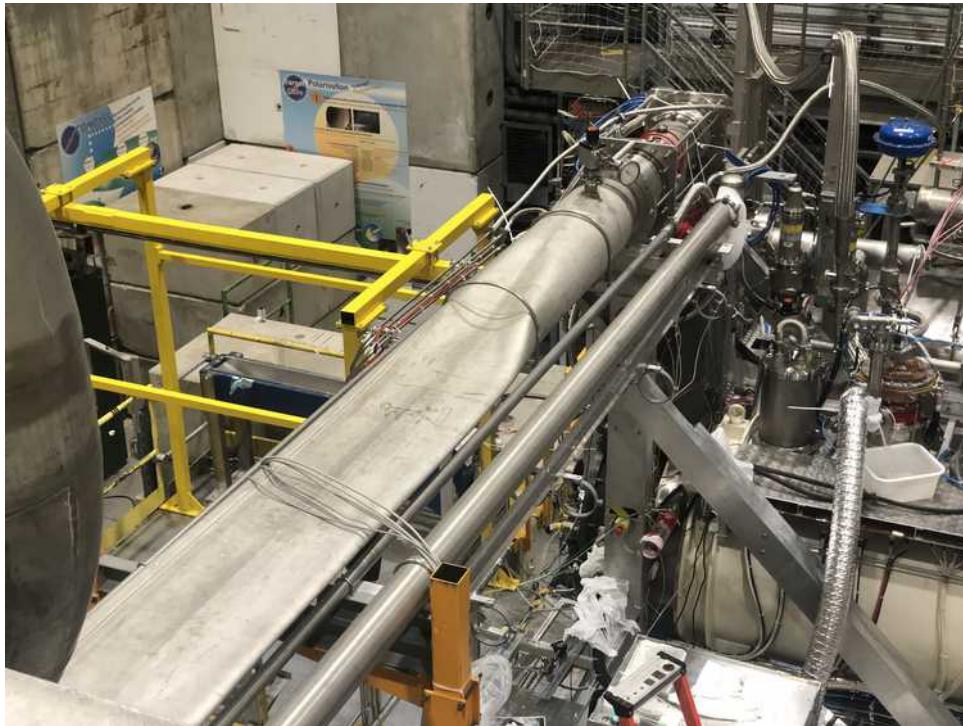
- ^3He pumping line found collapsed during routine check-up inside the area July 3

Caused by wrong mechanical design
Confirmed by calculations by BE dep.

- Target unloaded on July 5 at ~ 50 K
- ^4He pipes removed and scaffolding in place July 6
- ^3He pipe removed on July 7
- Welding of the pipe finished July 9
- In parallel – warming up the system to RT
- Pipe leak checked on July 14
- Unsuccessful installation attempt on July 15

- Pipe cut in two parts and fitted in position July 16
- Extra piece cut and welded, another dry installation
- Final welding, leak check and installation finished July 20

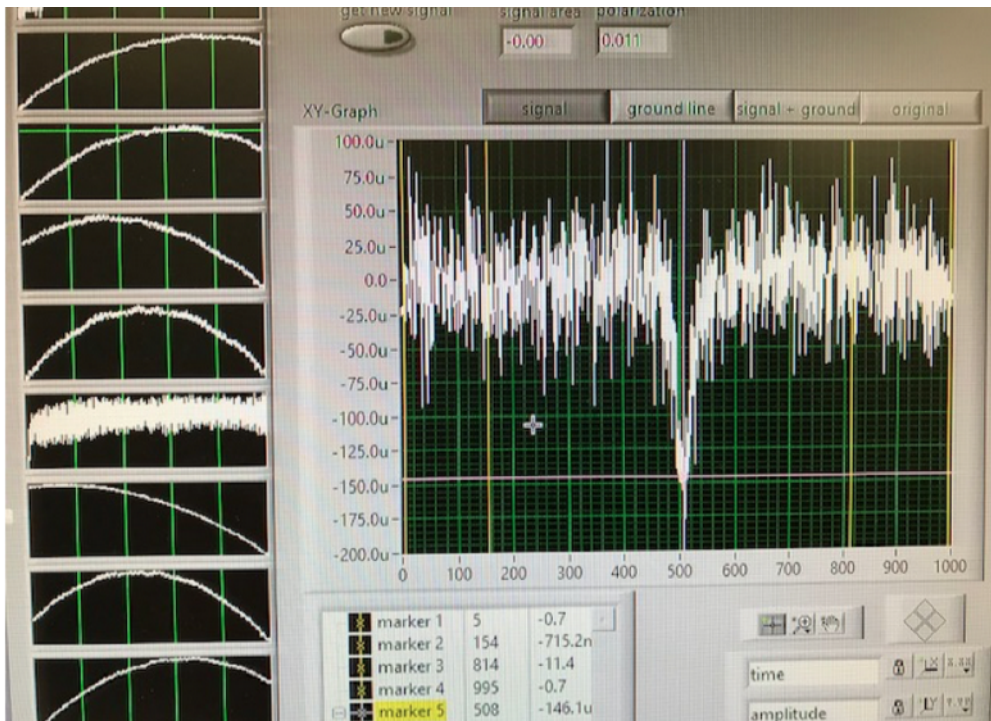
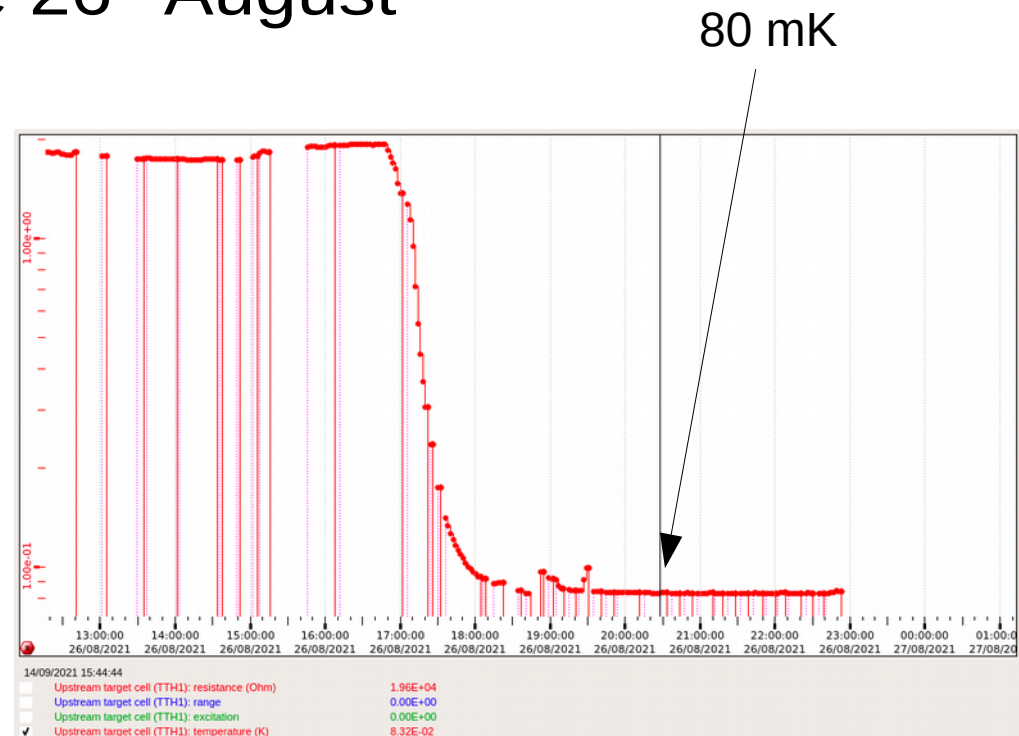
- TE calibration at 1.49 K 20th-23rd August
- Large noise on coils 1 & 6, but otherwise usable data
- Remove ⁴He from DR 23rd-25th August
- Condense ³He/⁴He mixture 26th August

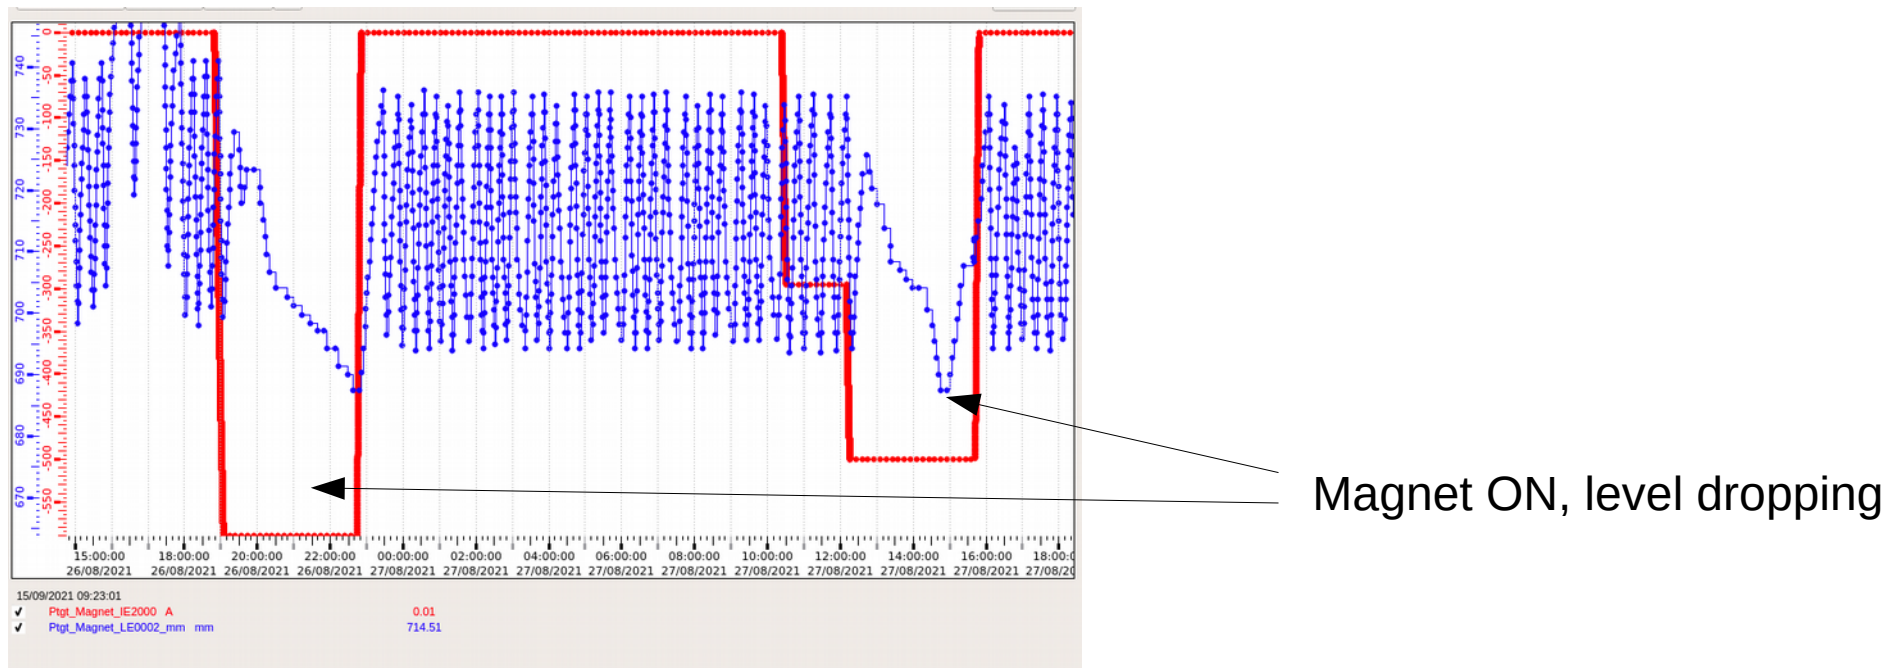
- Check dipole magnet direction → wrong, corrected by power converter people
- Stability test of dipole magnet → serious problem
- Unable to keep Lhe level in magnet when dipole on

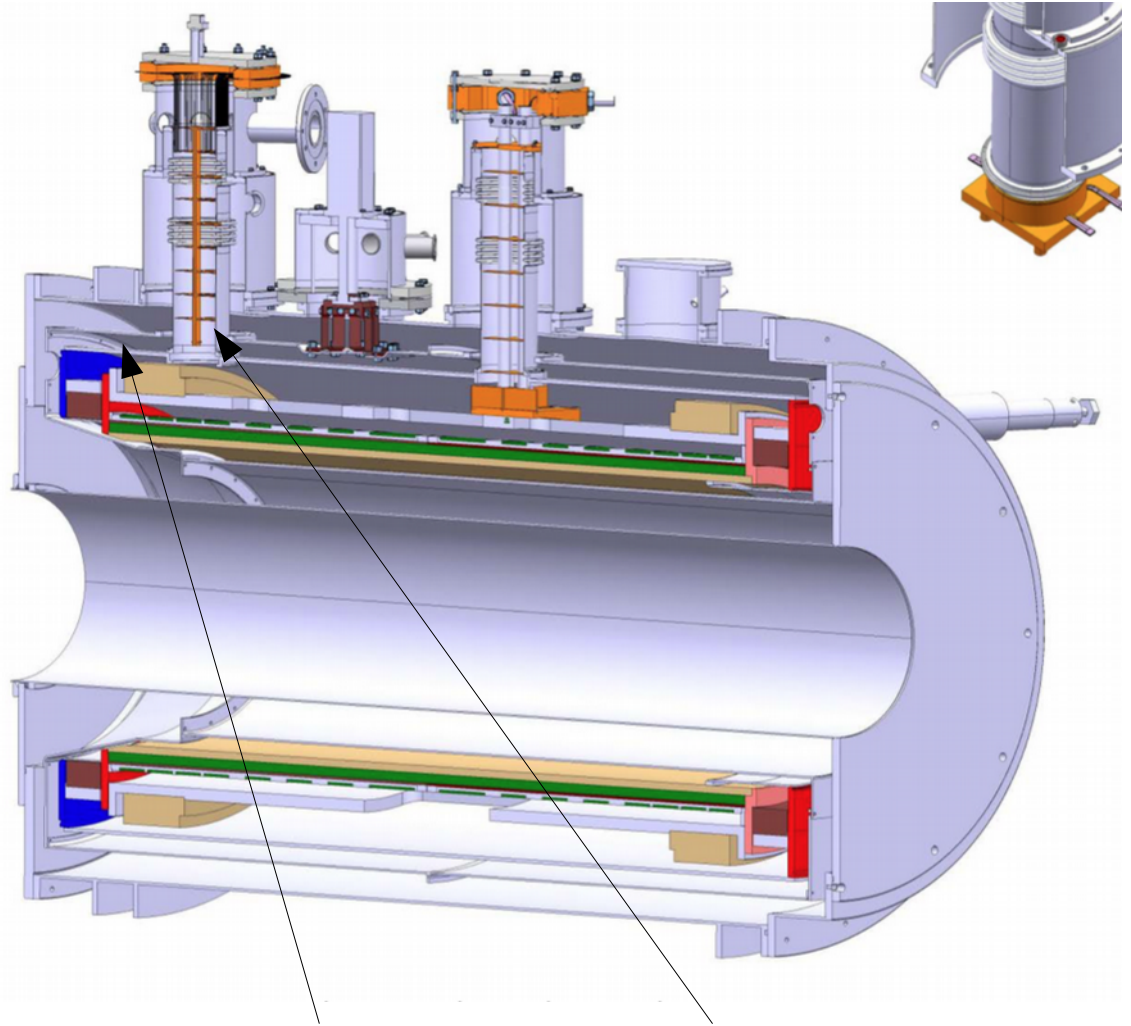
Voltage measurement

- Investigation with Alexey D and EP-DT August 30-31
- Measure voltage across coil during ramp and no-ramp
- No pathologies observed!
- Probable cause: too high temperature of magnet radiation shield
- Probable cause of that: corrosion of Cu/Al contact during 2019 cavity modification (long exposure to air)
- Solution: retune LHe flow and filling
- Strong recommendation: get a new transfer line for LHe
- Repair probably possible with magnet in place

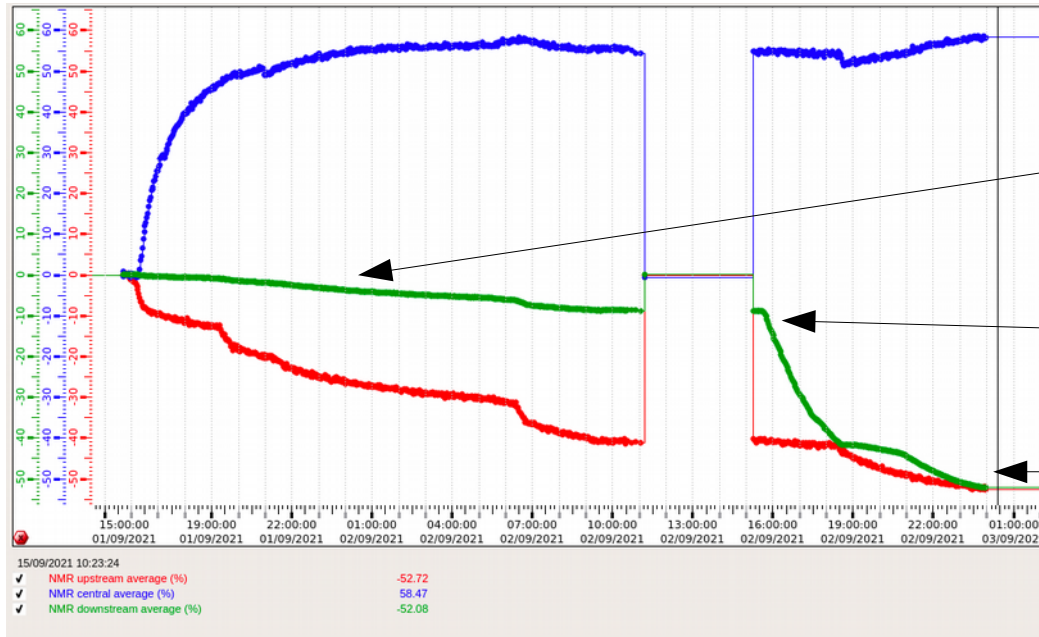
Almost no build up in downstream (splitting of power up/down)

Gunn diode installation, Separate generator for downstream

~50 % polarisation in ~24 hours, Error in TE signals handling-> Reality about 1/2 of the value!!

- Mix up in TE calibration constants → understood and corrected (NMR amplifier)
 - Low power in downstream cell → solved by Gunn diode
 - Bad magnetic field homogeneity → improved, in progress
 - Unstable EIOs (frequency and power)
 - EIOs frequency range limited
- Two new Gunn diodes
Next year (Yamagata)
- Finally proper build-up study started September 11
 - Polarize only central cell with Gunn diode

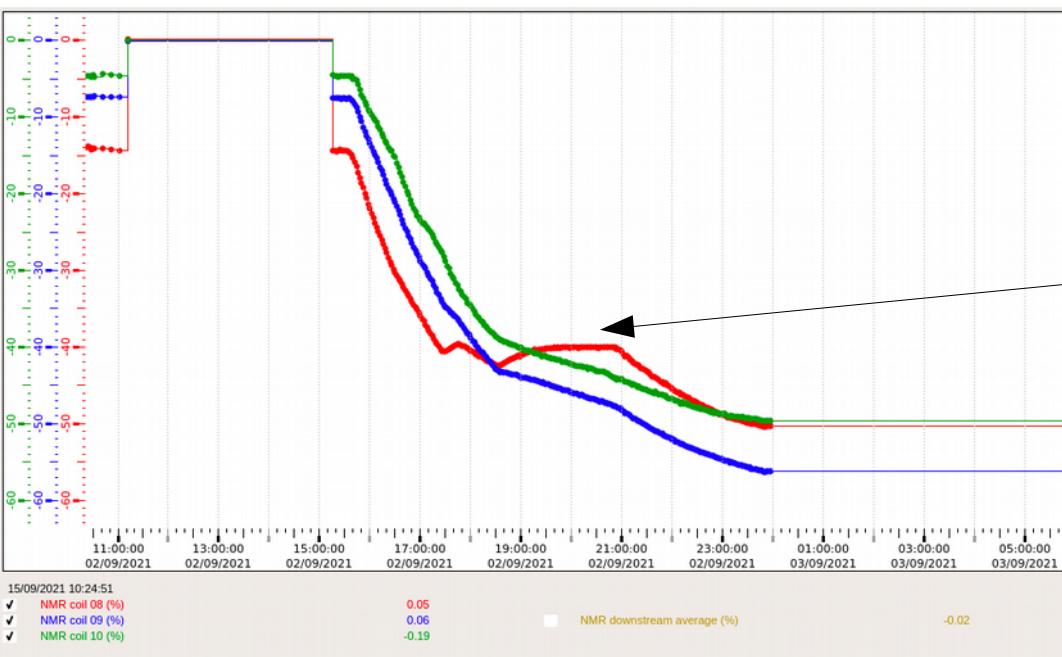
Very different behaviour among NMR coils
Variation in field → variation in optimal frequency

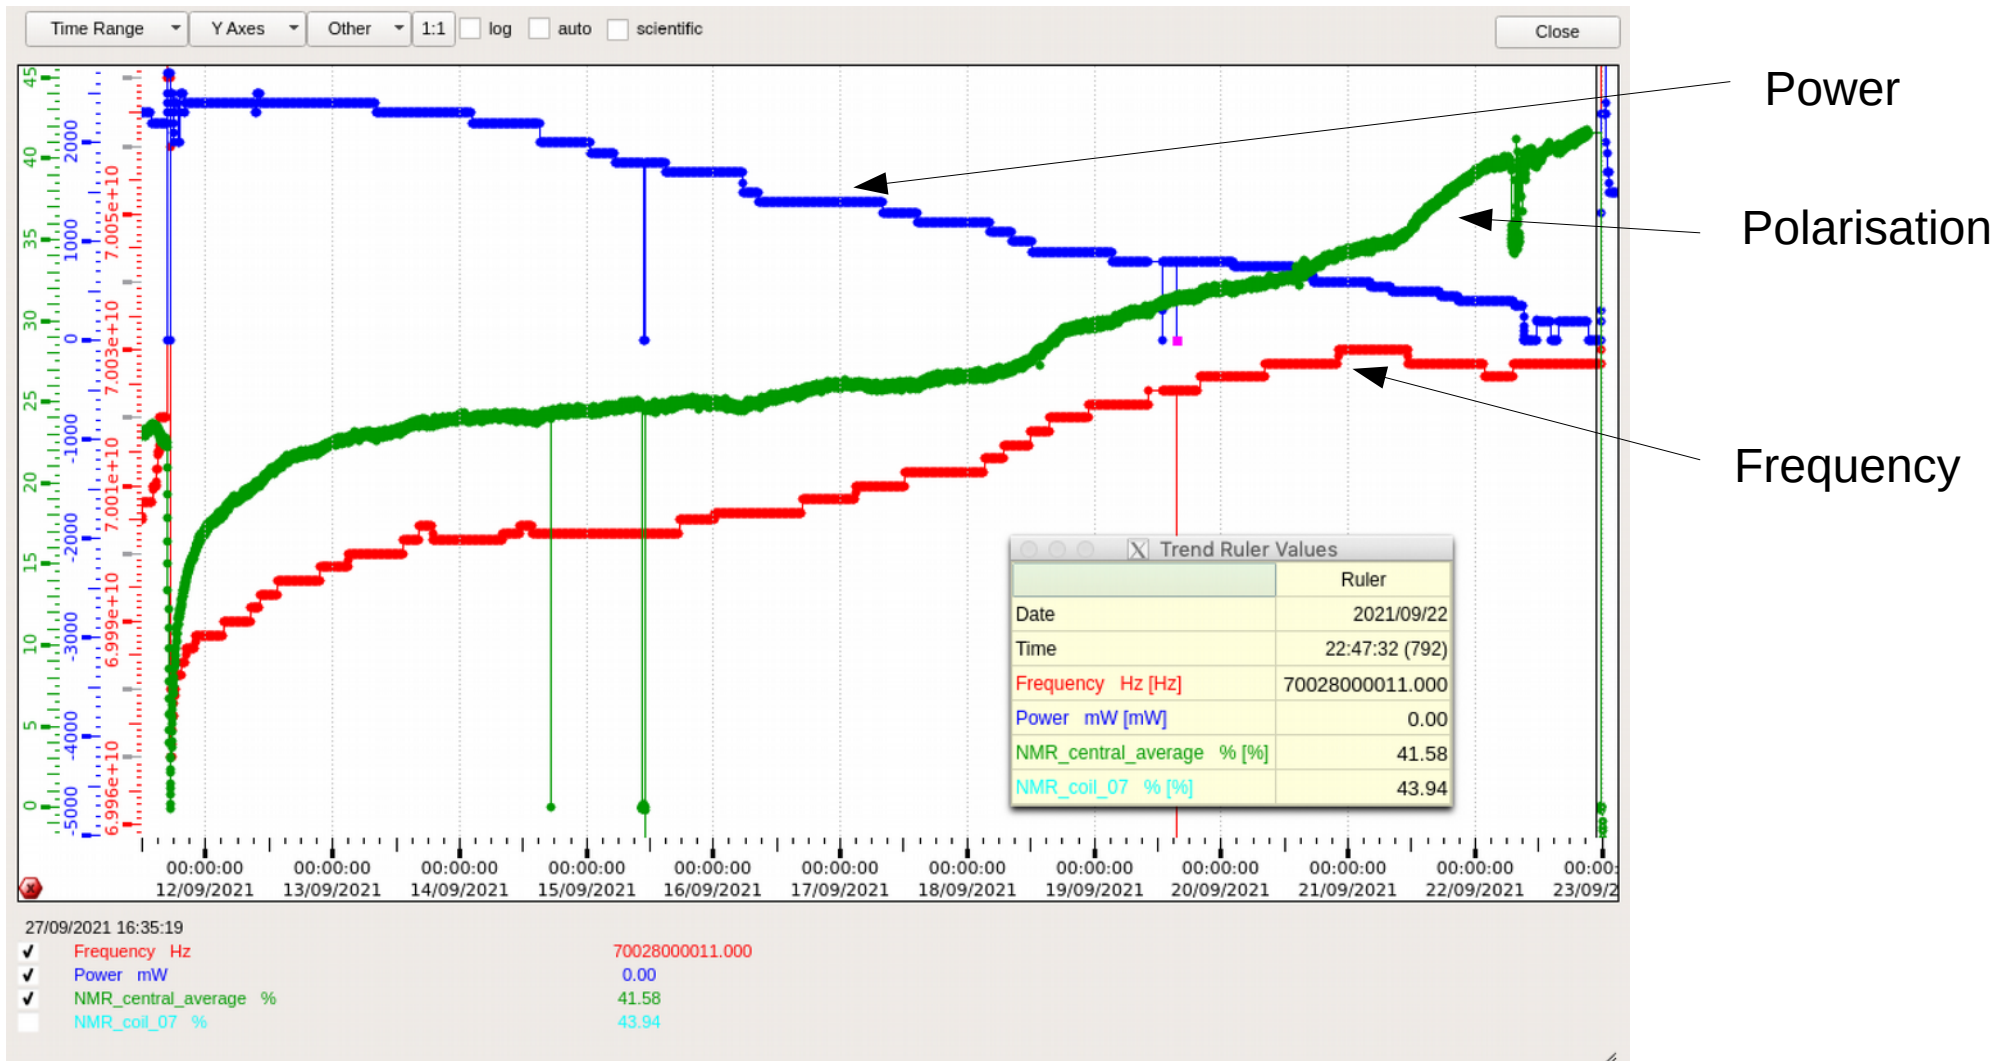
Reached average polarisation in central cell about +41%
Build-up time rather long → learning curve

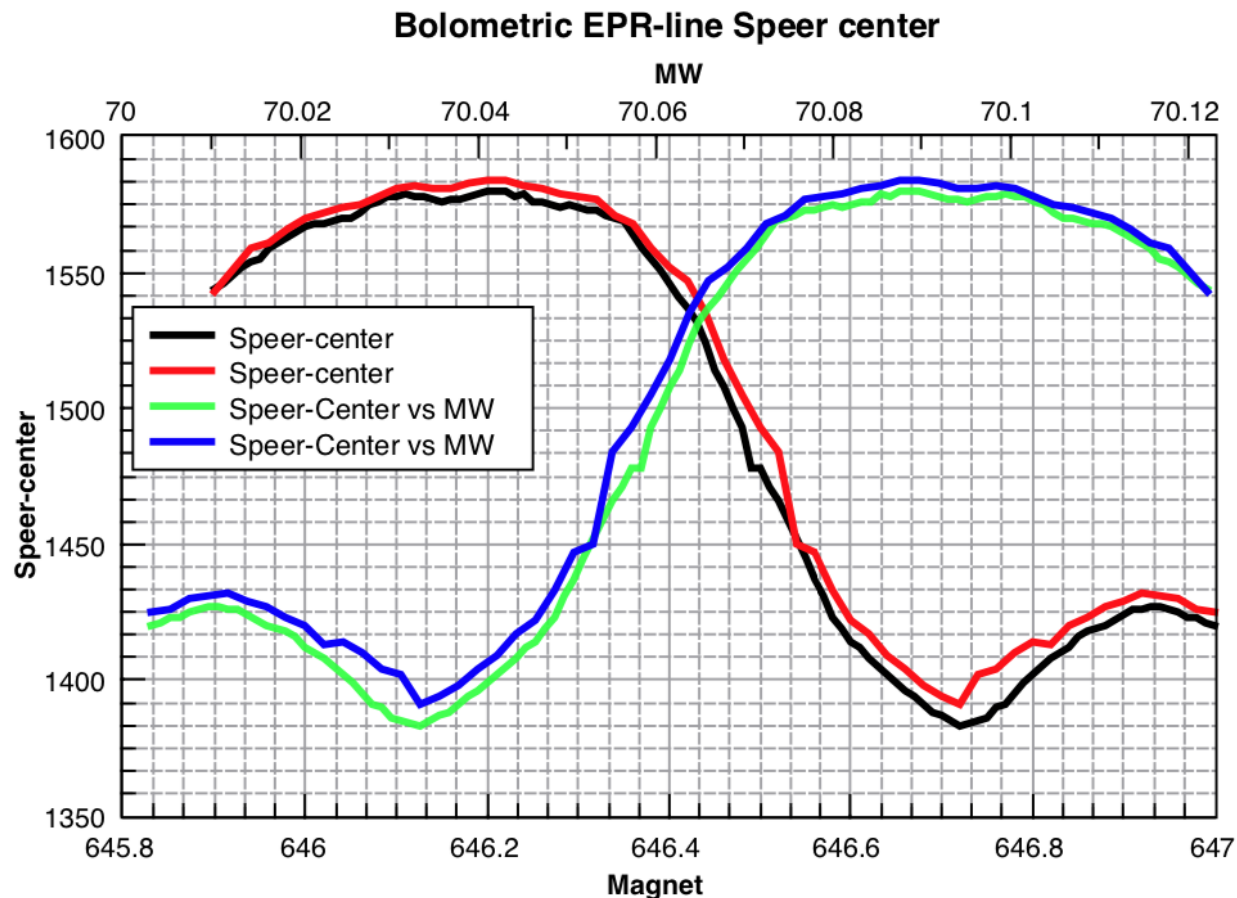
- New MCS functionality: change current in steps of $\pm 10\text{mA}$
- We measured bolometric EPR spectrum

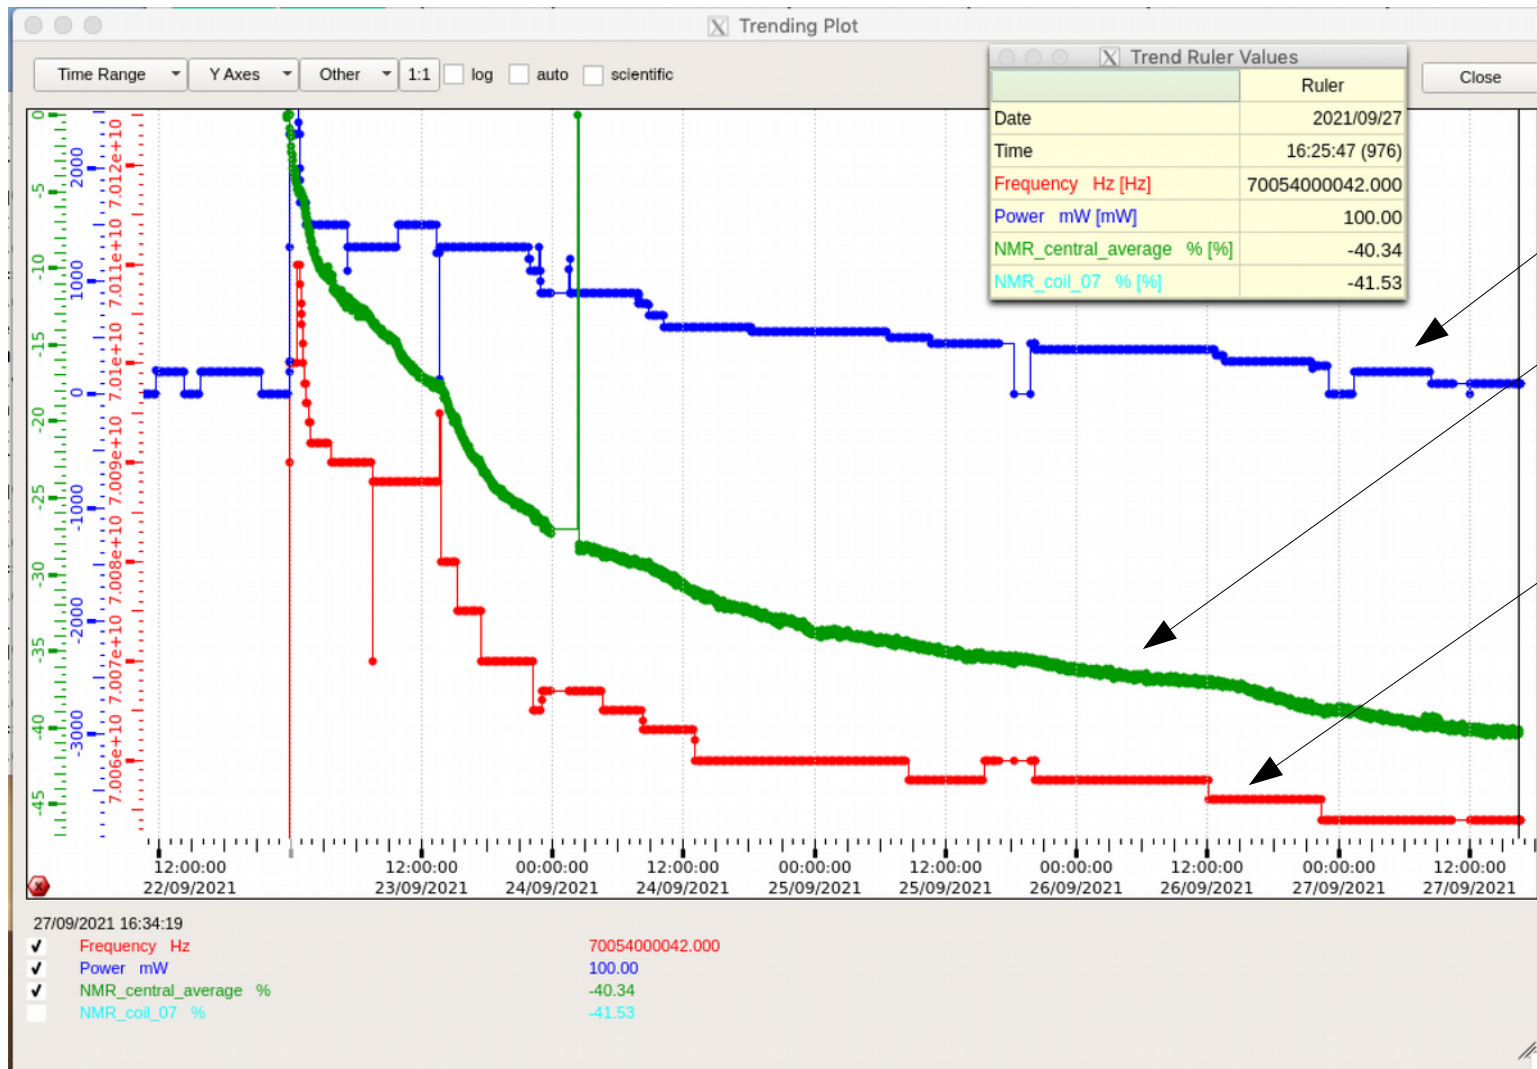
Reached average polarisation in central cell \sim -40%

Build-up time already faster
