# Assembly and gain uniformity measurements of a new large area PICOSEC detector

Antonija Utrobičić

RD51 Collaboration Meeting, February 16, 2021

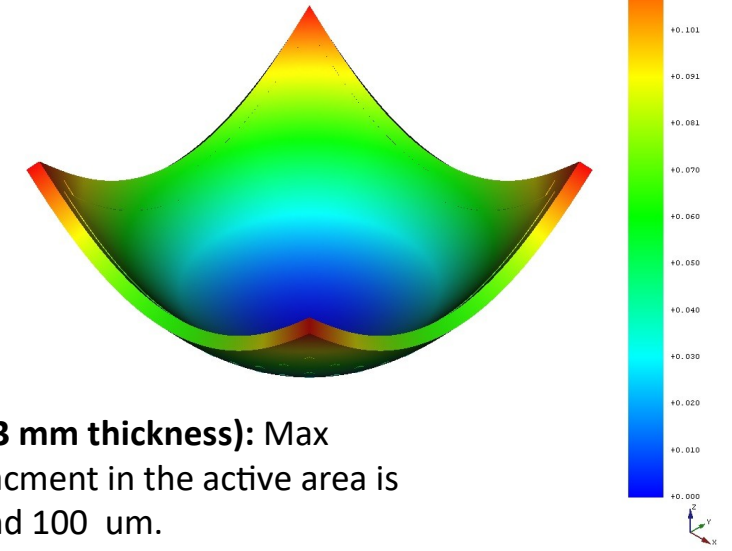
**FR4 (3 mm thickness):** Max displacement in the active area is around 100 um.

- Structural simulation of board deformations under mesh tension resulted in the usage of a thicker board stack and more rigid core material.
- **Material:** hybrid ceramic instead FR4
- **Thickness:** 4,85 mm instead of 3 mm.
- **Design requirements:** PCB flatness within 10 um over the active area.
- Objective: follow the manufacturing process and conduct the planarity measurements on each of the production steps.

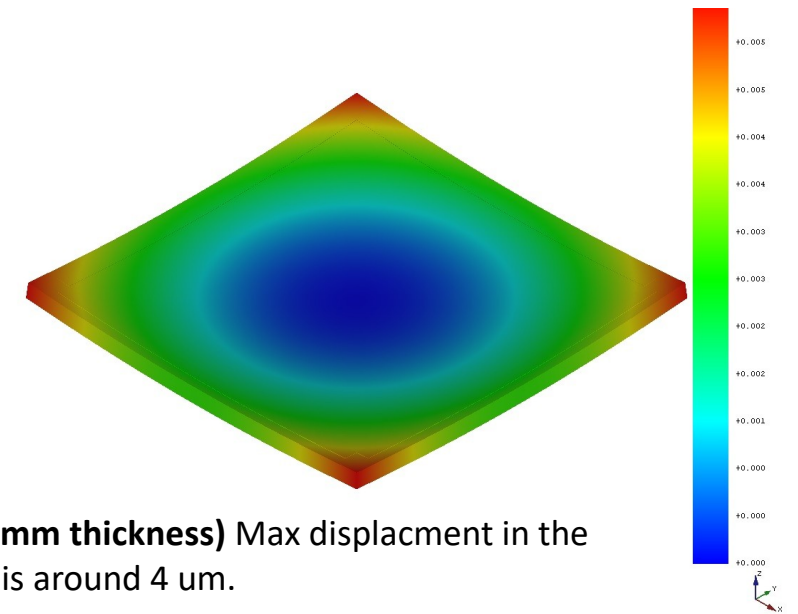
**Ceramic (4 mm thickness)** Max displacement in the active area is around 4 um.

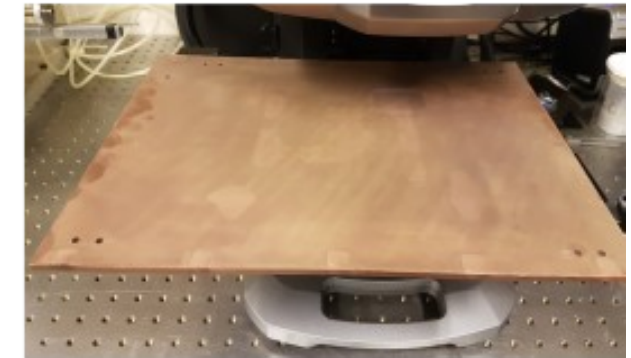
- 1. Production of the ceramic substrate:** gluing 4x1 mm ceramic boards and covering with 0,3 mm thin FR4 layer on top and bottom side.
  - Polishing of the top side FR4 layer-> planarity measurements.
  - Planarity below 15 um (MMB) and 23 um (MMA).
- 2. Epoxy coating and copper deposition** (55 um) on the top and bottom side of the board.
  - Planarity measurements → polishing → planarity measurements.
  - Planarity below 9 um (MMB) and 11,5 um (MMA).
- 3. Copper etching.**
  - Planarity below 7,8 um (MMB) and 7,2 um (MMA).
- 4. Epoxy fill between the copper traces/readout pads and polishing.**
  - Planarity below 7,6 um (MMB) and 8 um (MMA).

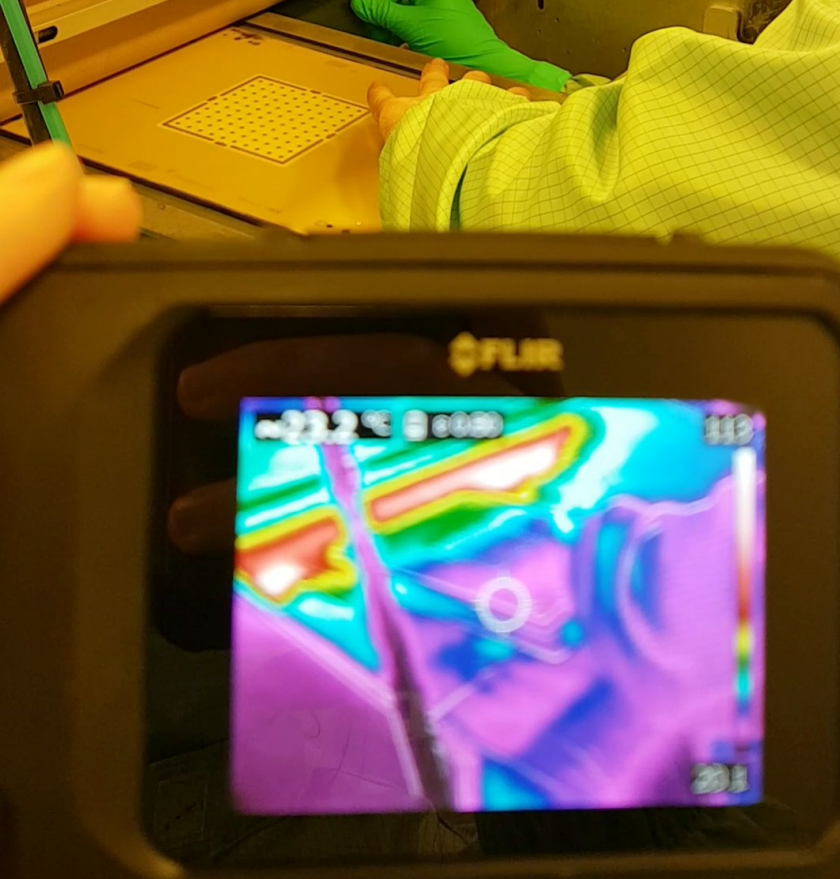
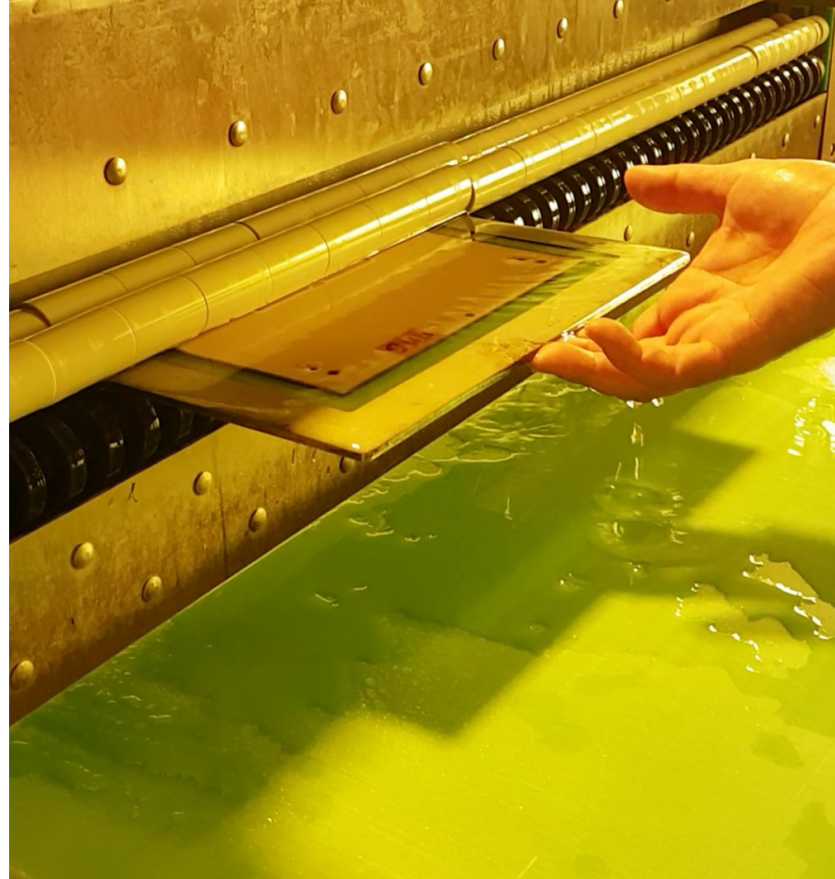
Top side / PADs side

Bottom side / Pogo pins side

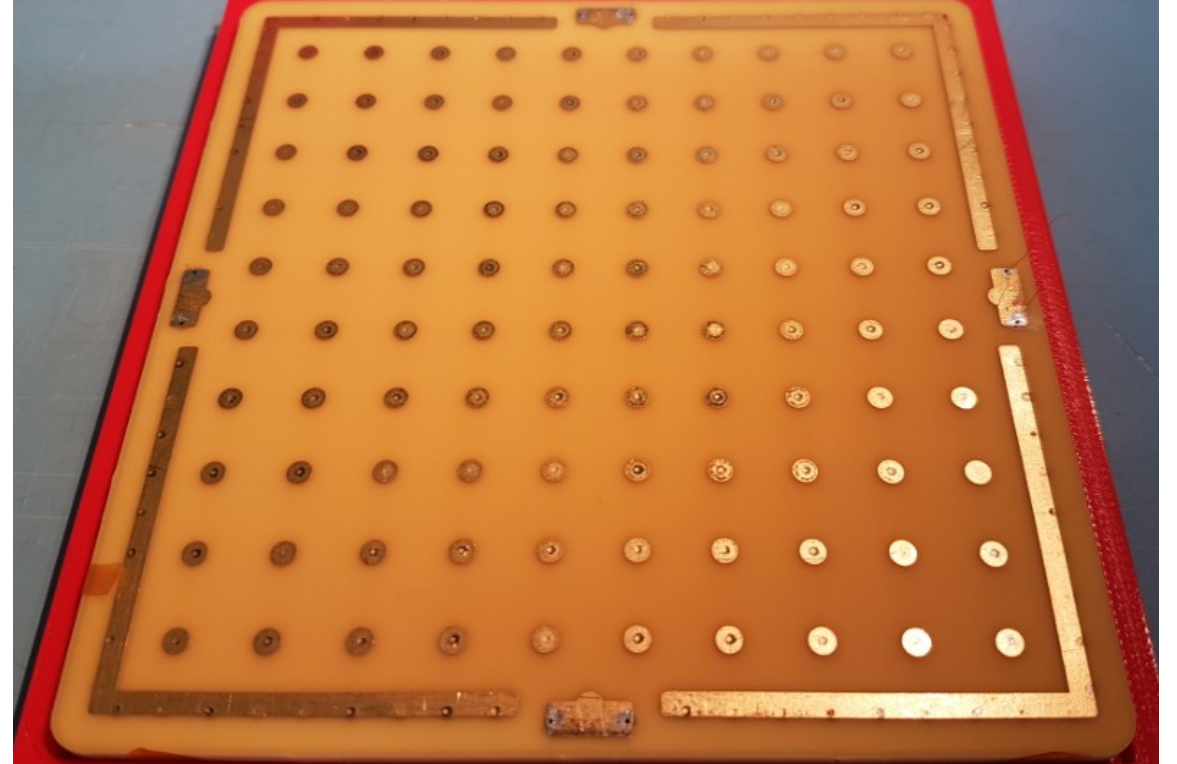
Back side of the board after bulking

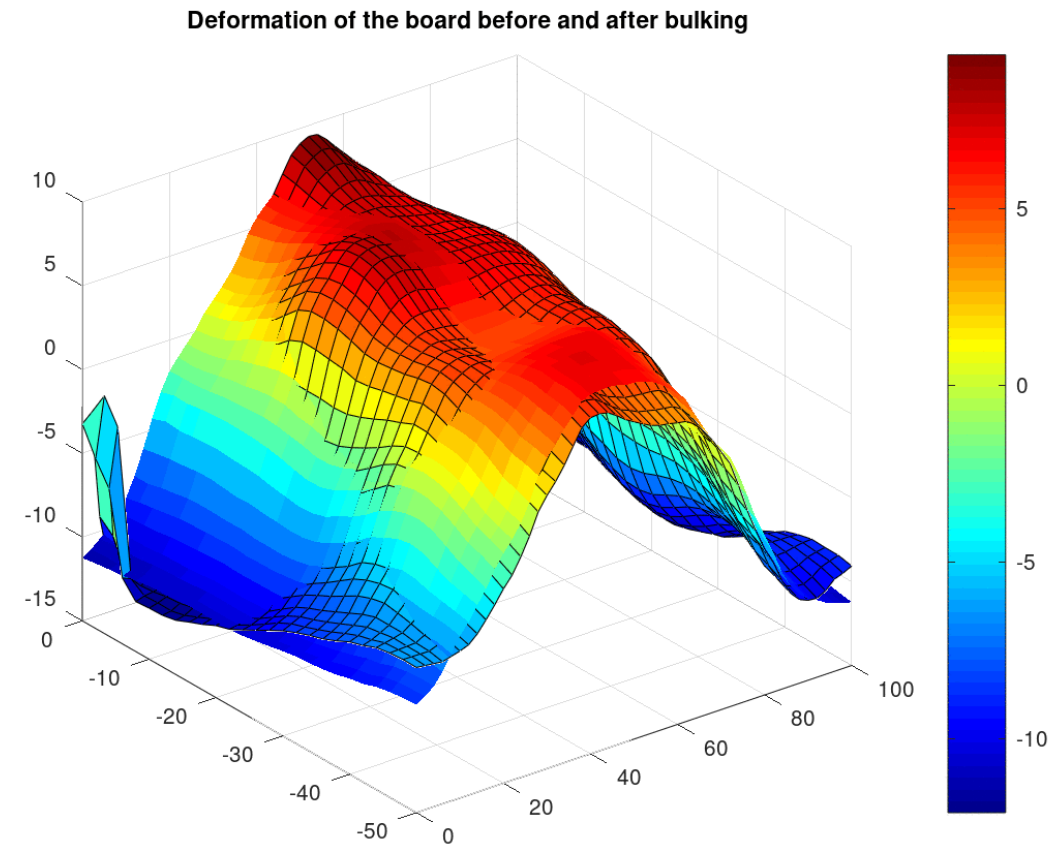
- **Very rough estimation:**
  - The deformations have propagated through the board on the top side, the thickness of the board is preserved.
  - Due to the MESH it is not possible to make planarity measurements on the top side.
- **Procedure:**
  - Make before and after comparison analysis of the back side of the board.
  - Calculate the difference.
  - Add the difference to the height top side before bulking.

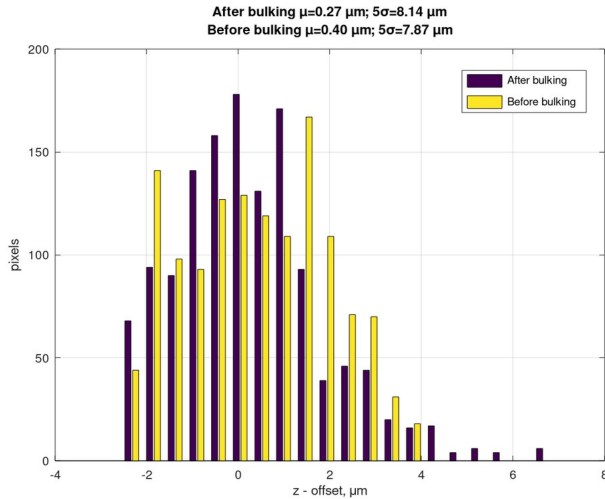
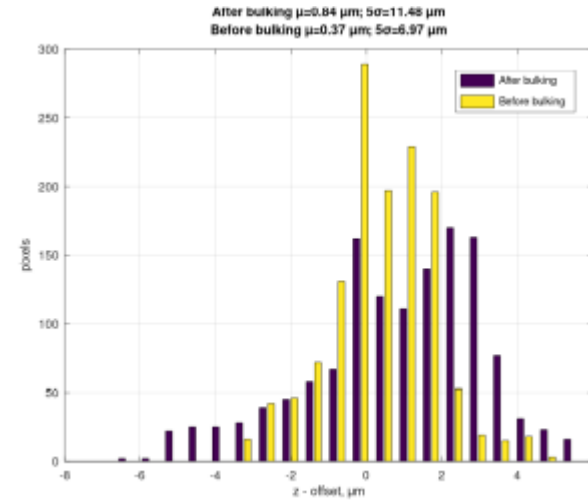
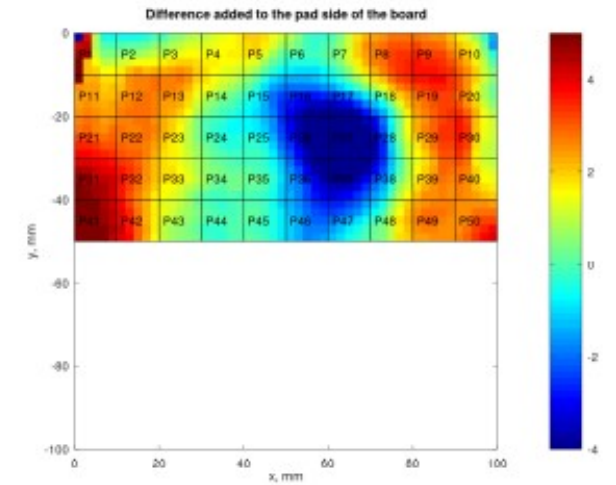
- Planarity measurements of the backside after bulking show that there were **no large deformations due to the bulking process**.
- Analysis of the planarity measurement data shows that **a very rough estimation is that the overall planarity on the pads side is still below 10  $\mu\text{m}$** .
- Better information from the uniformity tests after detector assembly.

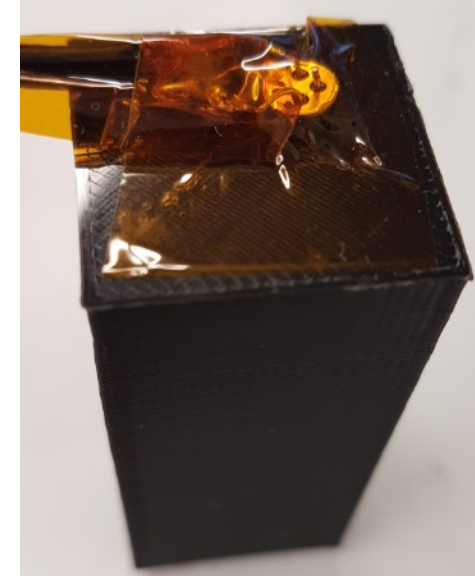
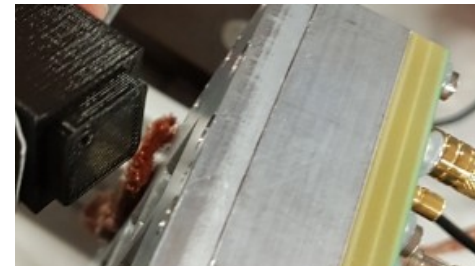
MgF<sub>2</sub>

Chromium photocathode

Mesh

Anode

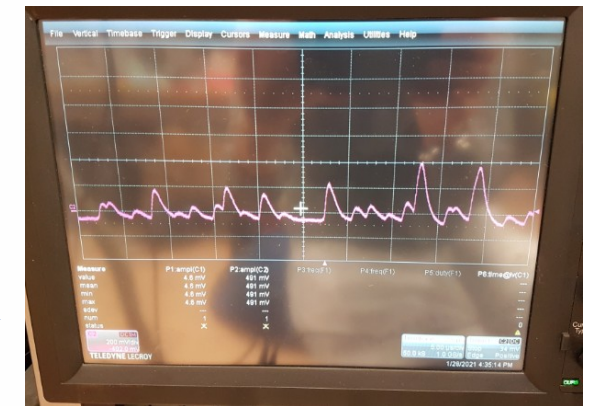
- Measurements with different diode light intensity and fixed detector gain were made to have single p.e condition.
- Diode current was increased until difference in spectrum was observed.
  - For LED current above cca. 30 mA the spectrum shape changes significantly.
  - It is possible that the time between two consecutive single p.e events is shorter than the shaping time of the amplifier causing signal pile-up.
  - These events could be resolved in time in measurements with a fast preamplifier. ...to be done soon.
- Gain uniformity measurements were made with small LED light intensity in order not to have signal pile-up.

Lot of pile-up events after shaper.

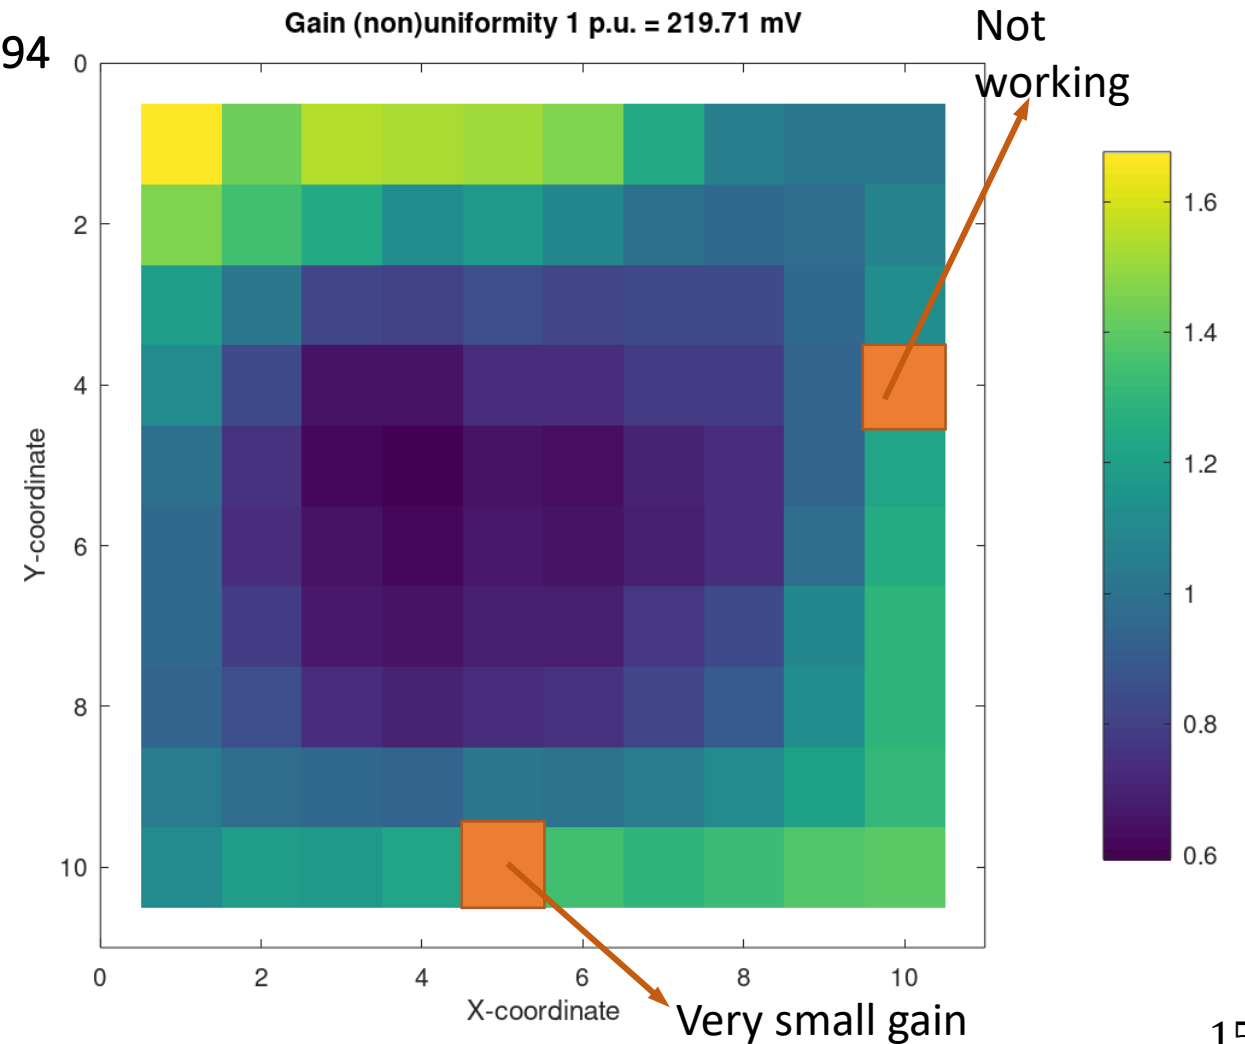
- Cathode voltage: 525 V
- Anode voltage: 265 V
- Problem with 2 channels (orange color on map): **channel 94** is not working and **channel 50** has very low gain.
- Polya fit was used to extract the mean of the spectrum.
- Large variation in gain observed
