MCP-PMT R&D and quantum efficiency lifetime measurements

Kenji INAMI
(Nagoya-u/KEK, Belle II TOP group)

2023/11/22 Phose2023

MCP-PMT for Belle II TOP detector

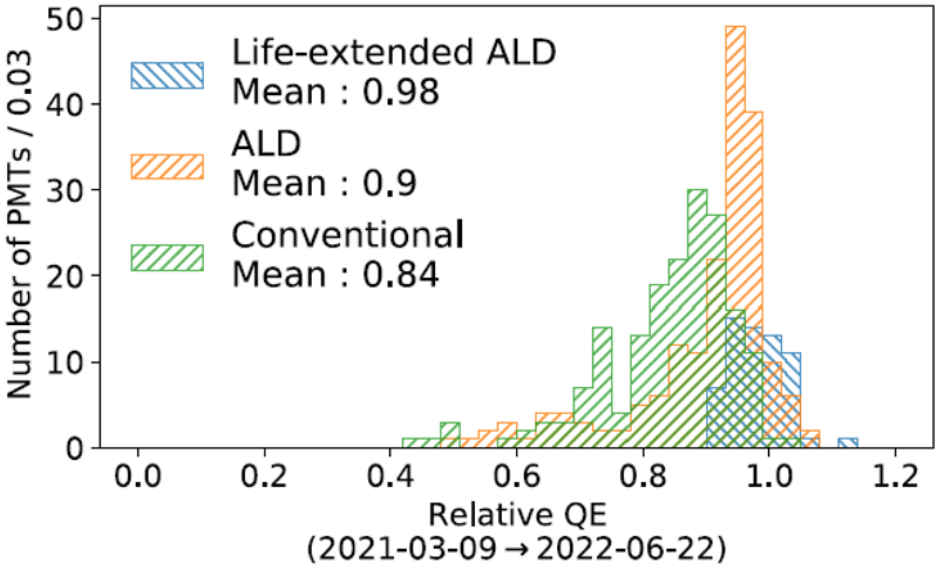
- QE variation history from the beginning of 2021

$$\text{Relative QE} = \frac{\text{QE at the end of 2022}}{\text{QE at the beggining of 2021}}$$

- Shows some QE degradation for conventional and ALD types, although the output charge is still small.

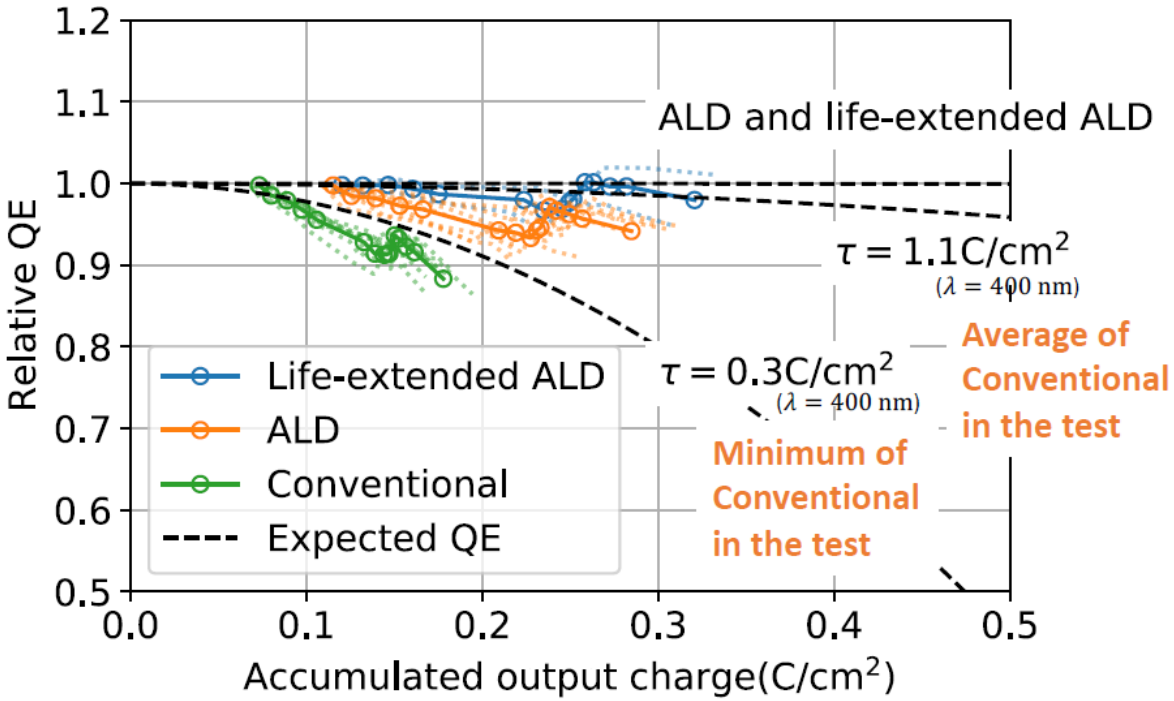
- As a function of output charge
- Compare with the expectation from the R&D result

→ Follows curves for much short lifetime
- Need to study the reason of QE variation
  - Although there is strange fluctuation

Dotted line : SLOT average
Solid line : Type average

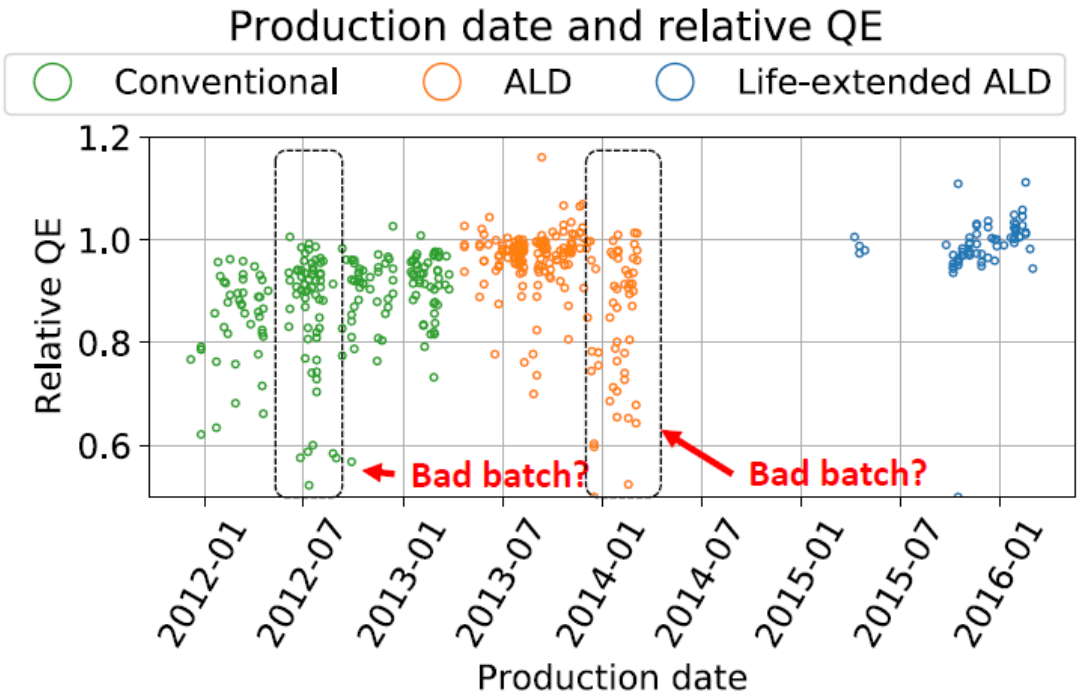
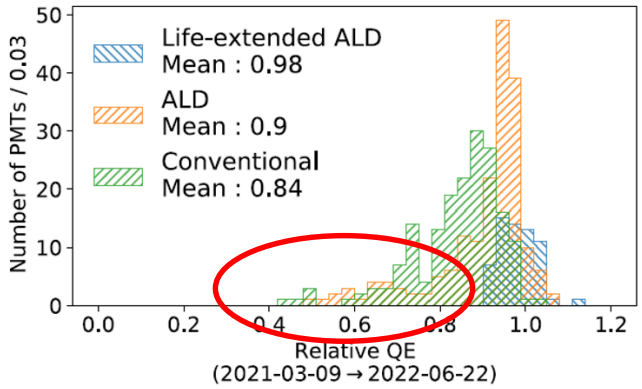
Production date dependence

- There looks the production date dependence.
  - Very short lifetime seems due to the production method.

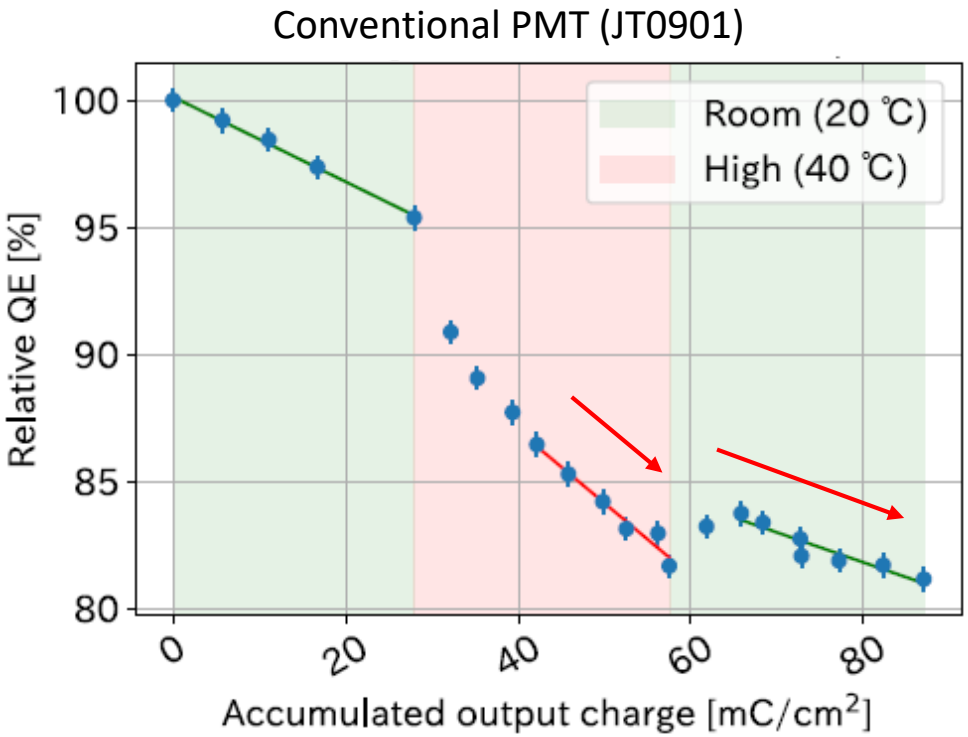
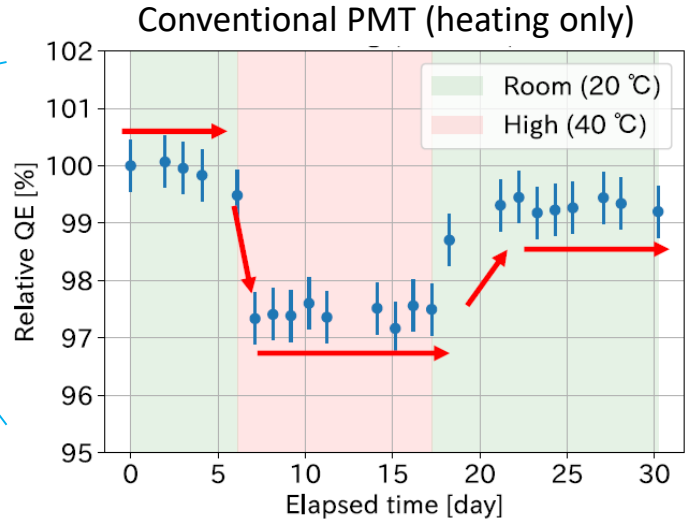
Lifetime test at high temperature

- Tested conventional PMTs
- There was a tendency of shorter lifetime for higher temperature
- Heating test without operation (no HV) performed as cross-check
  - Measured QE is stable under same condition
- Now , continue with other samples and different types.

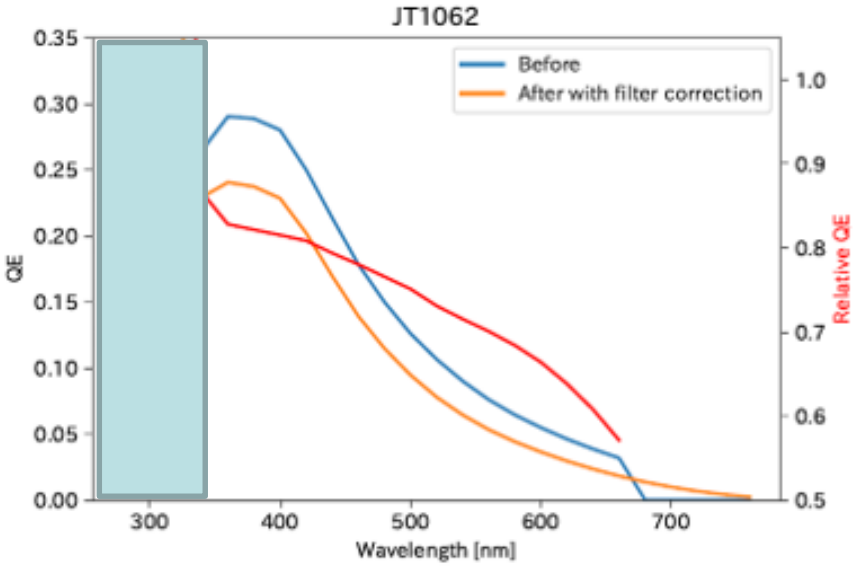
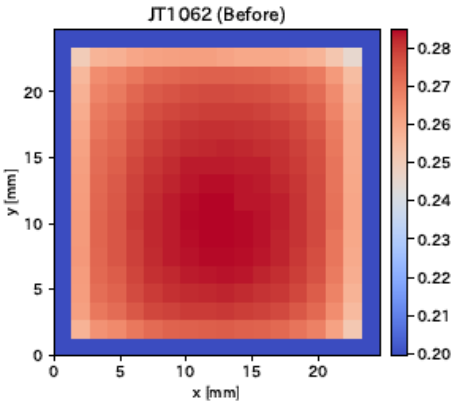
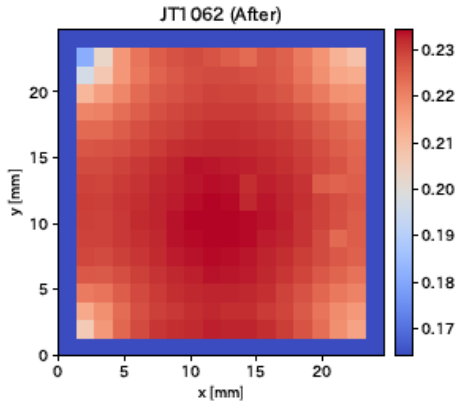
Check on uninstalled PMTs

- QE measurement in PMT module
  - Measurement with optical filter
  - Applied correction of transmittance and reflectance at boundaries (a few %)

- Found actual QE drop
    - » Similar degradation with lifetime test
