EXPERIENCE WITH THE VACUUM SYSTEM IN SuperKEKB

Y. Suetsugu
Accelerator Laboratory, KEK

SuperKEKB

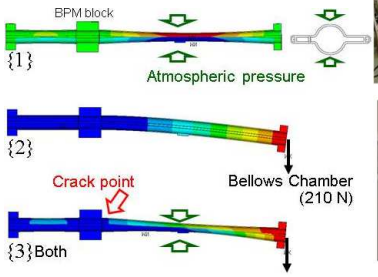
Stress calculation

- Beam pipes with antechambers
  - Welding lines (Tig welding) of aluminum beam pipes cracked just after starting evacuation in the tunnel (3 pieces).
  - Structural simulation indicated a high stress at top and bottom of the beam channel due to
    - Atmospheric pressure
    - Weight of bellows chamber at end, if not supported.
  - Be careful with non-circular beam pipes.

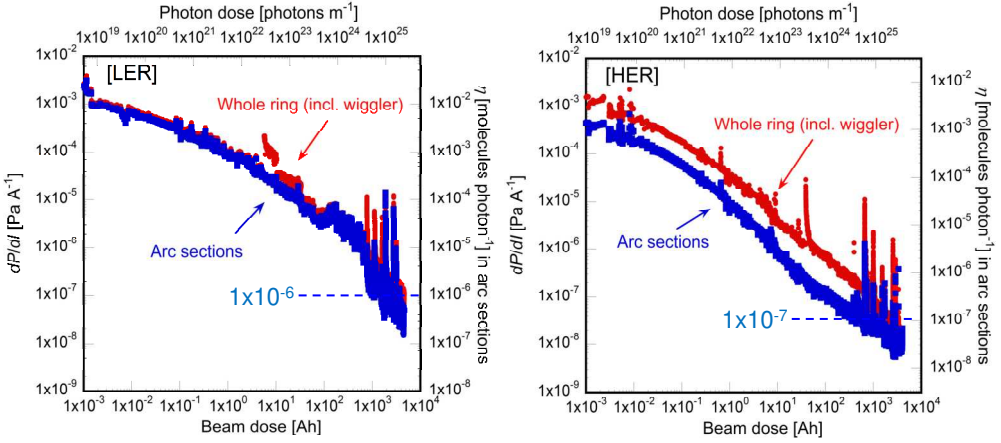
- Vacuum scrubbing (dP/dI vs beam dose, η vs photon dose)
  - LER: η decreased to less than 1×10^{-6} molecules photon^{-1}, at a photon dose of 2.5×10^{25} photons m^{-1}, here the pumping speed of 0.06 m^{3}s^{-1}m^{-1} is assumed.
  - HER: η is lower than that in LER. For arc section, where the beam pipes was reused, η decreased to less than 1×10^{-7} molecules photon^{-1}, at a photon dose of 3.7×10^{25} photons m^{-1}. → Memory effect

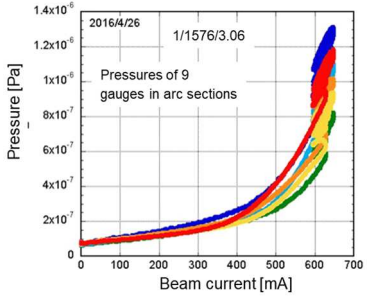
Pressure vs beam current

- Non-linear behavior of pressure against beam current due to ECE was observed at a beam current of ~900 mA during Phase-1 (w/o mag. fields).
  - EC → Electron multipactoring → Non-linear behavior of pressure
- TiN-coated beam pipes with antechambers at drift spaces were the source of EC.
  - Measured electron density is near to the threshold of the instability, ~3×10^{11} e^- m^{-3}
  - Permanent magnets around the beam pipes suppressed the non-linear pressure rise.
- This ECE was cured by permanent magnets around beam pipes after Phase-2.
  - Magnetic field of ~50 G in the beam direction.
- At present, any obvious signs of EC are not observed.

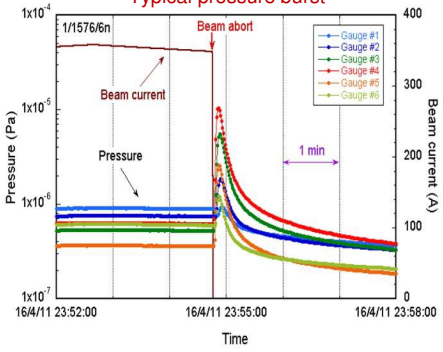
Typical pressure burst

- Beam aborts (losses) accompanied by local pressure bursts have been frequently observed in especially LER during Phase-1.
  - The locations of the pressure bursts have spread to more than 20 points along the ring.
  - In most cases, the bursts were observed near aluminum beam pipes in dipole magnets, with groove structure (a measure against ECE).
  - The beam-loss monitors at collimators triggered the beam aborts.
  - Beam loss lasted a few ms before the beam abort.

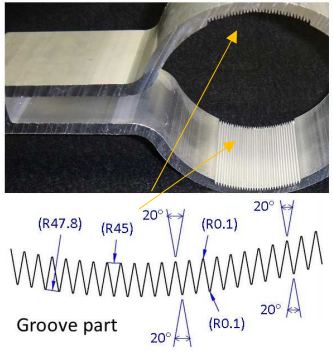
Groove in the beam pipe

- A possible cause: Collision of “dusts” with circulating beams.
  - Groove structure is likely to catch dusts.
  - Aluminum grooves were formed at the first stage of beam pipe fabrication, before cutting.
  - Lots of large dusts were gathered from a beam pipe after the knocking.
  - A “knocker” was set at a beam pipe in a bending magnet, where the burst had been observed frequently, and we could reproduce the phenomena by knocking it.
- As a countermeasure, we knocked most of beam pipes in bending magnets (with groove) around the ring before Phase-2.
  - The reduction of the frequency of bursts was observed after Phase-2.
  - Continue to be careful at higher beam currents.

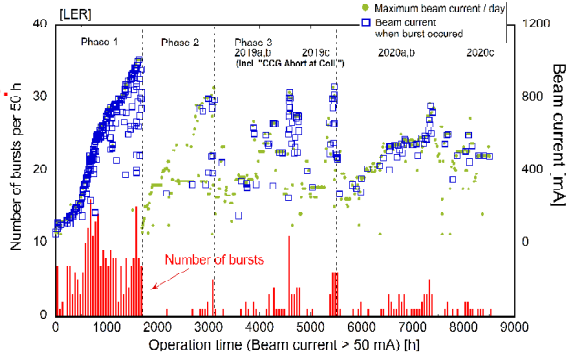
History of beam aborts accompanied by pressure bursts

- Beam aborts (losses) accompanied by local pressure bursts have been frequently observed in the LER during Phase-1.
    - Knocking of beam pipes seems working to some extent after Phase-2.

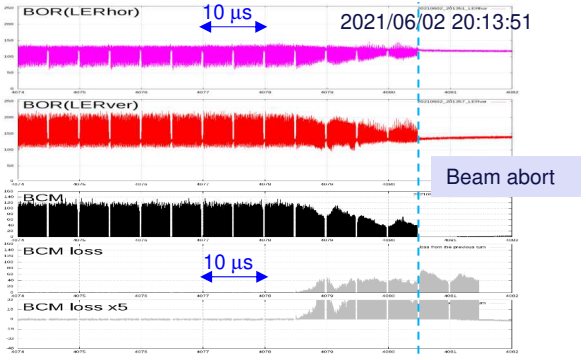
Typical records of BOR (Beam Oscillation Recorder)

- Recently, rapid (in 20~30 μs = 2 ~ 3 turns) heavy beam losses have been observed in (mostly) LER and HER.
  - Sometimes, it resulted in damage of collimator head and QCS (SCC final focus magnets) quench, and also damage of detectors.
  - No clear transvers oscillation has not been observed by BOR (Bunch Oscillation monitor)
- The cause has not been clarified yet.
  - Possible causes will be “dust event” and/or beam instability.
  - However, the beam loss is so fast, and simulations so far have not been able to explain the phenomena.
  - Preparation of more loss monitors around ring is planned to identify the origin points of these losses.
- An urgent issue to be solved to increase beam current further.
