# **QPS - analysis of main problems, areas to target, possible improvements**

R. Denz, TE-MPE-CP

Evian 2011

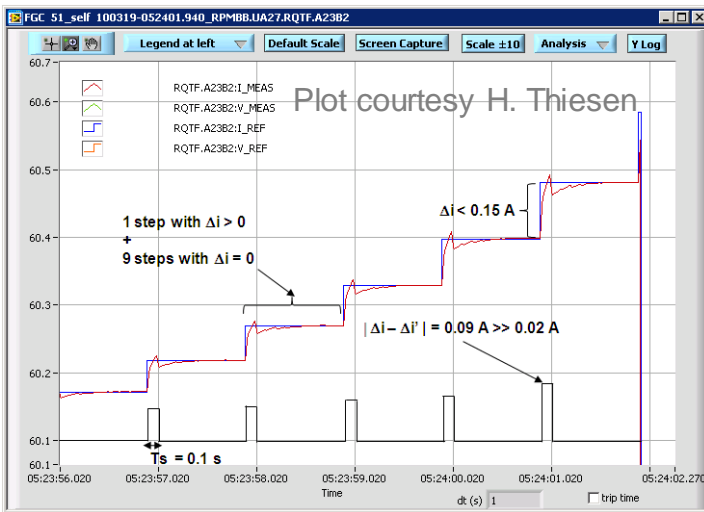
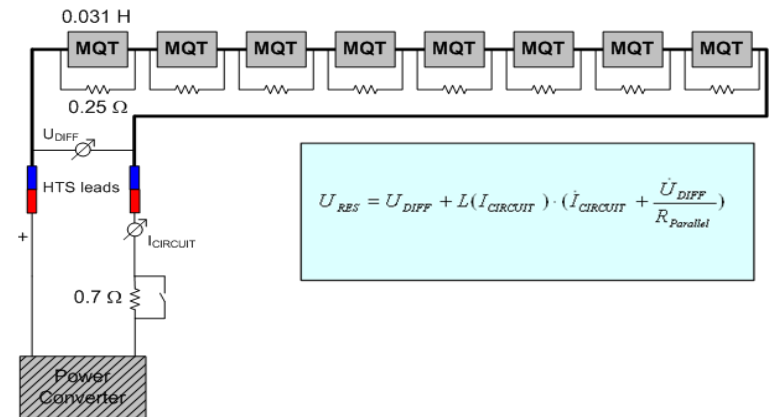
- ➔ The tune feedback applies only small changes in current but creates a voltage signal, which QPS cannot distinguish from a real quench
- ➔ As first mitigation measure the discrimination time of the detection systems has been increased to  $t_{EVAL} = 190$  ms
- ➔ In 2011 there were still a significant number of trips e.g. during squeeze
  - re-evaluation of detection settings has been launched (→ A Verweil)
- ➔ [ If the tune feedback is applied with  $|| > 100$  A (e.g. after LS1) further mitigation and consolidation measures will become necessary.
  - $\pm 2$ V,  $t_{EVAL} = 190$  ms,  $|| < 100$  A
  - $\pm 100$  mV,  $t_{EVAL} = 190$  ms,  $100$  A  $\leq || \leq 200$  A,  $||_{MAX} \leq 200$  A

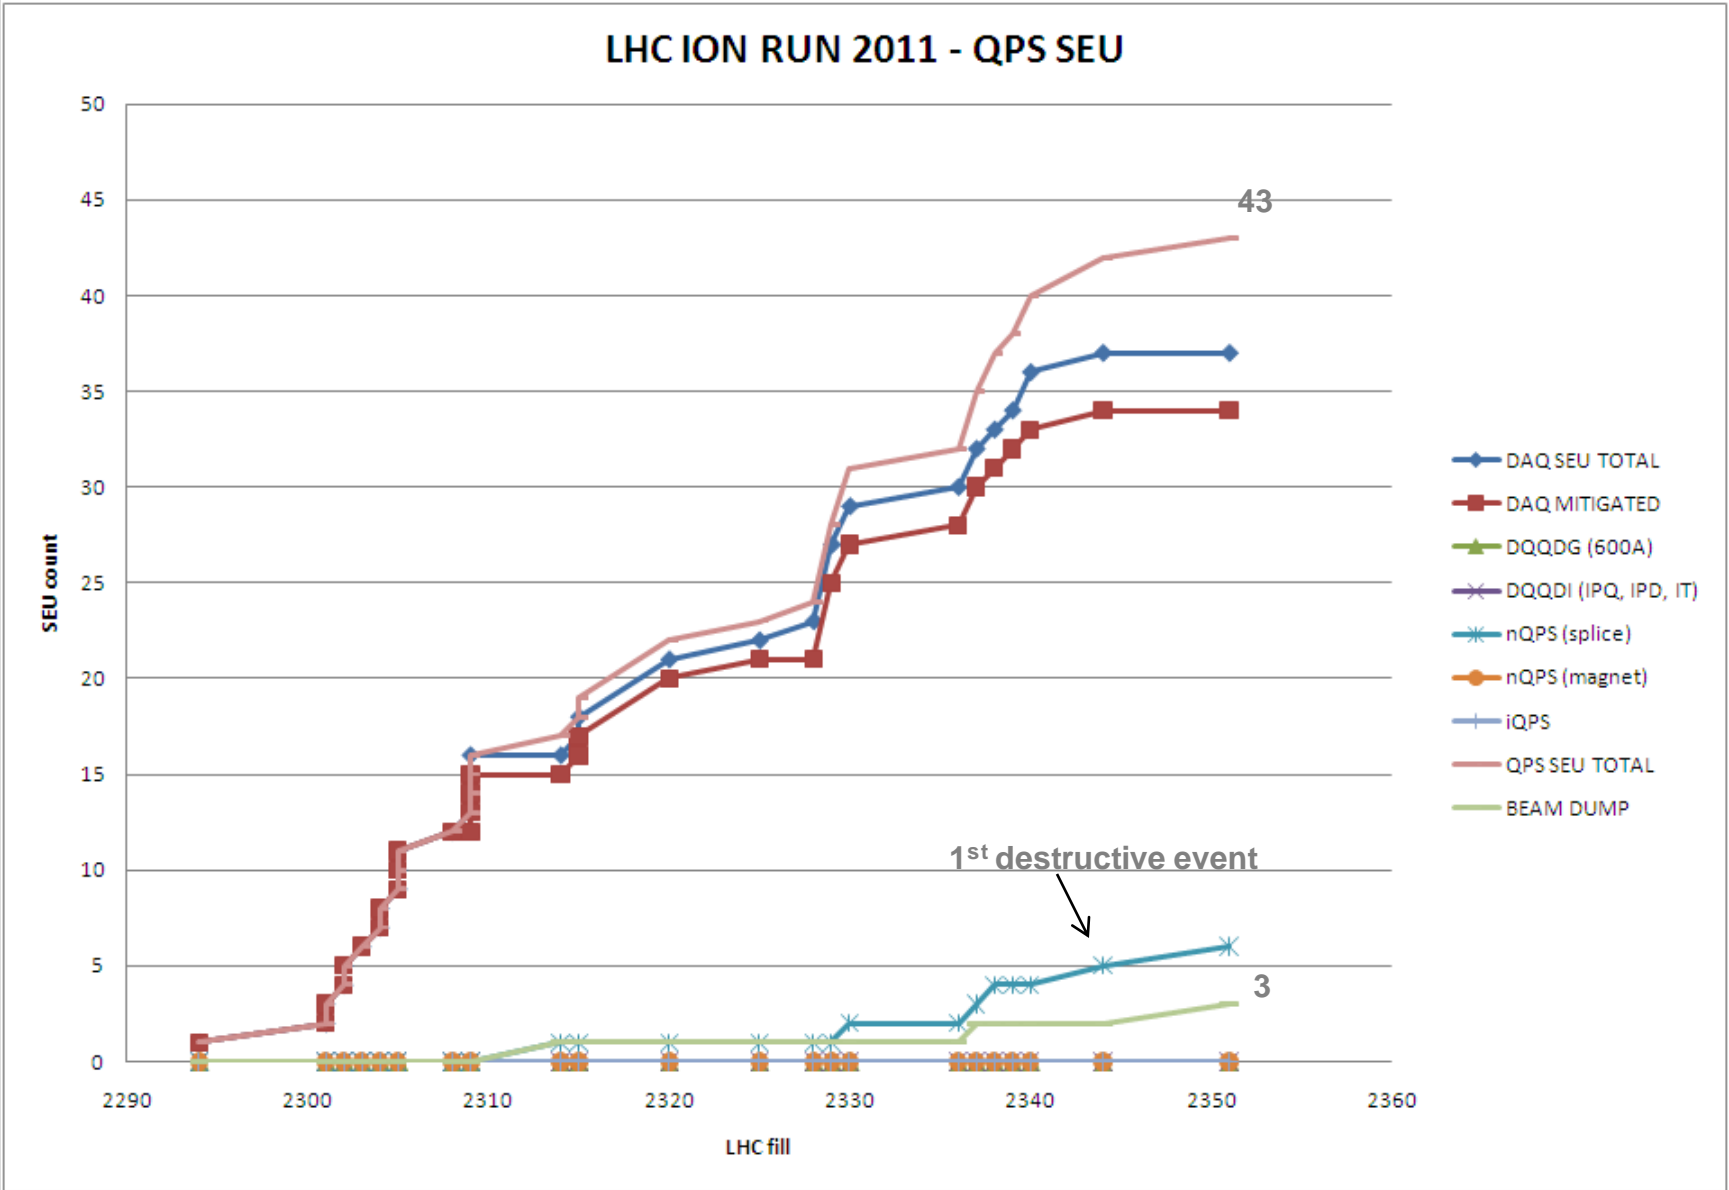
**System**

**Locations**

DQQDI (IPQ, IPD, IT)

UJ14, UJ16 (2x) , RR17, RR53, RR57

DQQDG (600 A)

UJ14 (2x), UJ16 (3x), RR17, RR73, RR77 (3x)

nQPS (splice protection)

B8L1, B11L5, B11R5, B9L8

Detection system type	Exposed systems	Radiation induced spurious triggers
DQQDL (MB & MQ protection, analog, radiation tolerant)	4032	0
DQQDS (MB & MQ protection, digital, radiation tolerant)	1632	0 (1 caused by host controller during ion run)
DQQDG (600 A, digital, partly hardened)	250 out of 836	10
DQQDI,T (IPQ, IPD, IT, digital, partly hardened)	138 out of 408	6
DQQBS (nQPS splice protection, partly hardened)	2068	6 (2 during ion run)
DQQDC (HTS lead protection, partly hardened)	508 out of 1198	0

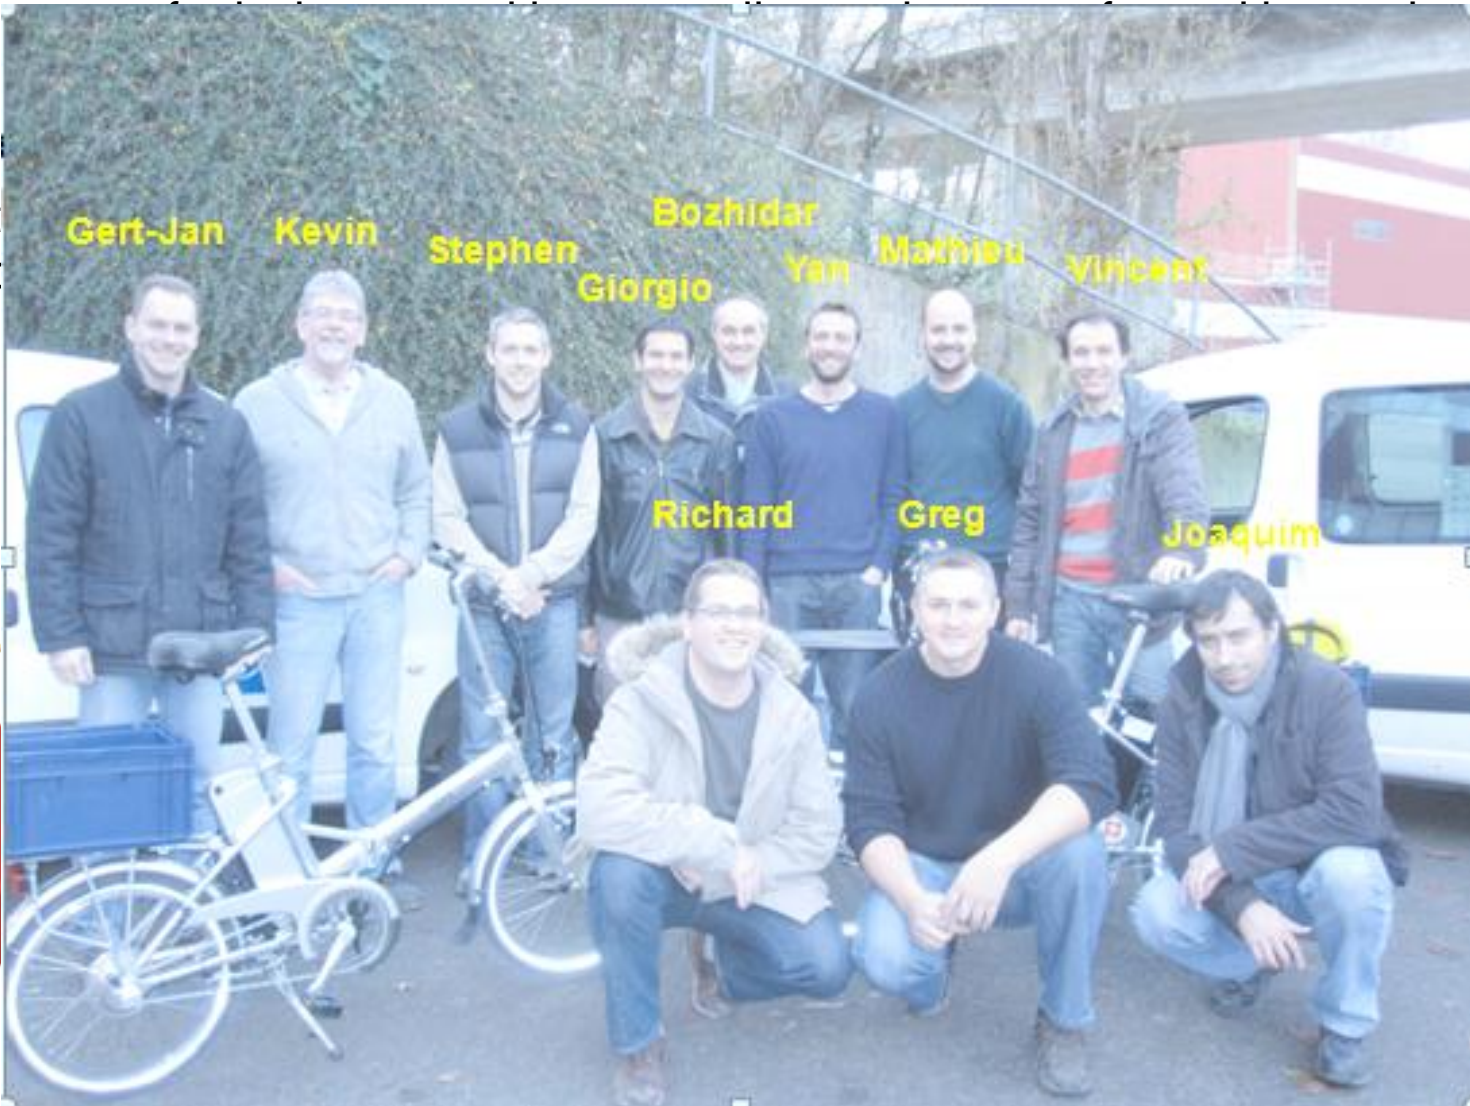
- During the LHC exploitation a round-the-clock support to operation in case of space issues is provided by the MPE stand-by service.
- Interventions are recorded 24/7.

Energy extraction  
5
