LHC Beam Operation workshop - Evian 2011

Injection and Dump System

W. Bartmann, M.J. Barnes, C. Bracco, E. Carlier, B. Goddard,
V. Kain, M. Meddahi, V. Mertens, J. Uythoven, L. Drosdal

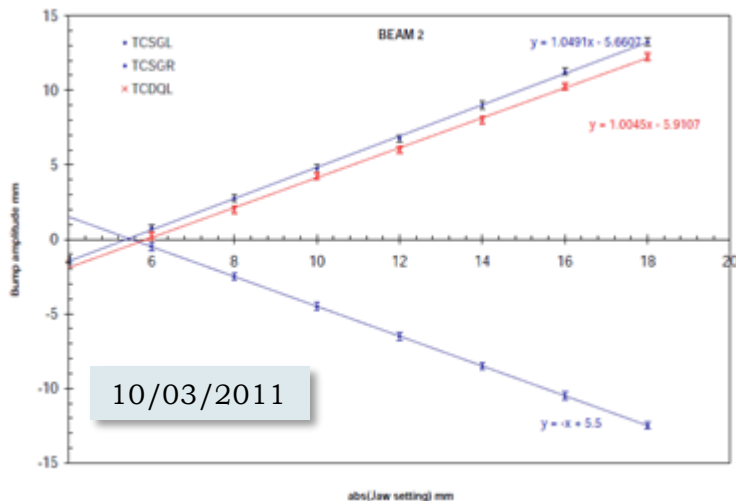
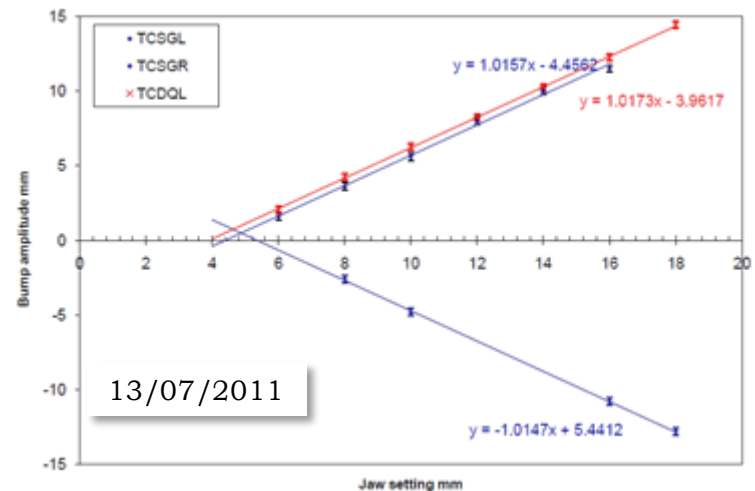
Other problems with TCDQ

- ▶ Problems with running **TCDQ sequence**, **loading settings** and **thresholds** → generally solved repeating sequence and/or running ramp (in some cases the beam had to be dumped)
- ▶ **Mechanical offset:**
 - ▶ Measured on 10/03/2011 and compensated by adding:
 - ▶ B1: -0.25 mm for all settings
 - ▶ B2: +0.5 mm at 3.5 TeV setting and +1 mm at 450 GeV
 - ▶ B2 TCDQ offset “Corrected” during TS → previously defined settings non more valid → TCDQ offset put back **but** in the wrong direction → offset had to be re-measured (2 hours) → new settings
 - ▶ B2: -0.6 mm for all settings

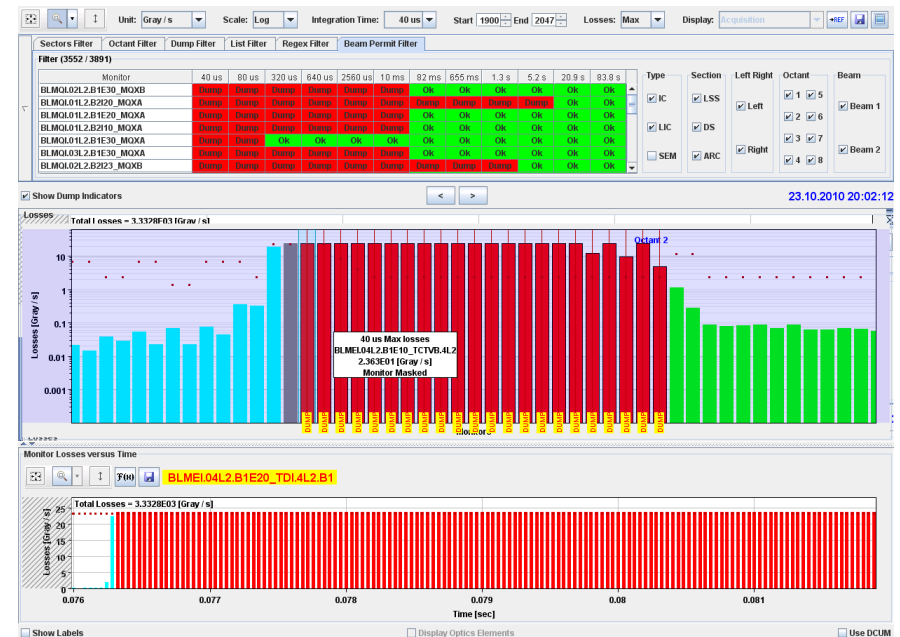
- ▶ Abort Gap Keeper (AGK) prevented MKI from firing → Train of **32 bunches dumped on upper TDI jaw** → showers to ALICE
- ▶ Losses in ALICE in agreement with simulations (further benchmarking data from TDI grazing tests) → **ALICE ready for 288 bunches on TDI**
- ▶ LHCb, only grazing tests with TDI

No indication of limits on injected intensity: 288 bunches OK! **BUT TDI must be correctly set up!!**

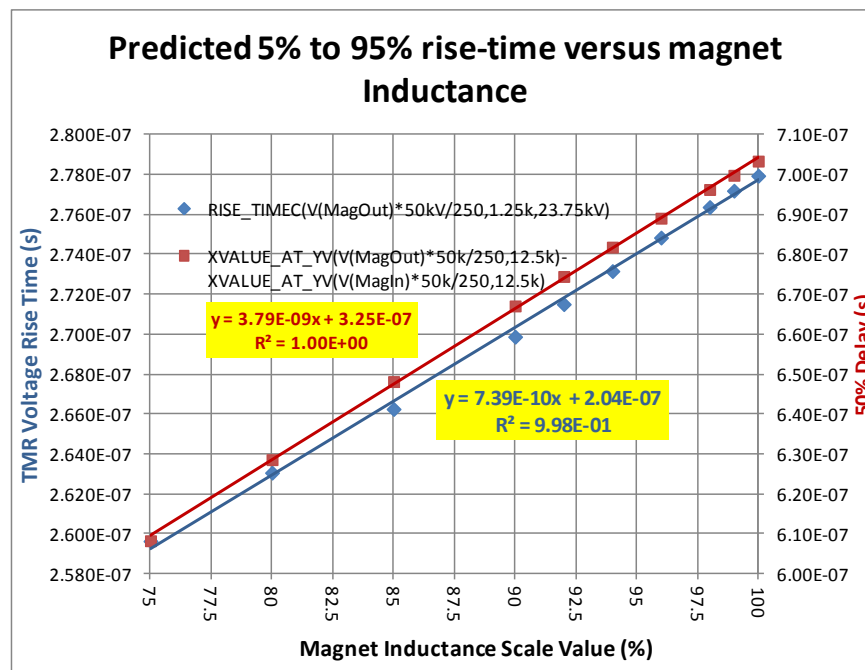
Softstart \rightarrow measure rise-time \rightarrow indirect measurement of inductance (temperature)

During Xmas stop: new diagnostic to measure delay (more sensitive)

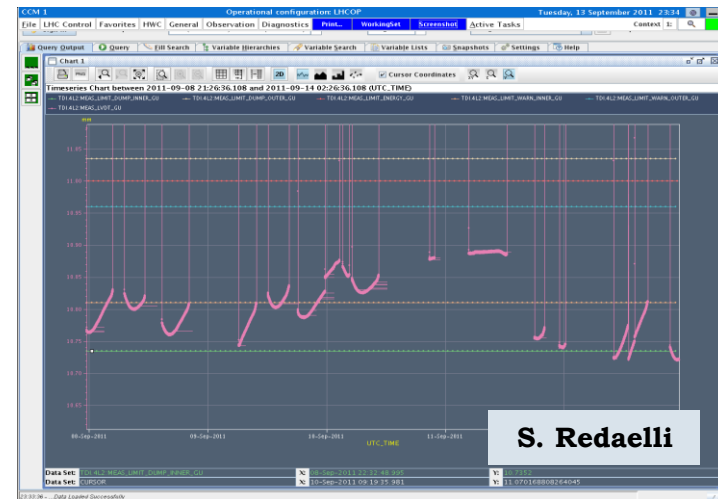
- ▶ TDI.4L2 controls problem:
 - ▶ required setting different from measured motor position
 - ▶ Noise in the measurement of jaw positions → gap opening outside limits → TDI.4L2 gap interlocks changed by $100\mu\text{m}$ to avoid interlocks due to drift of the position reading triggered by electromagnetic noise

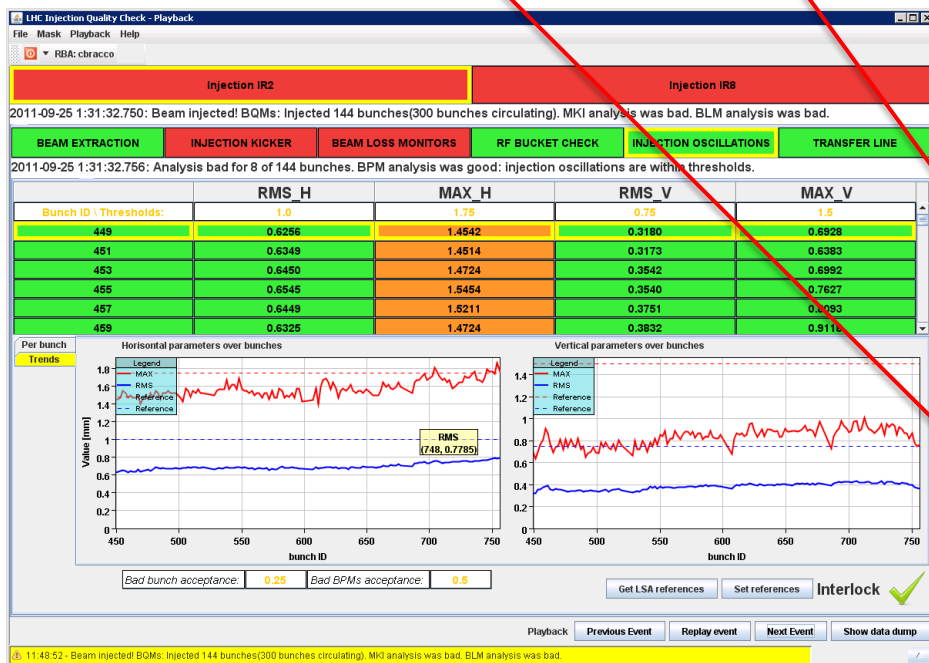
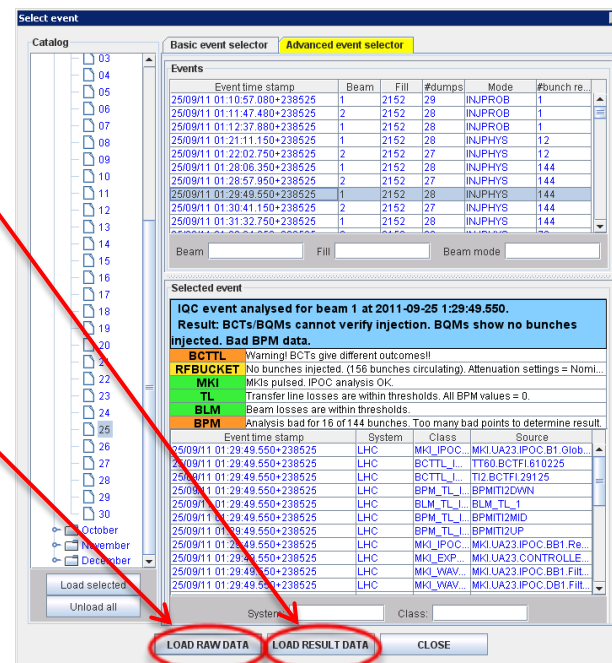
IQC

- ▶ Injection oscillations max/rms vs bunch number;
- ▶ Playback: actual or of the date reference thresholds
