LHC Beam Operation workshop - Evian 2011

Injection and Dump System

W. Bartmann, M.J. Barnes, C. Bracco, E. Carlier, B. Goddard,
V. Kain, M. Meddahi, V. Mertens, J. Uythoven, L. Drosdal

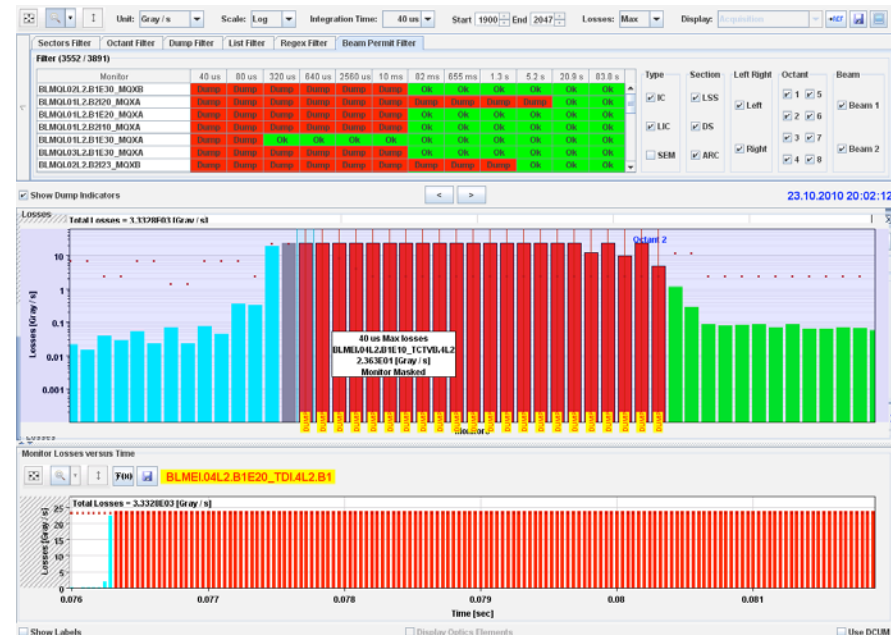
- ▶ Abort Gap Keeper (AGK) prevented MKI from firing → Train of **32 bunches dumped on upper TDI jaw** → showers to ALICE
- ▶ Losses in ALICE in agreement with simulations (further benchmarking data from TDI grazing tests) → **ALICE ready for 288 bunches on TDI**
- ▶ LHCb, only grazing tests with TDI

No indication of limits on injected intensity: 288 bunches OK! **BUT TDI must be correctly set up!!**

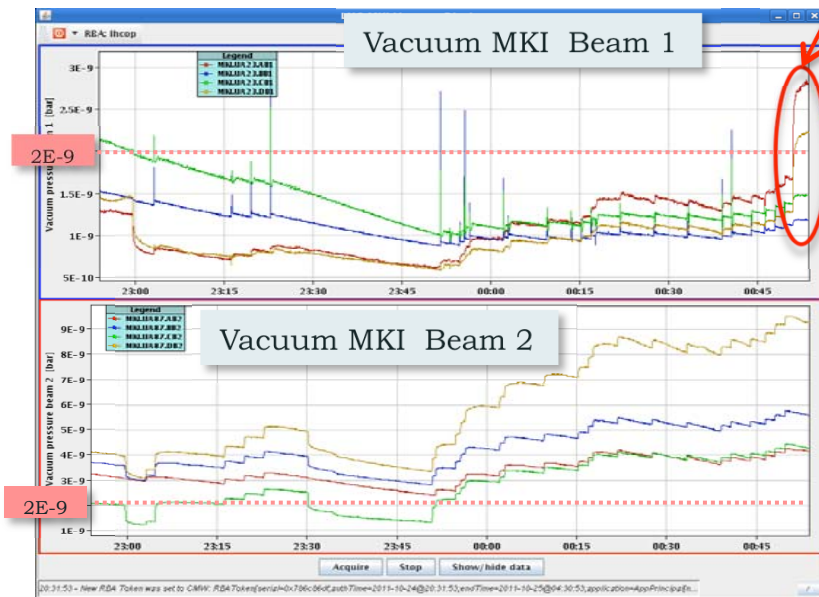
Solenoid switched off

- To avoid possible vacuum/breakdown problems with the MKIs, solenoids:
- ▶ ON during normal operation
 - ▶ OFF during scrubbing provided pressure does not become too high (respect SIS injection interlock)
 - ▶ In future, possible to include a $\int P \cdot dt$ interlock (under study)

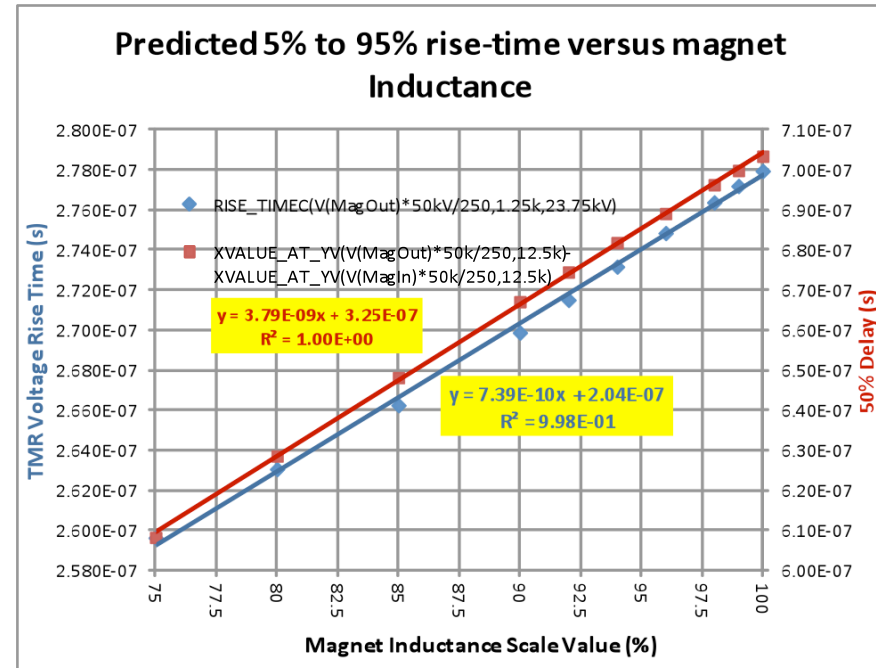
Ferrite Heating Measurements in Clean Room:
Curie point of ferrite corresponds to 106 °C measured on ground plates

- ✓ Magnet **inductance** decreases with reducing ferrite permeability → magnet strength decrease
- ✓ **Rise-time** decreases with reducing inductance and/or capacitance
- ✓ **Delay** decreases with reducing inductance and/or capacitance

Softstart → measure rise-time → indirect measurement of inductance (temperature)

During Xmas stop: new diagnostic to measure delay (more sensitive)
