# INJECTION AND DUMP SYSTEM

C. Bracco, W. Bartmann, M.J. Barnes, E. Carlier, L.N. Drosdal, B. Goddard, V. Kain, M. Meddahi, V. Mertens, J. Uythoven, CERN, Geneva, Switzerland

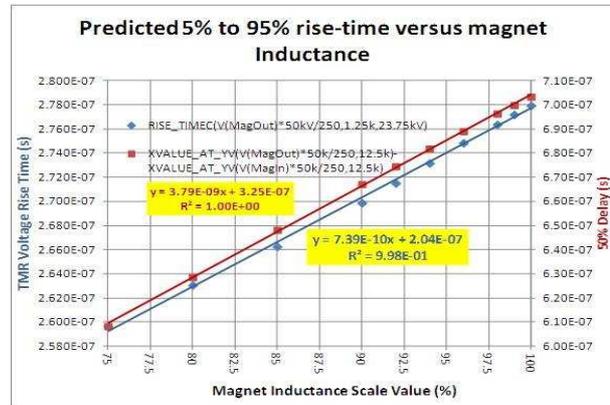
A direct measurement of the ferrite inductance could be obtained by quantifying the beam deviation from the nominal deflection. Indirect measurements can be performed during the soft-start. In particular one can measure either the MKI rise time or the delay; both decrease linearly

with reducing magnet inductance (see simulation results in Fig. 3). At present the rise time method is used; new diagnostic will be installed, during the 2011/2012 Christmas Stop, allowing for more sensitive delay measurements.

Figure 3: MKI Rise time and delay are plotted as a function of the ferrite magnet inductance (simulations results). These two quantities can be measured during the soft start and provide an indirect measurement of the kicker strength.
