Existing Hardware Machine components

Frank Tecker - AB/OP
for the CTF3 Team

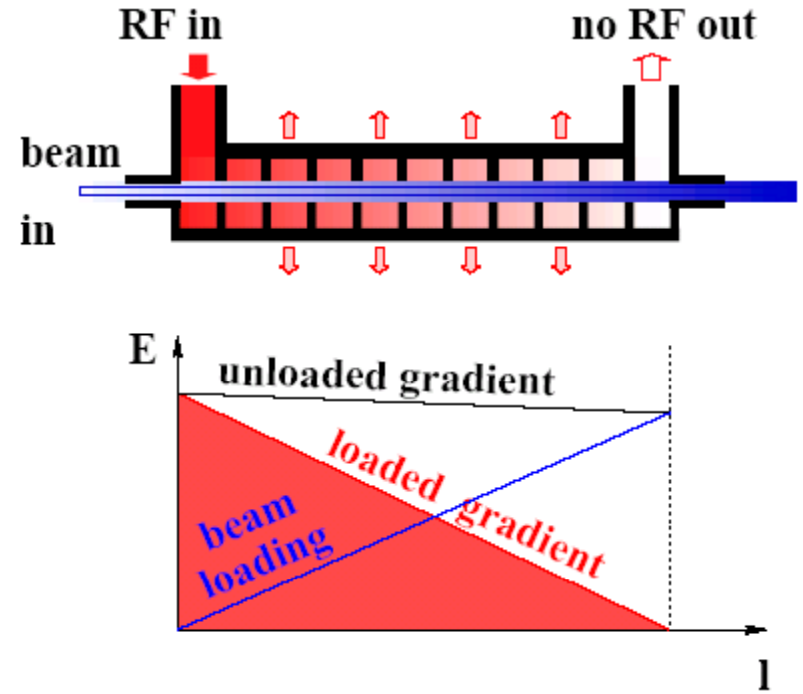
Gun – Current stability

- Current stability **crucial** because of full beam-loading in the linac

1% current variation = 1% energy variation

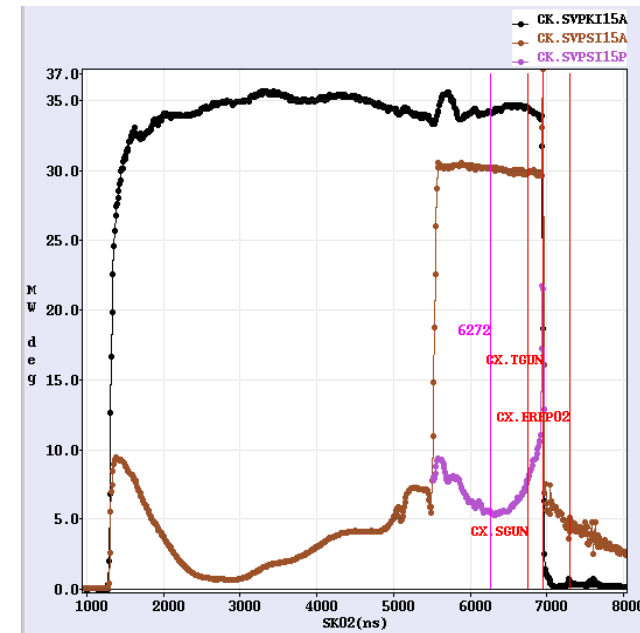
Klystrons + RF

- Need all 11 klystrons available reliably for proper operation
- Klystron trip consequence:
 - Direct down time
 - Recuperation time (for RF pulse compression)
 - temperature change in LIPS/BOC cavities
 - phase adjustment
- Set-up of power level with margin to avoid trips
- Important: proper conditioning at the beginning
- Plan in sufficient time in the schedule
- Remark: small team of specialists, very efficient but limited

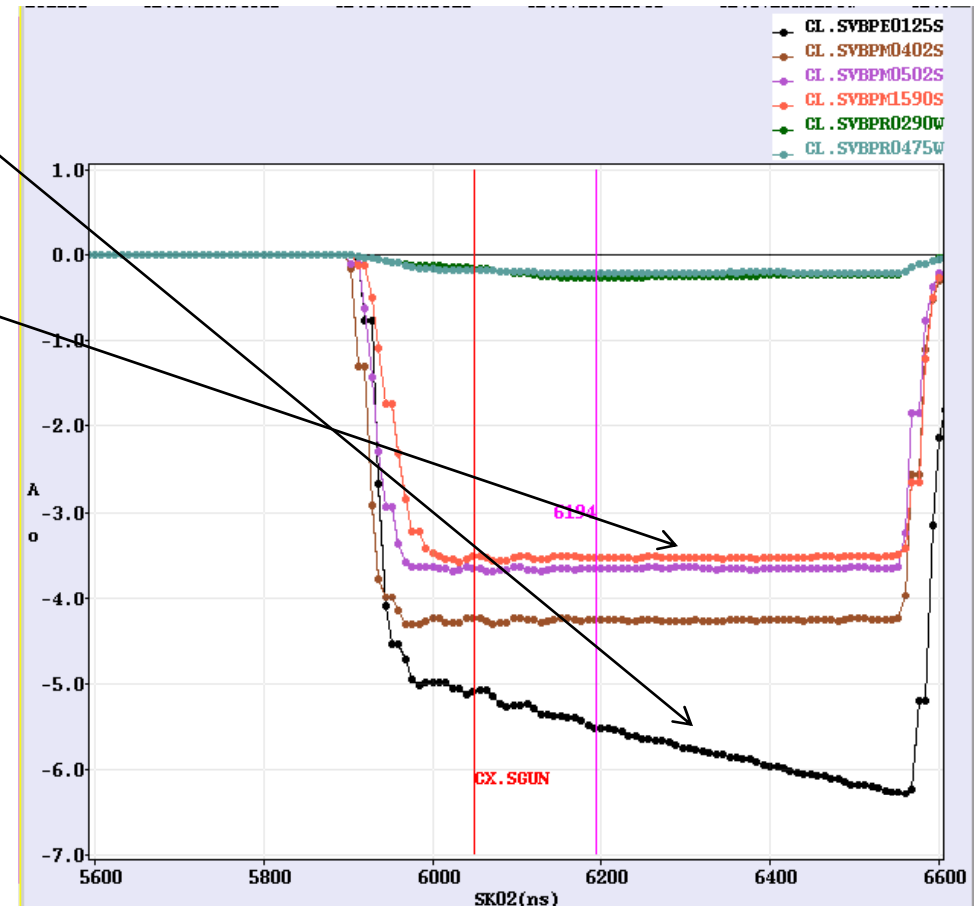
BPMs and WCMs

- We have different types of current / Beam Position Monitors (different chamber geometry) with different electronics
- **BPE**: electrostatic, in solenoids charge up during pulse, bias test not successful
- **BPM**: circular, **working very well** since the beginning
- **BPR**: RF BPM working well, one phase-shifter needs proper remote control
- **WCM** (Wall Current Monitor): working well, basically unused foreseen beam loss system
