# Quality assurance of TOTEM T2 GEM detectors

Timo Hildén

Helsinki Institute of physics

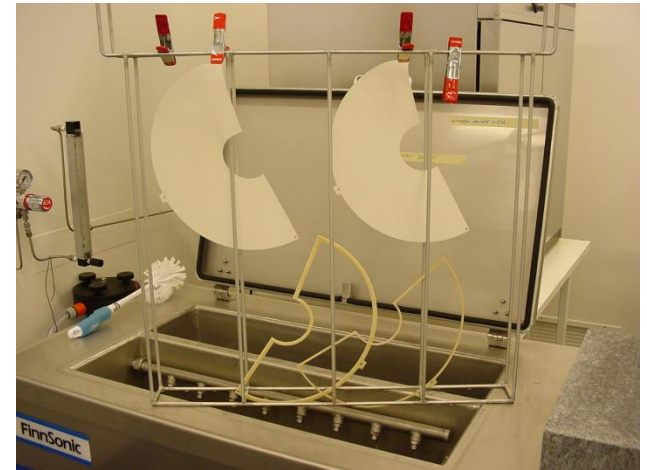
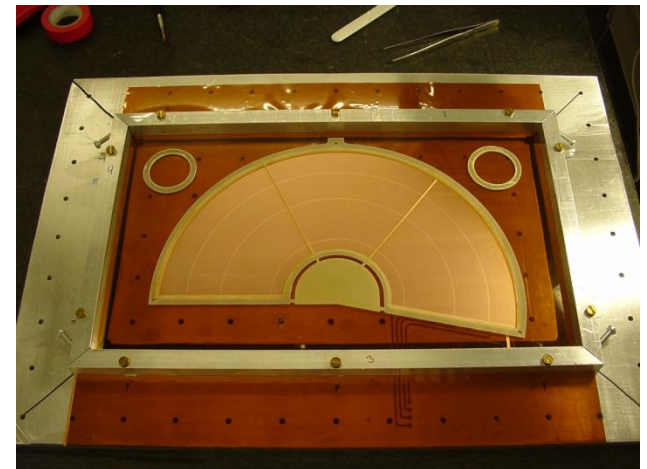
- Cleaning in ultrasonic bath
- Fibers sticking out from the frames after machining - Nuvovern coating
- High voltage tests with 5000 V after Nuvovern treatment
- Foils were stretched with a special stretcher for framing
- Foil tension samples taken occasionally on ring-like frames

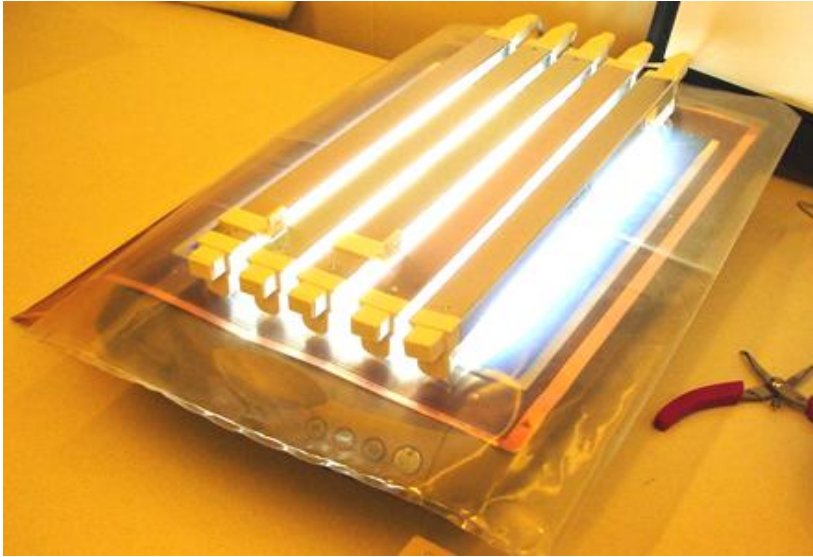
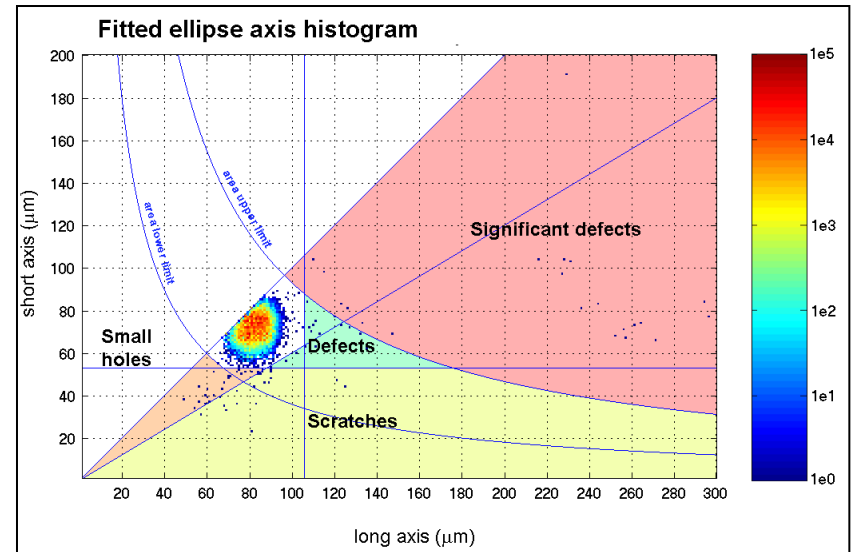
- Optical scanning method was developed utilizing Commercial flatbed scanner with blue diffuser and a background lighting setup
- scanning with resolution of 2400 dpi – pixel size  $\sim 10 \mu\text{m}$ .
- Images archived for later inspection
- more sophisticated system was developed later

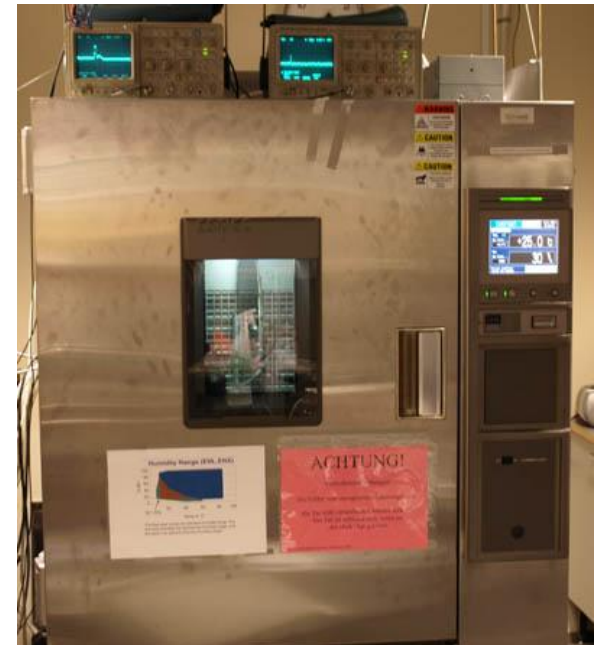
- Problems with HV system in humid conditions
- A layer of Dow Corning conformal coating was supplied over the HV board and the Polyimide HV strips outside the chamber
- Environmental chamber to test the detectors in 50% humidity with nitrogen
- Stability tested for 12 hours in 4.5 kV, eventually ramped up to 5 kV for an hour
