EAR1 Beam Line - Report on the Status

Oliver Aberle, EN/STI

n_TOF Collaboration / Collaboration Board

November 2013

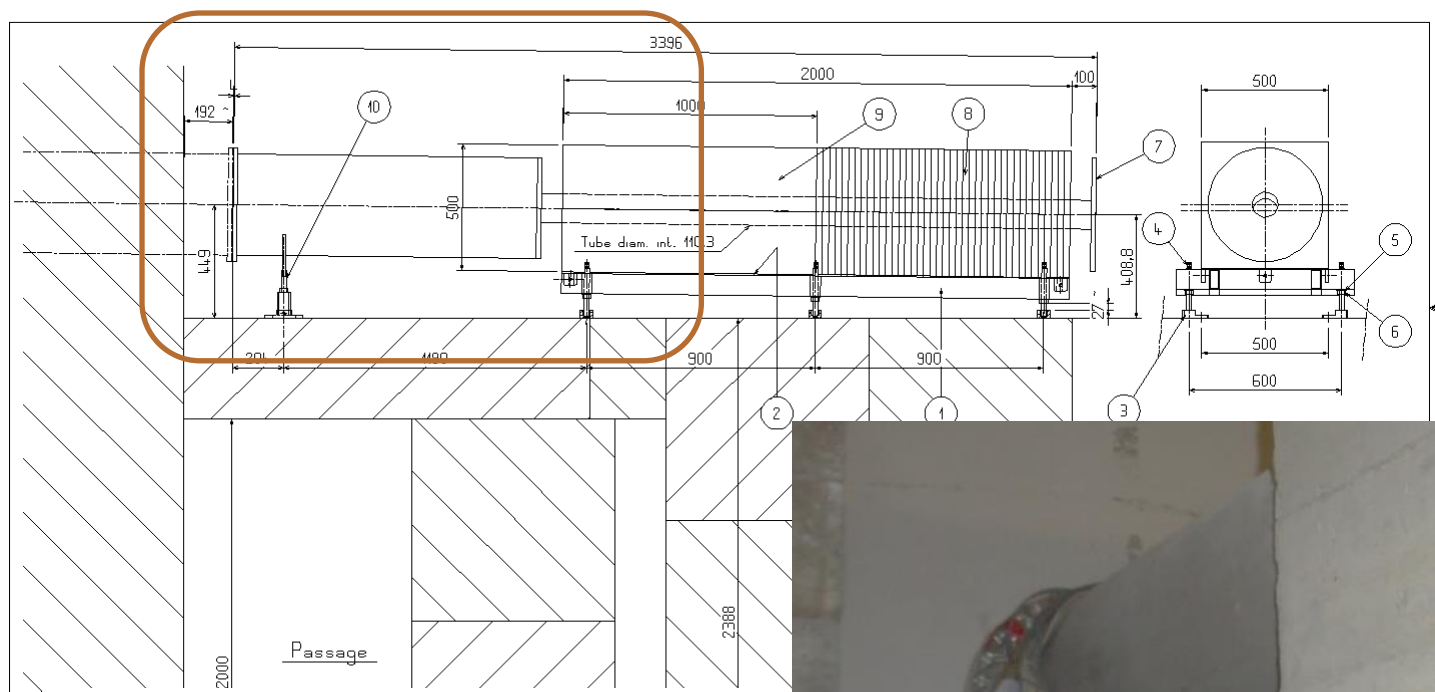
Collimator No. 1

Collimator 1 was found to be misaligned by 1.9 cm H, 0.75 cm V, during the realignment campaign in 2010 (see MC [C.B. April 2010](#))

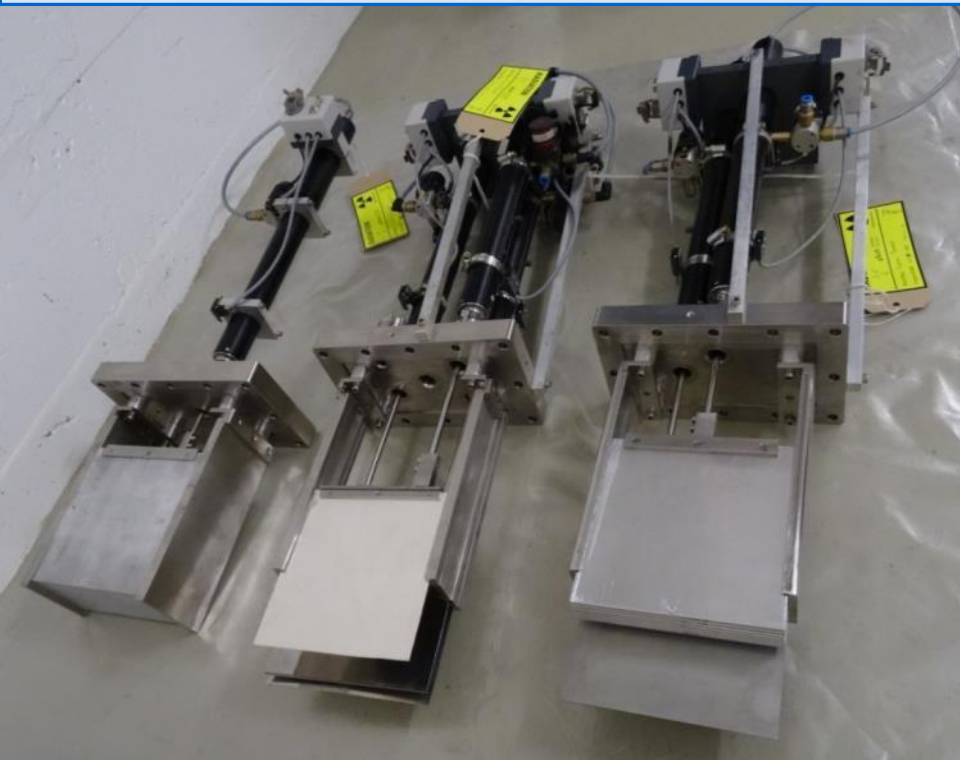
Filter box

1	Al 80 mm	ok	4 x 20 mm
2	Ag 0.5 mm	ok	5 x 0.1 mm
3	not used		
4	W 0.8 mm		1 x 0.6 + 1 x 0.3 mm?
5	Co 0.25 mm	ok	2 x 0.125?
6	not used		
7	Mo 1.0 mm	ok	1 x 1 mm
8	Al 30 mm	ok	6 x 5 mm

- 3 ports
- 1, 2 and 5 feed-throughs
- Are there material/thickness changes needed compared to the existing ones?

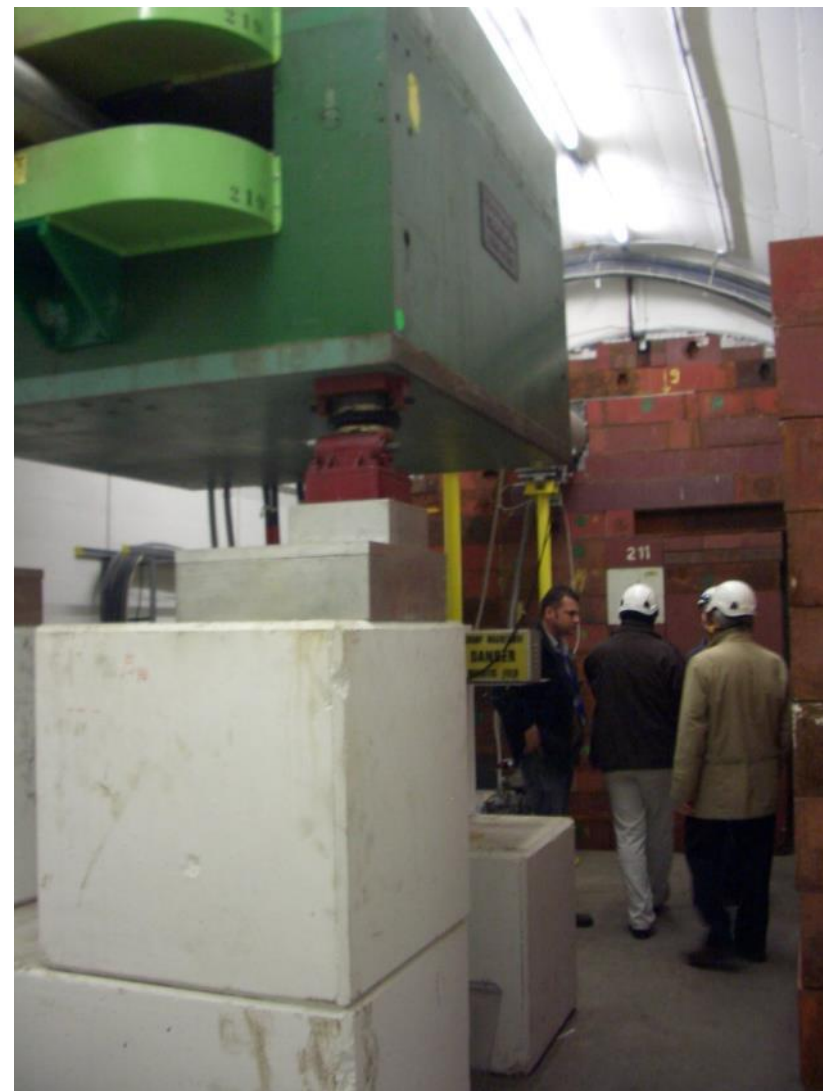
Consolidation

- Old magnet, power supply without spare parts ✘
- Vacuum layout modifications (first collimator, window) ✔
- RP monitoring (e.g. Cooling water sampling) ✔
- Implementing existing equipment into the new DAQ ✔
