## The Sector 3-4 incident

Ph. Lebrun *on behalf of the*  
Task Force on the Analysis of the 19 September 2008 Incident

LHC Performance Workshop 2009  
Chamonix, 2-6 February 2009

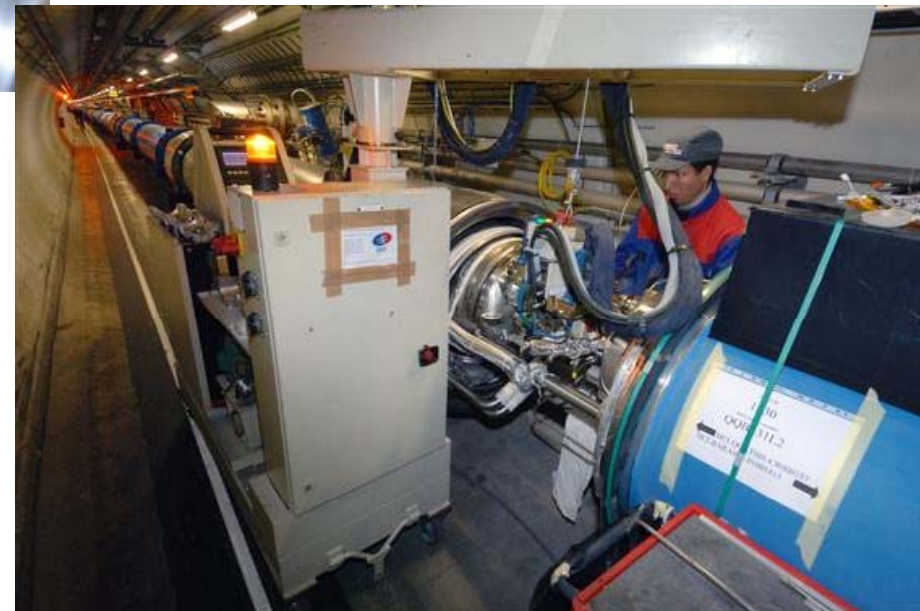
History of interconnections in sector 3-4 (Oct 2006-July 2007) shows no particular cause of defect, but worst working conditions of all machine:

- low temperature and humidity in tunnel
- low productivity of industrial staff (Jan 2007) following contract policy of company

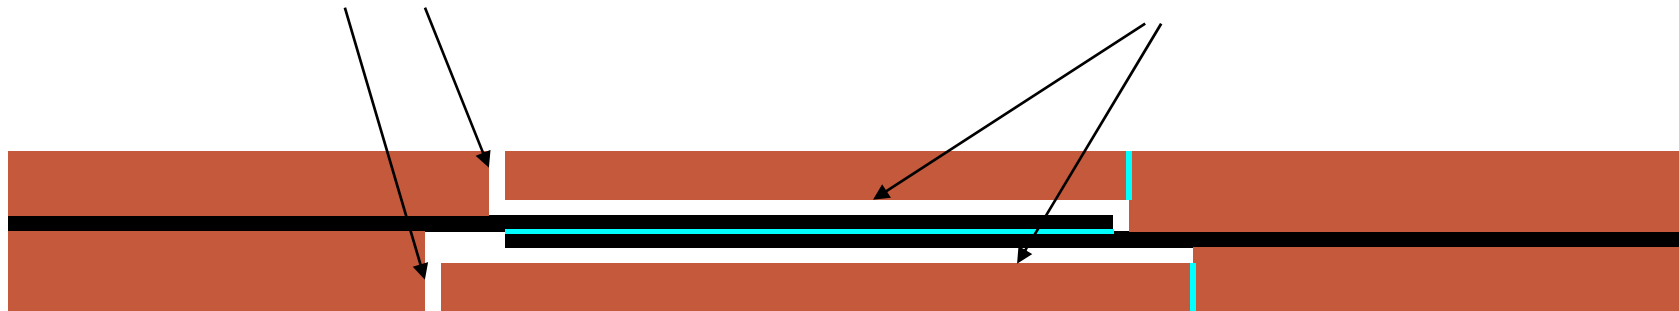
A resistive joint of about  $220 \text{ n}\Omega$  with bad electrical and thermal contacts with the stabilizer

No electrical contact between wedge and U-profile with the bus on at least 1 side of the joint

No bonding at joint with the U-profile and the wedge

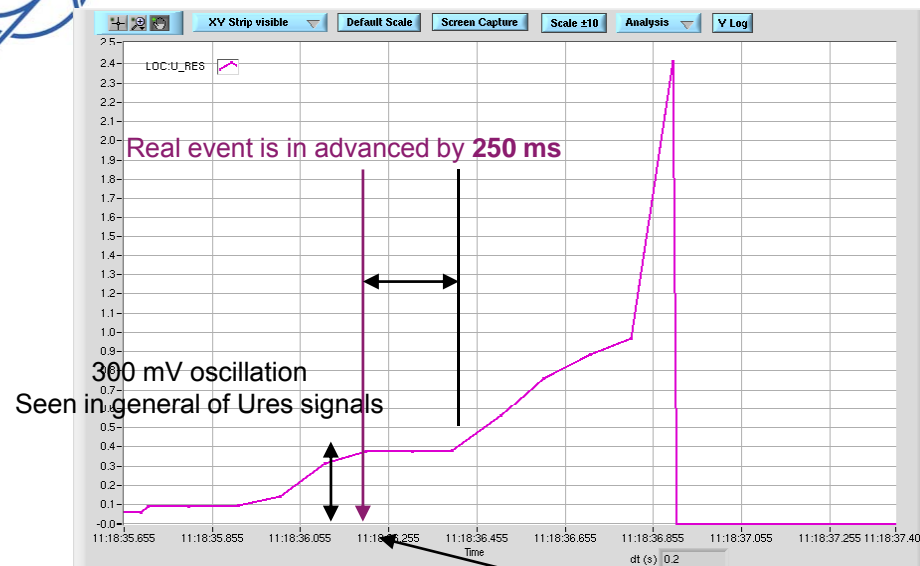
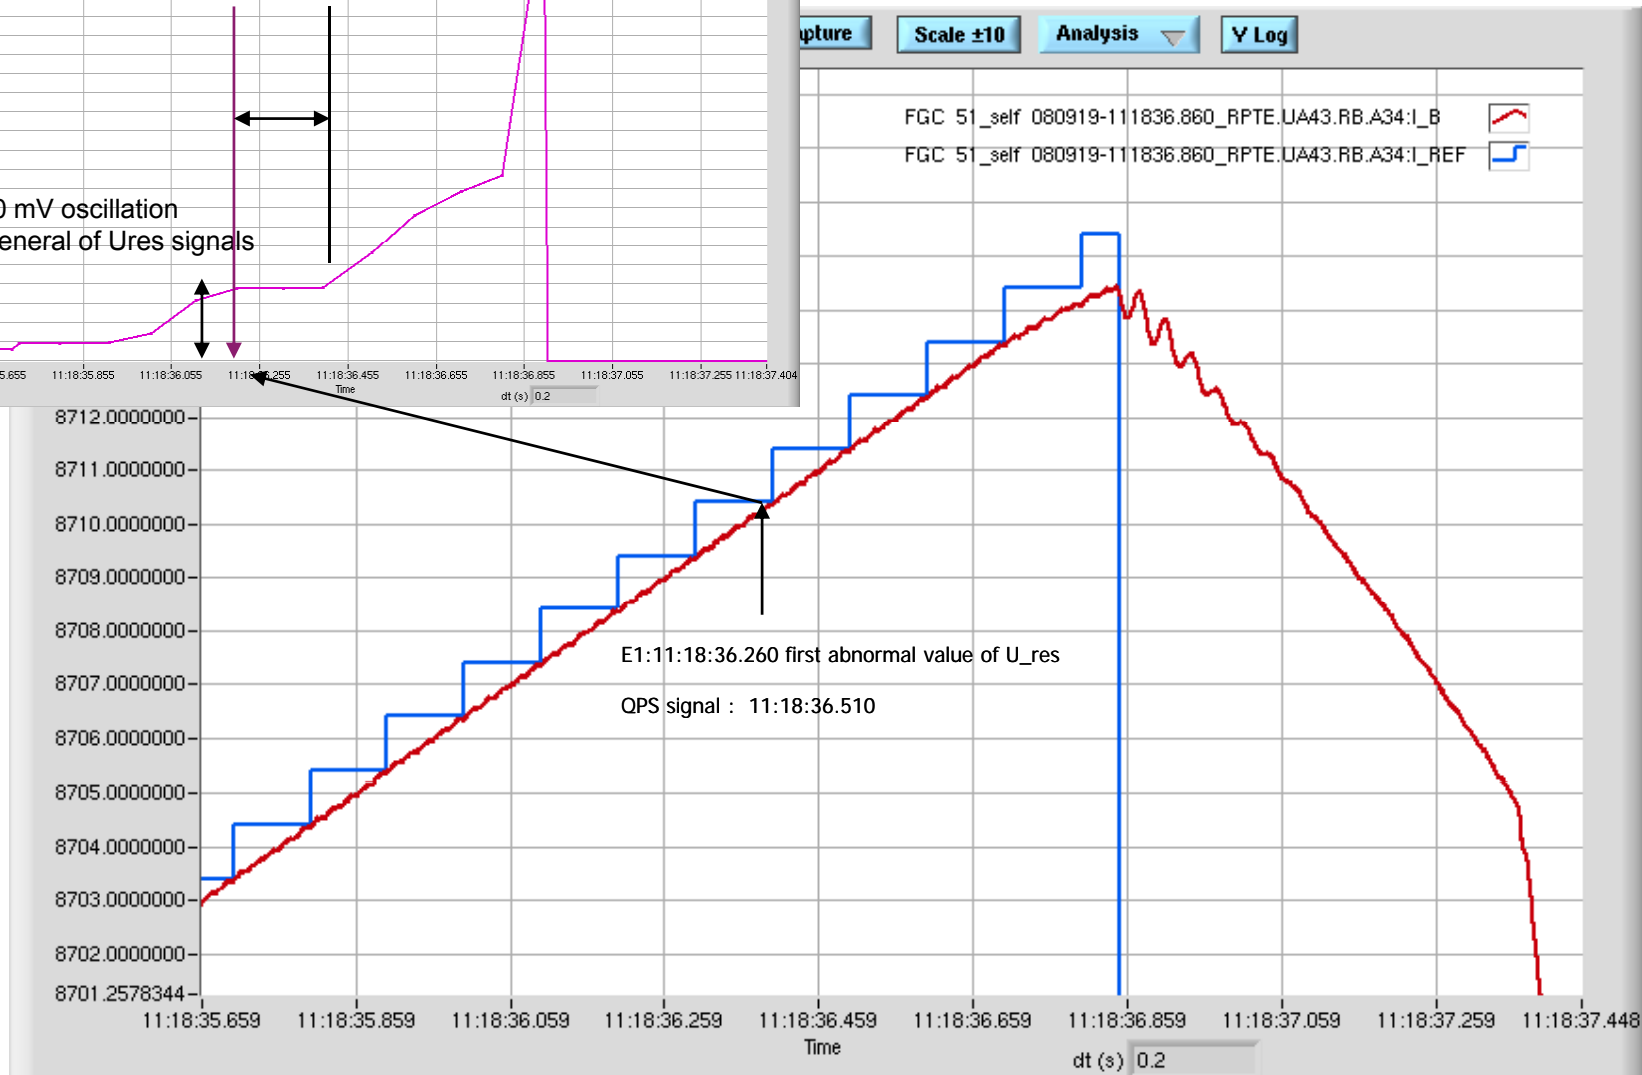
# Event Nr. 1 @ 11:18:36.260

## Abnormal value of U<sub>res</sub> of bus bar detector

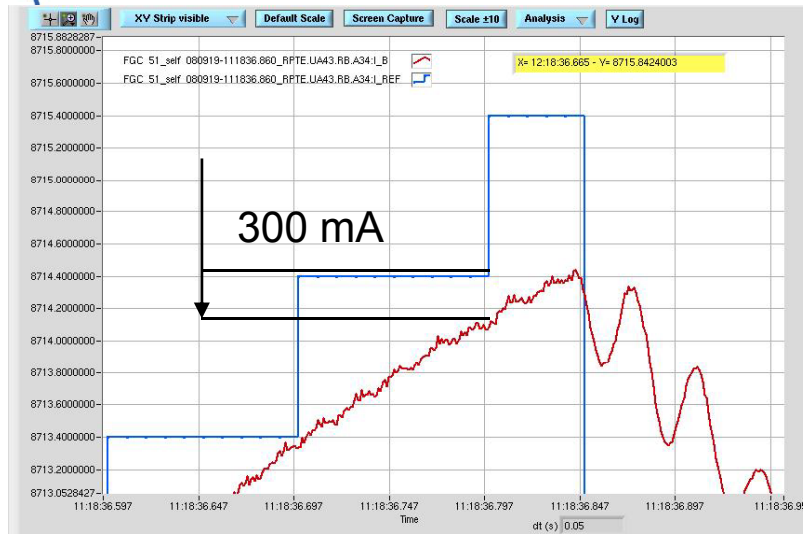
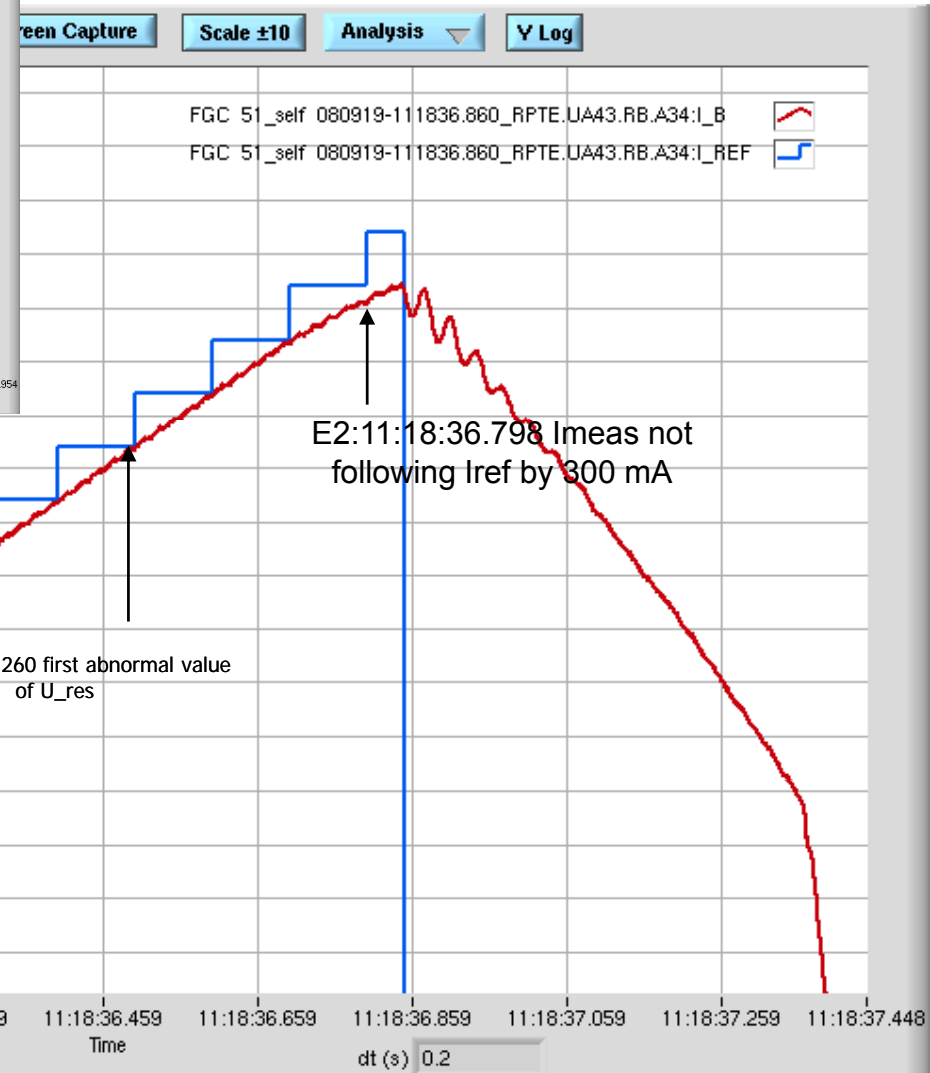
# Event Nr. 2 @ 11:18:36.798

## I meas not following Iref by 300 mA

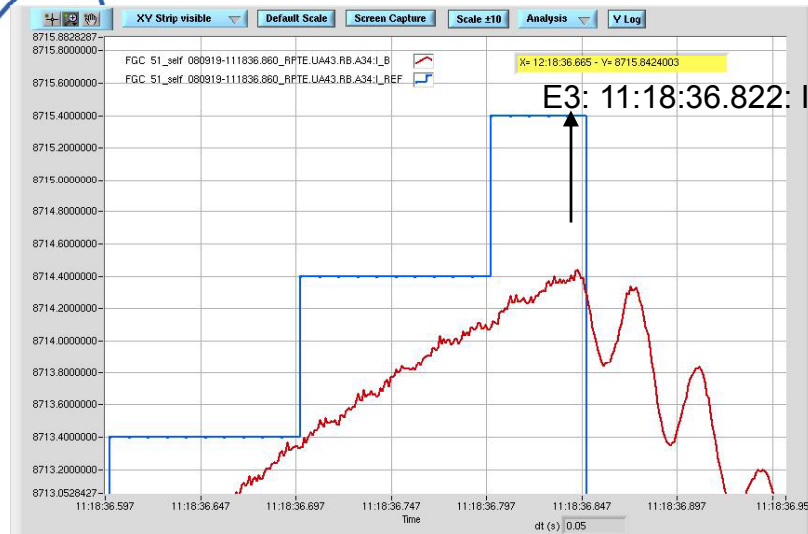
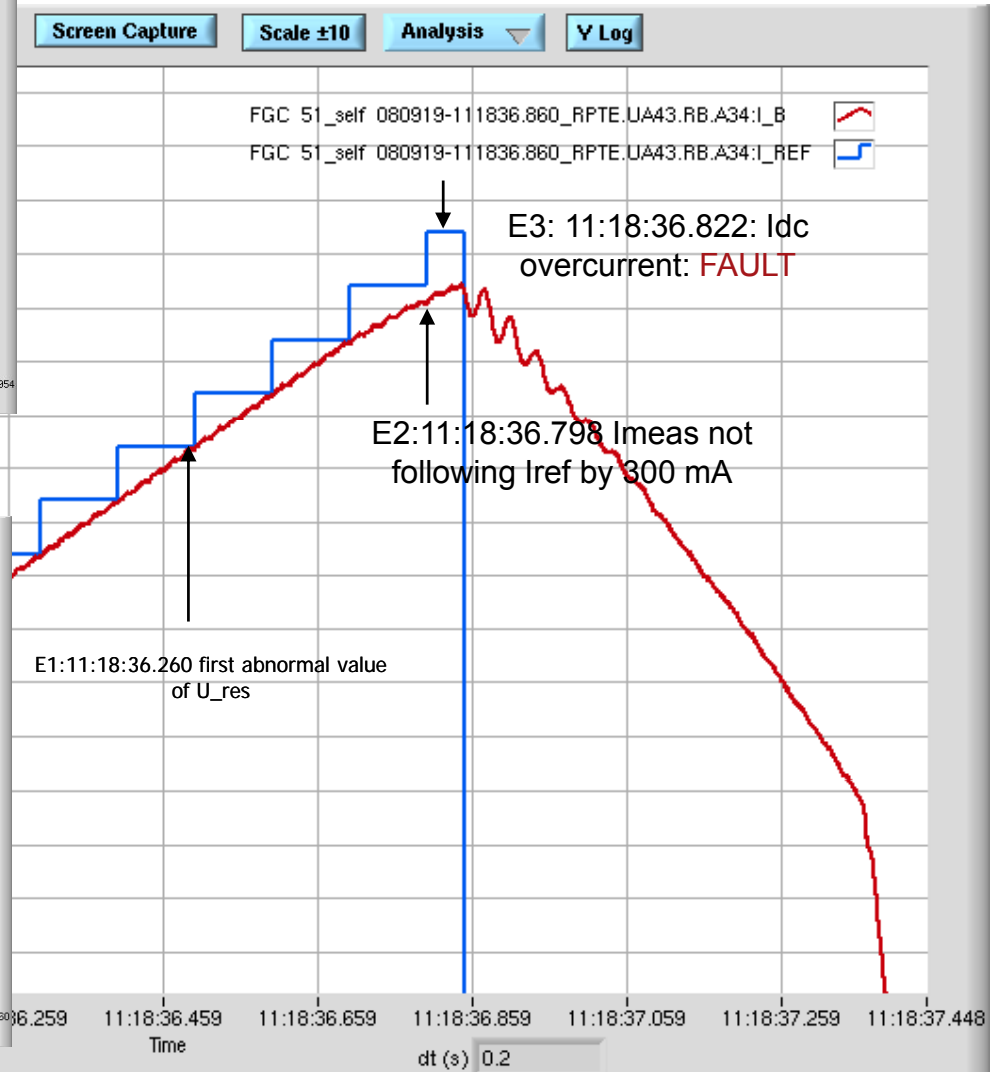
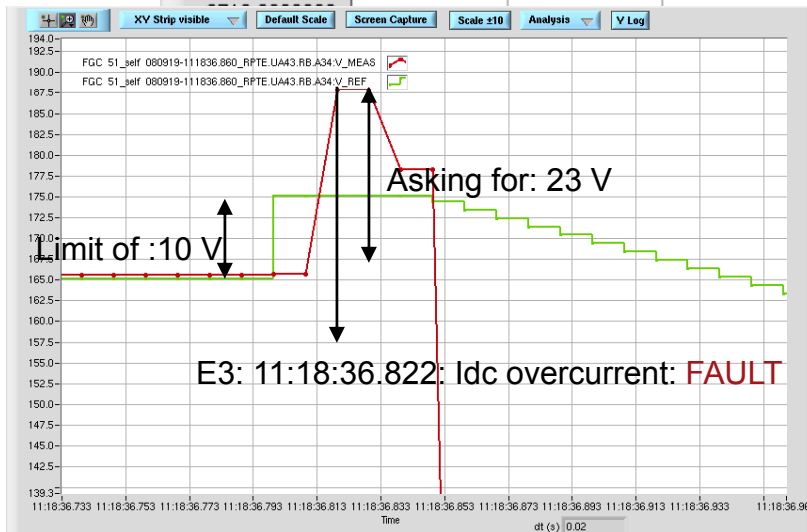
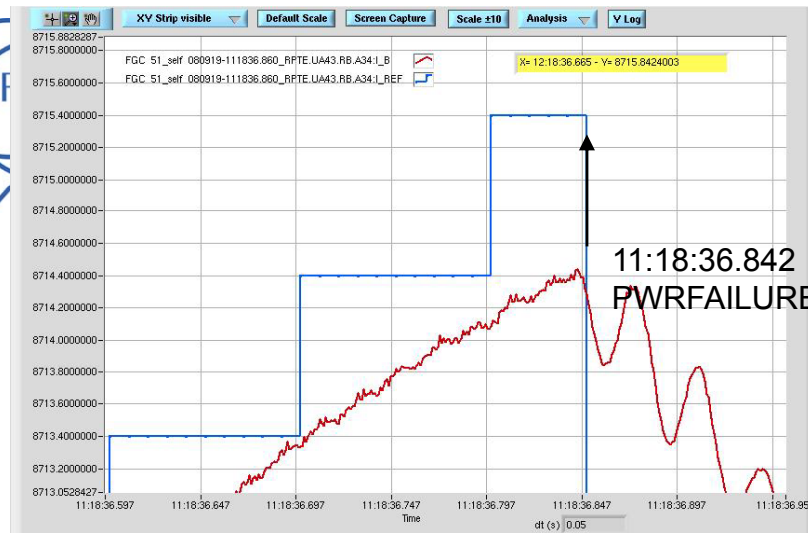
# Event Nr. 3 @ 11:18:36.822 Idc Current overflow: FAULT

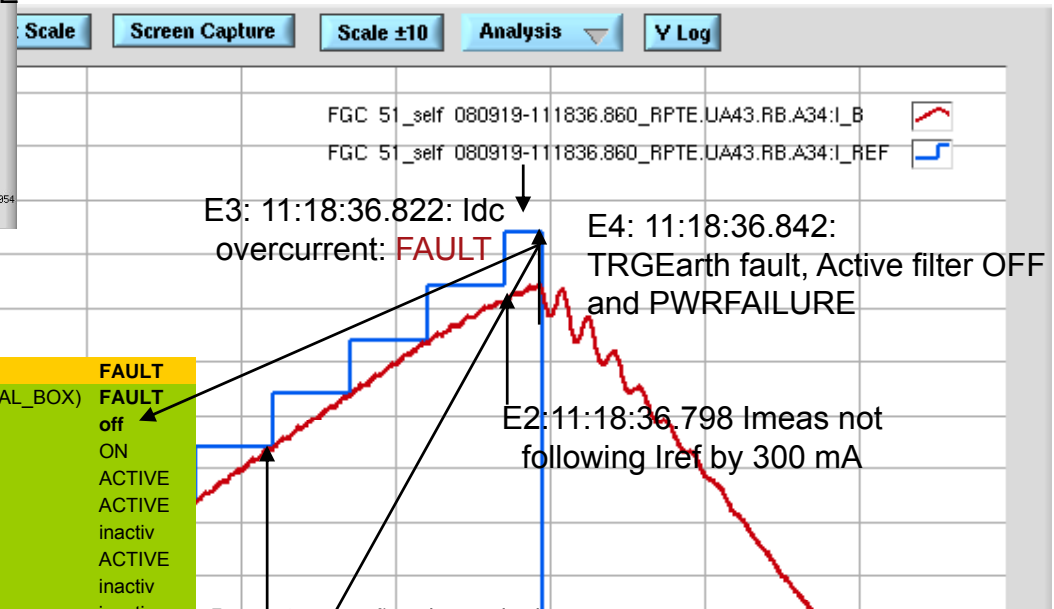
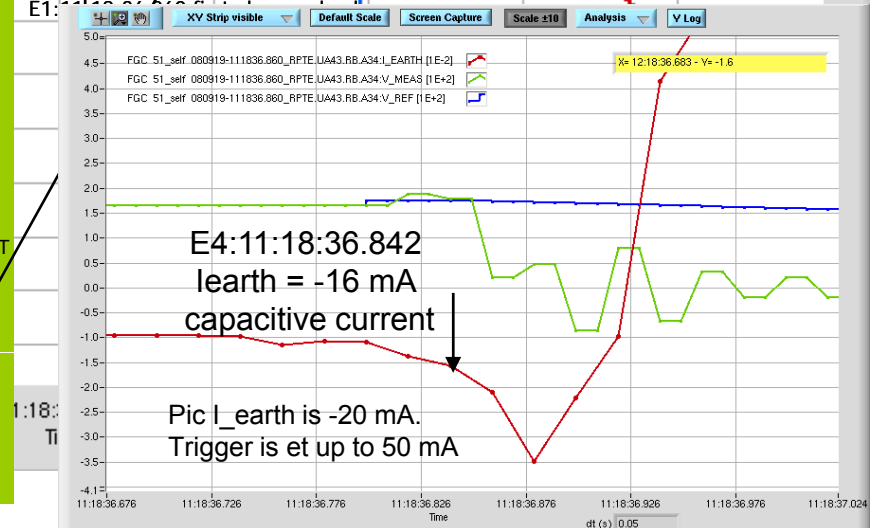
# Events Nr. 4-6 @ 11:18:36.842

## TRGEARTH-Fault, Active filter off, PWRFAILURE

11:18:36.842 TRGEarth Fault, Active filter off,  
PWRFAILURE

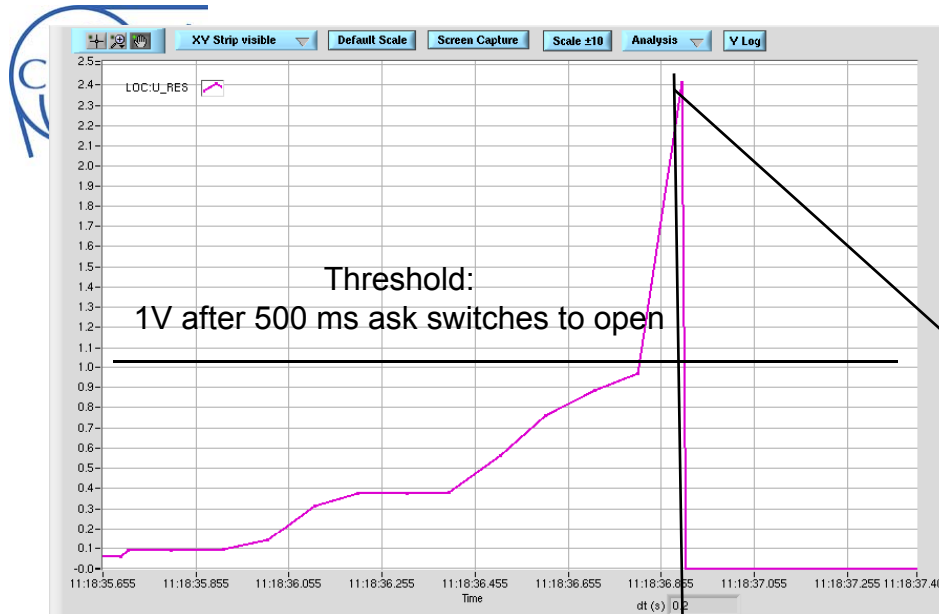
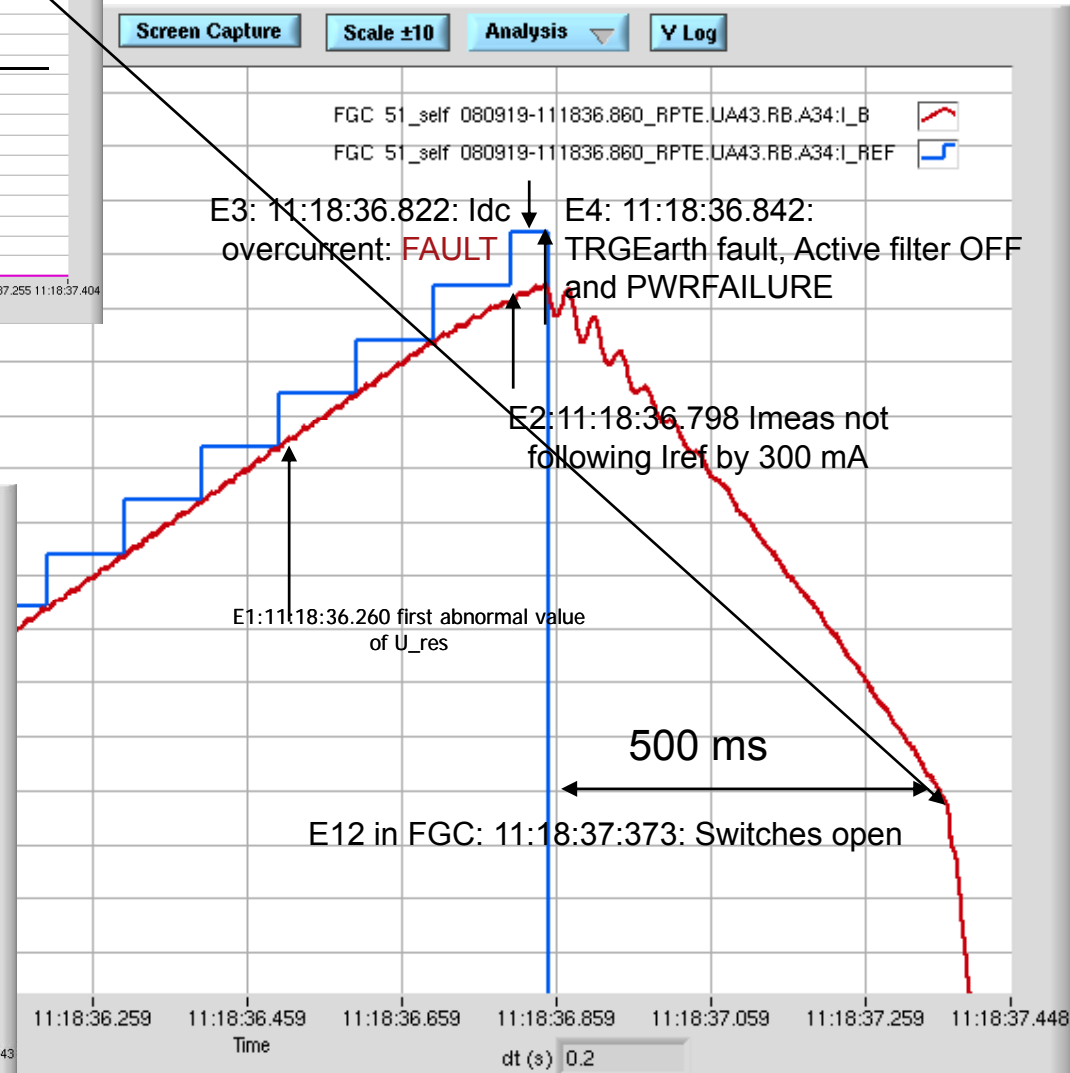
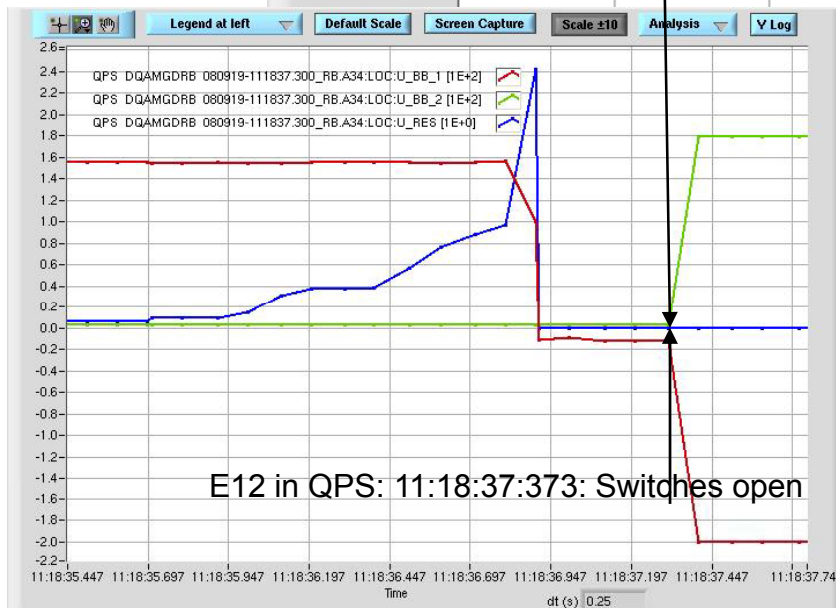
# Event Nr. 12 @ 11:18:37.373 Switches open

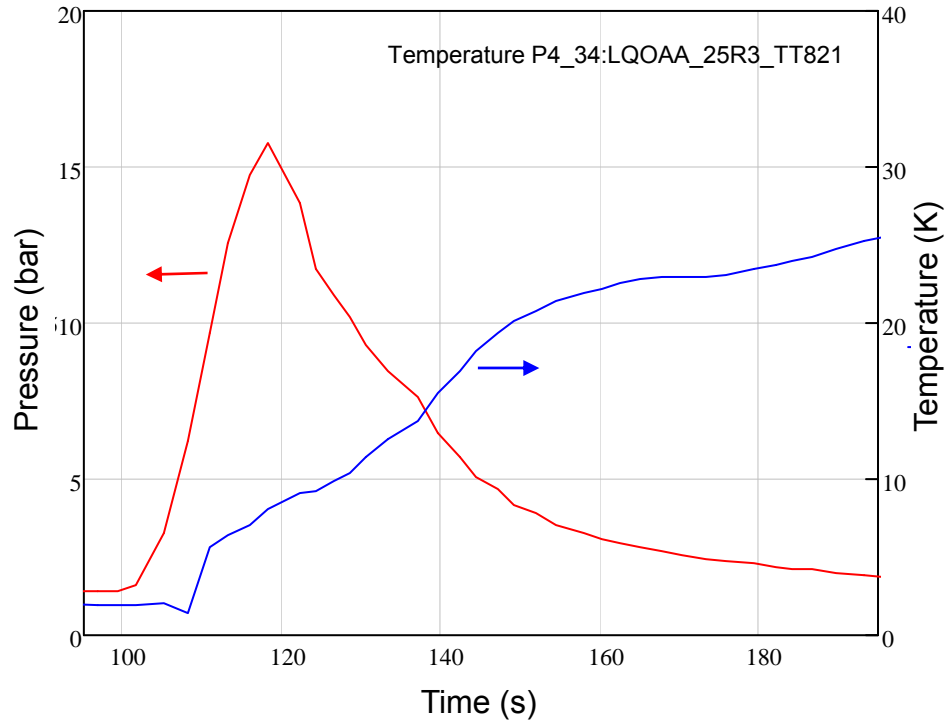
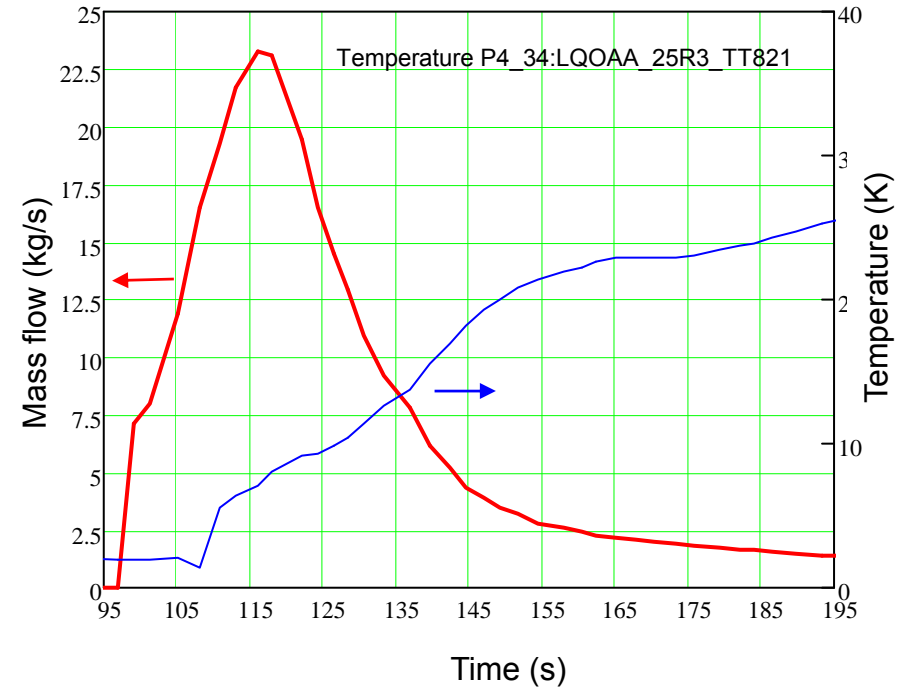
# Estimation of helium discharge from cold mass

## Hypothesis:

Helium temperature given by sensor P4\_34:LQOAA\_25R3\_TT821

All helium discharged through 1 hole. No plug major failure.

Constant hydraulic diameter 54 mm

Total mass of helium =  $214 \text{ m} \times 0.026 \text{ m}^3/\text{m} \times 147.8 \text{ kg}/\text{m}^3 = 822 \text{ kg}$

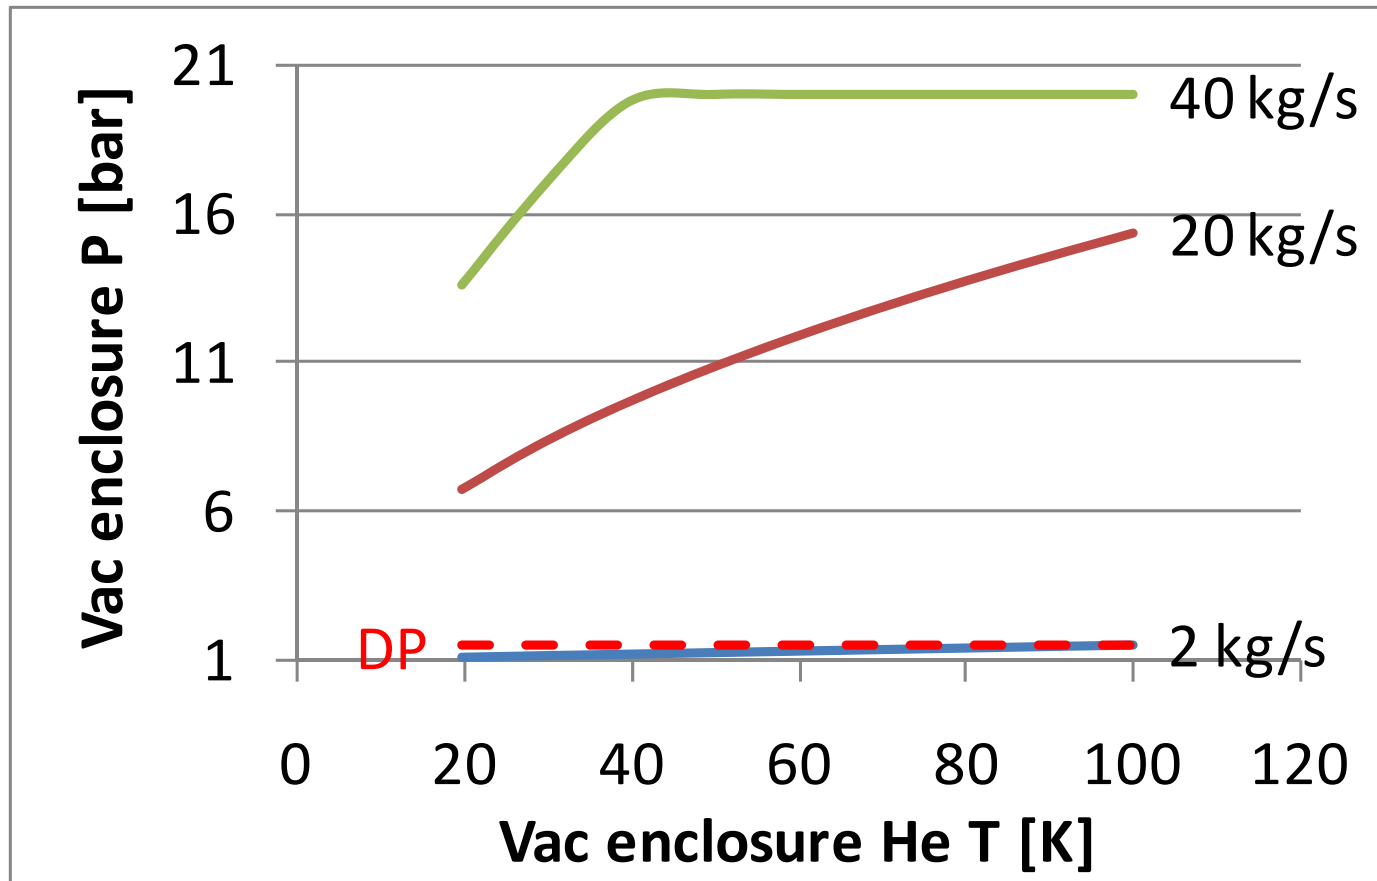
# Flow discharge characteristics of relief devices on insulation vacuum enclosure (per sub-sector)

Present configuration: 2 DN90

- Redefine MCI to cope with collateral effects of helium discharge from cold mass
  - done for electrical arcs
  - to be done for beam-induced damage
- Increase number/size of relief devices on cryostat vacuum vessels for coping with redefined MCI

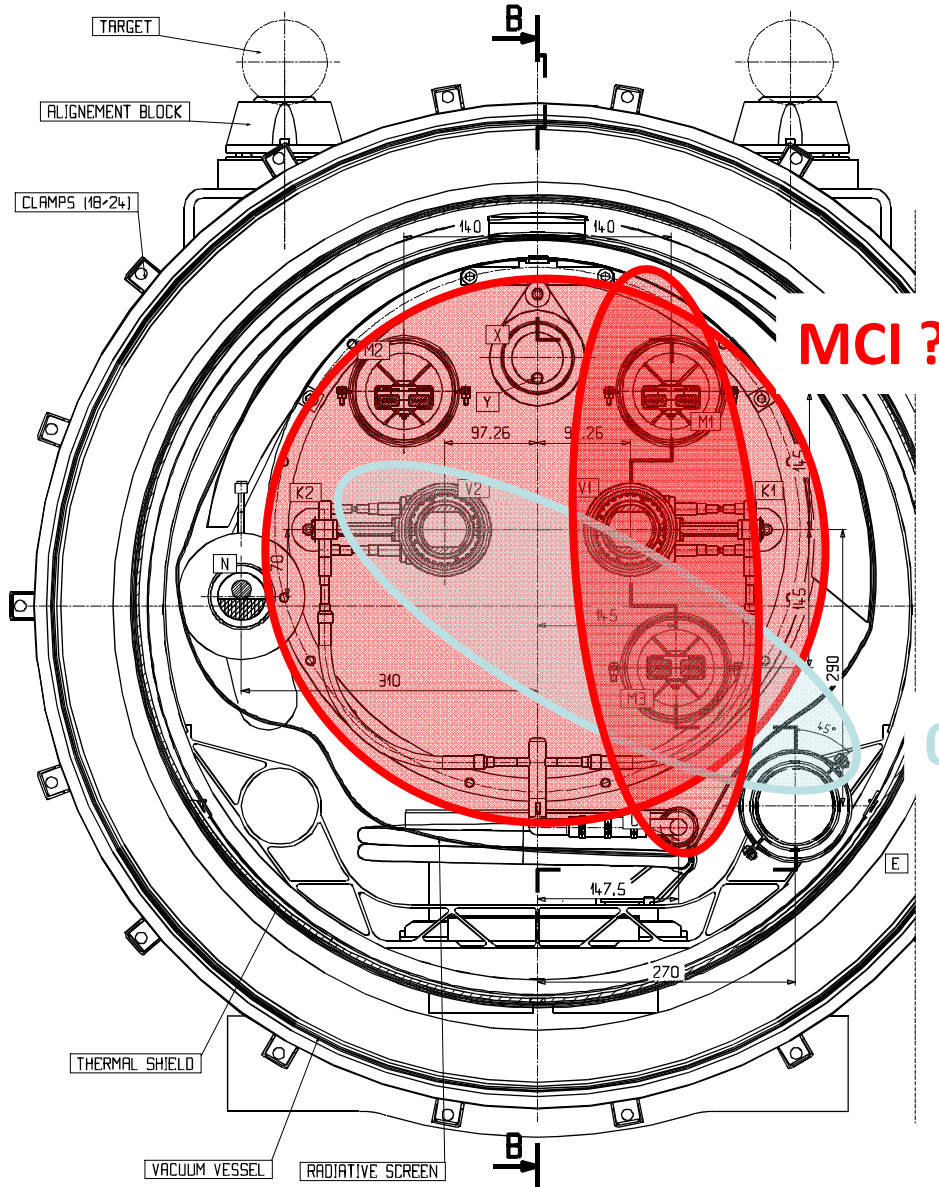
# Revision of MCI due to electrical arc

MCI?

080919 incident
