Internal Review of the LHC Machine Protection System: The Beam Dumping System

Jan Uythoven
For the LBDS Team

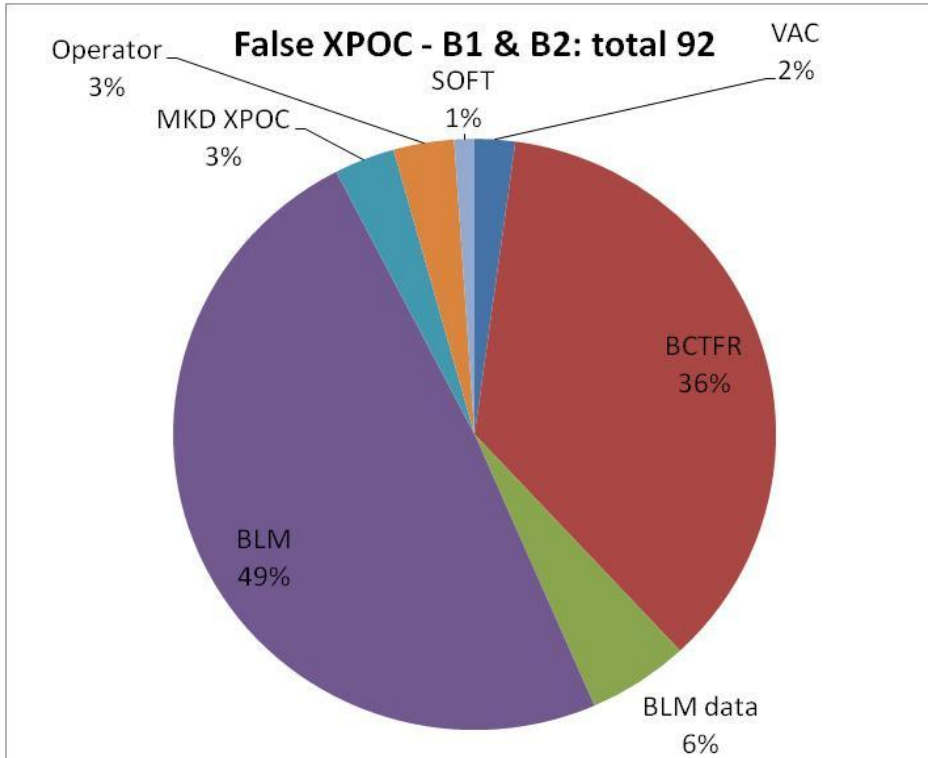
Total of False XPOCs, B1 + B2: 92

- BLM: Beam in the abort gap or losses at injection
- BCTFR: No data
- BLM data: No data
- Operator: Dumped with BIS loop open
- MKD XPOC: MKD generator 'drifts'
- Vac: No vacuum data
- Soft: Analysis error in MKD module

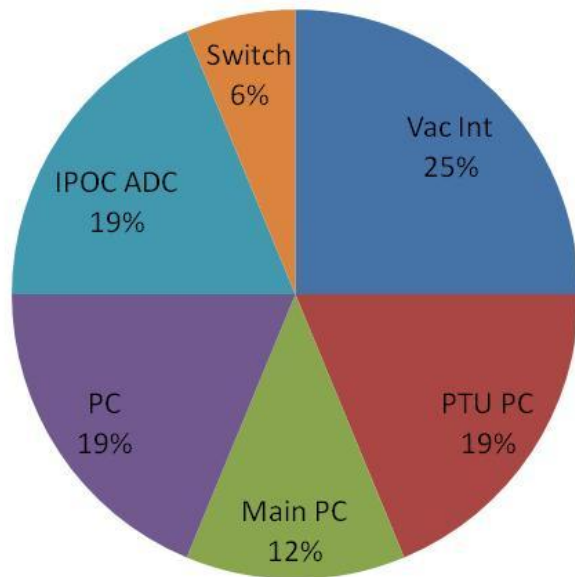
LBDS Internal Faults: total 16

- Vacuum: Vacuum glitches MKB interlock, filtered
- IPOC ADC: cards failing, all cards replaced
- PTU PC: problem C, all exchanged
- Main PC: Stability problem
- PC: 5 V or 15 V, replaced
- Switch: surveillance problem, switch was ok

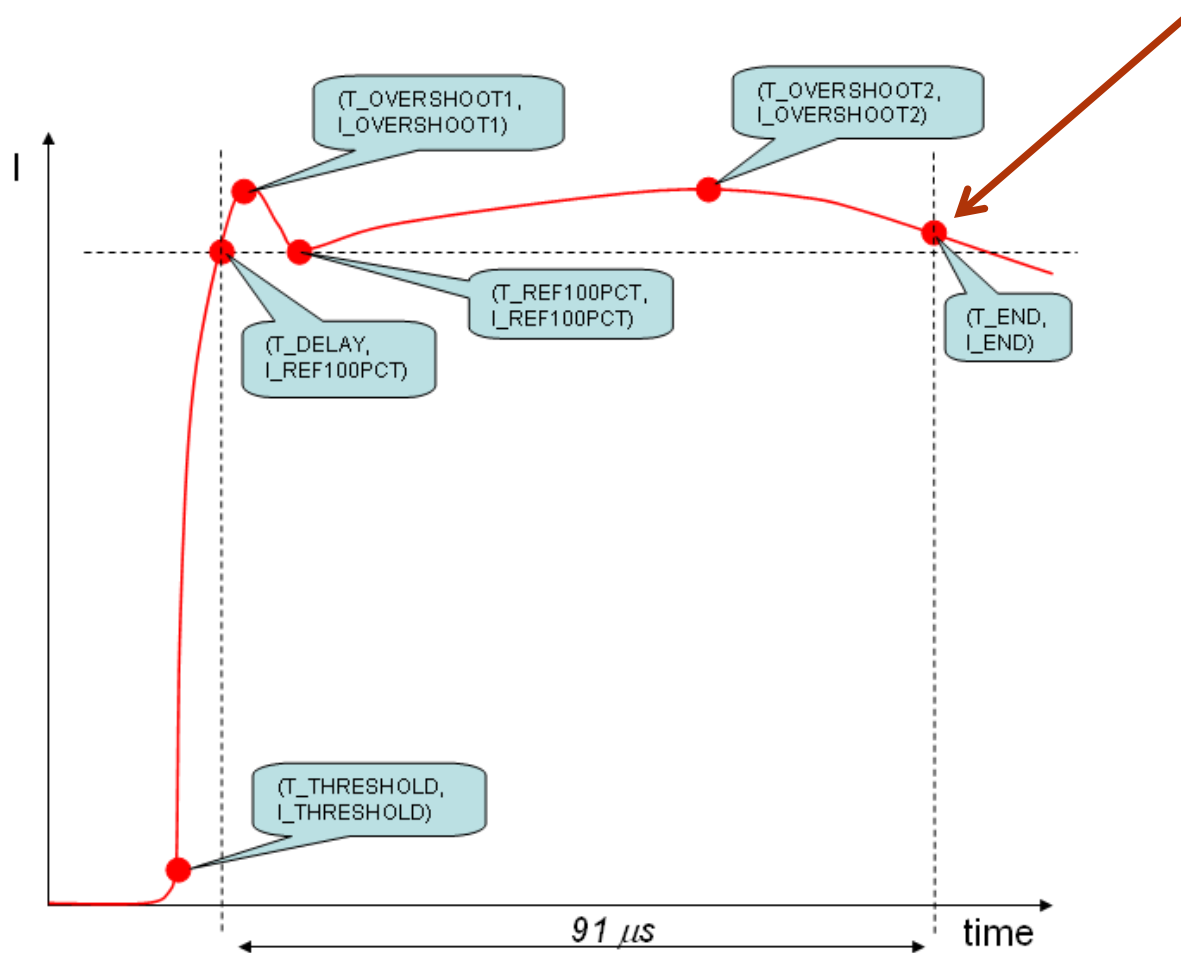
XPOC trend and error leading to generator exchange last technical stop

Reference generator O R_end : 1.40 +/- 0.5 %

References gen M: 1.25 %, gen C 0.85 %, gen E 0.69 %

Conclusions: All R_end references dropped, but most on the replaced generator O.
On top of this: generator O had this sudden drop given false XPOCs.

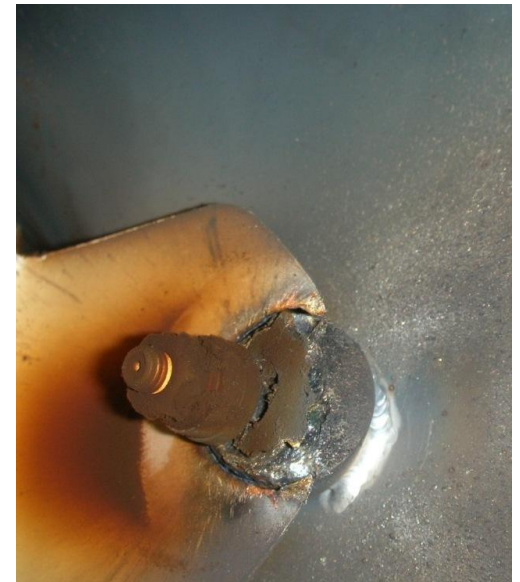
- Generators (2008 – 2009)
 - Damaged multi-contact on the multi-chip diode which is in parallel with the GTO stack. Solution: multi-contact replaced by soldering
- Magnets (2008 – 2009)
 - Breakdown on araldite insulators between forward and return path of MKB magnet. Solution: insulators replaced by ceramic ones (MKI type)
 - Damaged ground connection of MKB coil. Solution: redesign of the contact and stronger contact tightening
 - Cracks of the MKB coil insulation. Solution: coils ends remoulded with different araldite filler (silica rather than dolomite)
- Vacuum pressure false interlock due to noise on signal solved by filtering and voting solution, but still need to find out why noisy signal

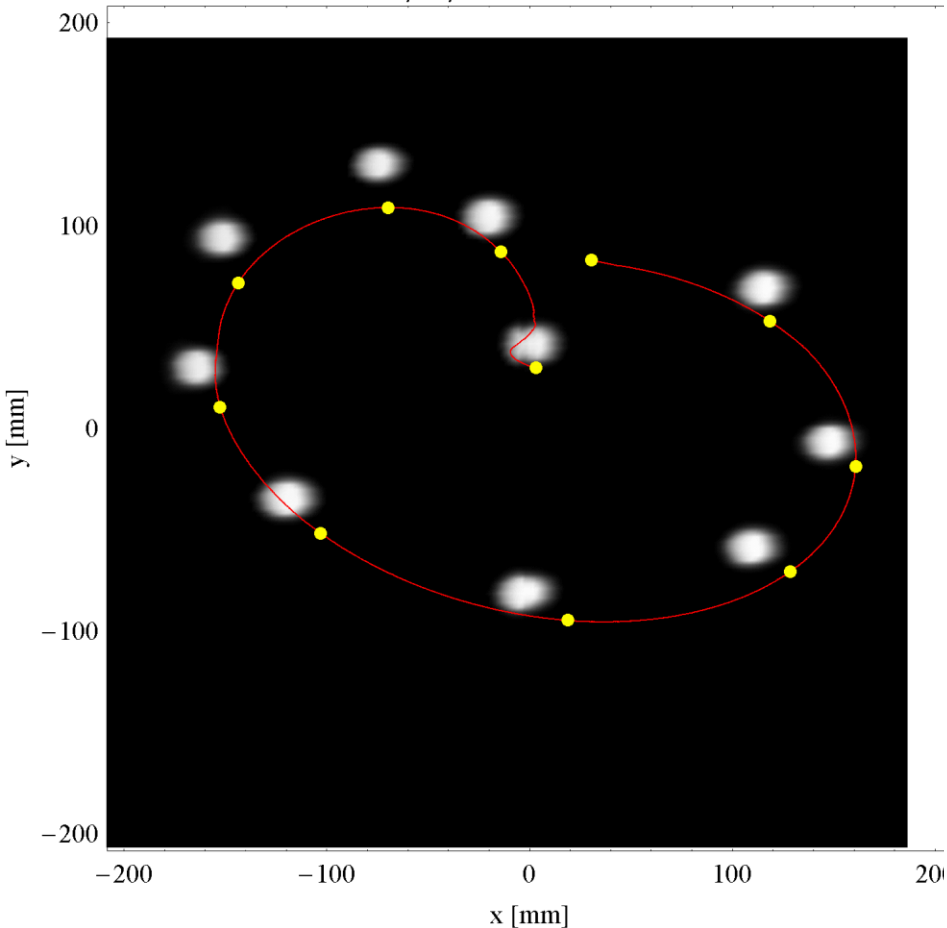
TD68.BTVDD.689339.B1

Position of dumped beams on BTVDD (in front TDE) according to calculations
