LIU-PSB Working Group Meeting (15/08/2013)

BLM FOR THE INJECTORS PROJECT CABLING NON-CONFORMITIES

Christos Zamantzas (christos.zamantzas@cern.ch)

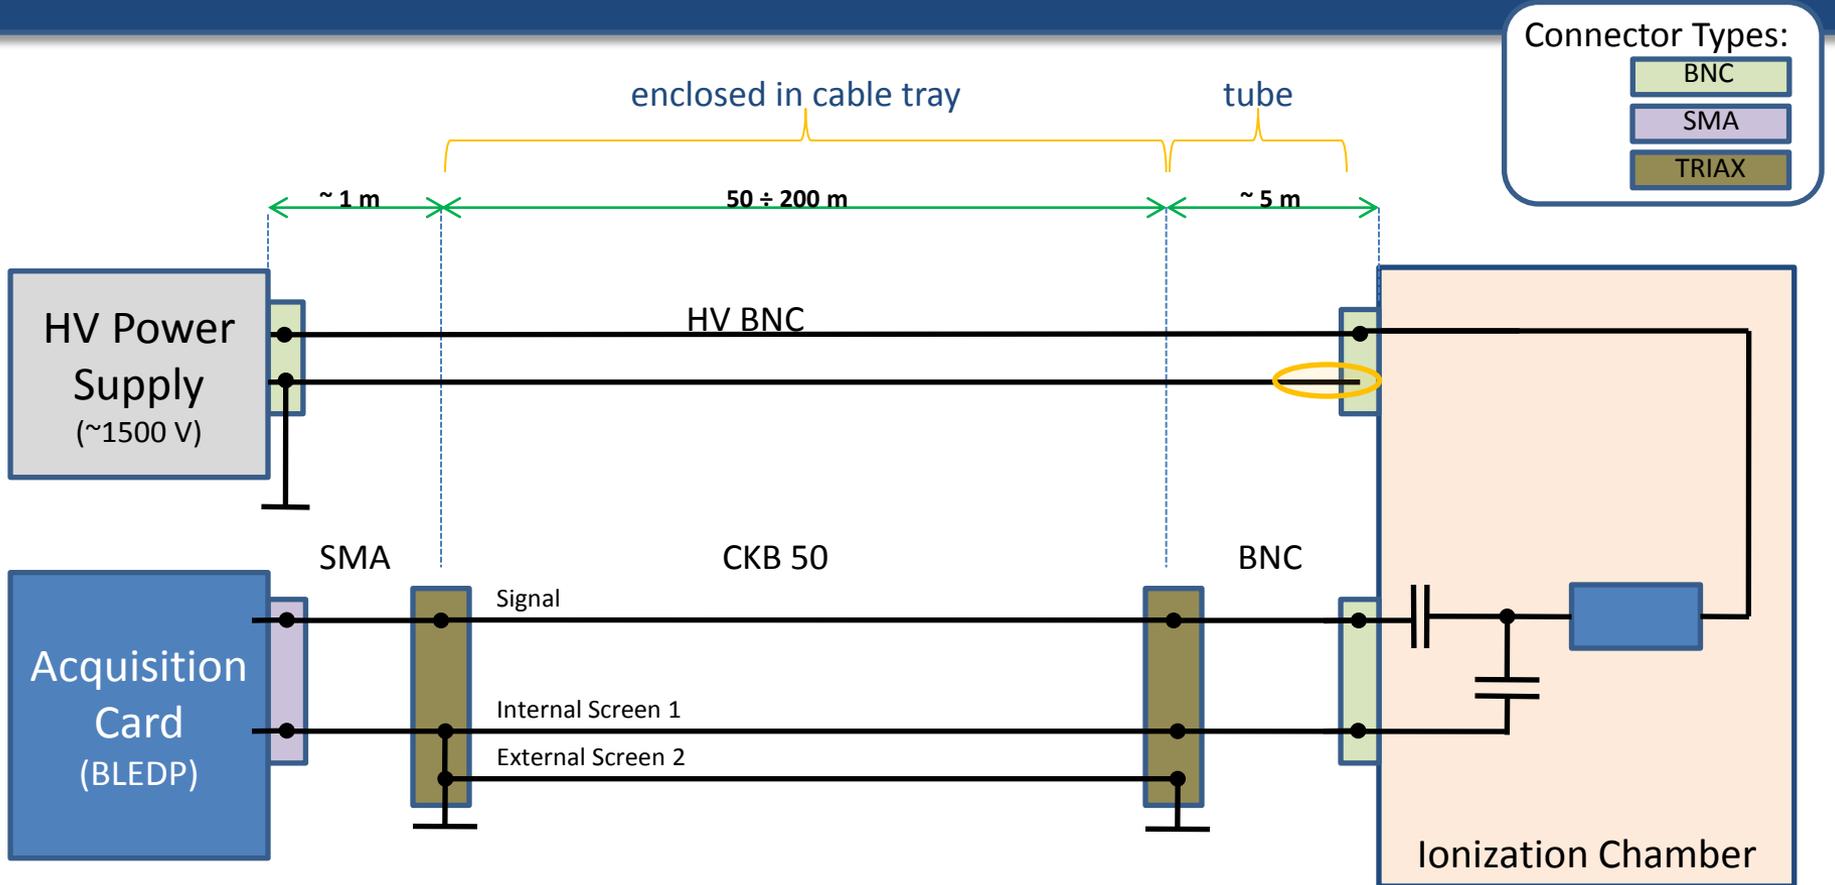
Cabling Diagram

- Screen of HV BNC is open on the IC side to assure there is **no ground loop**.
- Internal screen to **shield low frequency** noise (GND only on electronics side, IC is floating).
- External screen to **shield high frequency** noise.
