ELENA Source Charging Up status and plans

D. Gamba, R. Gebel, B. Lefort, F. Wenander

27th of Jan. 2021

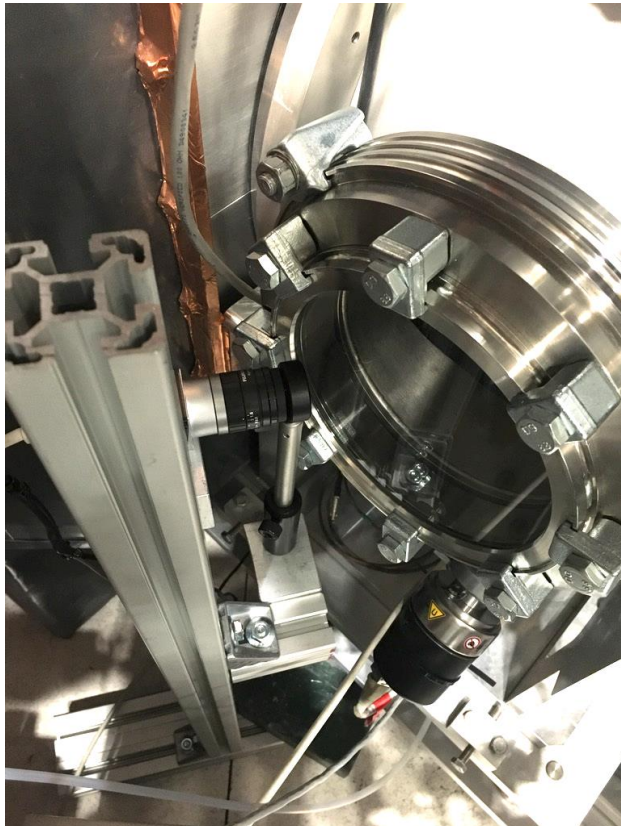
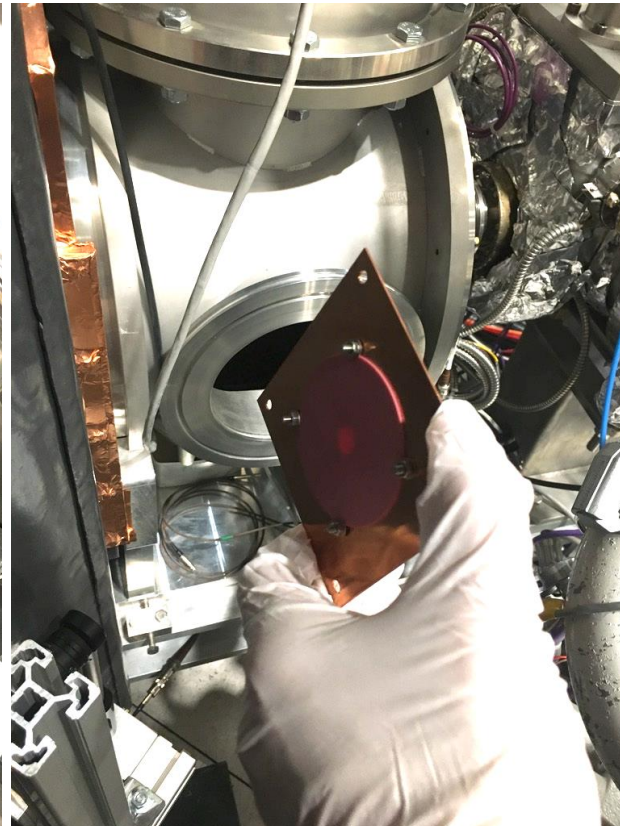
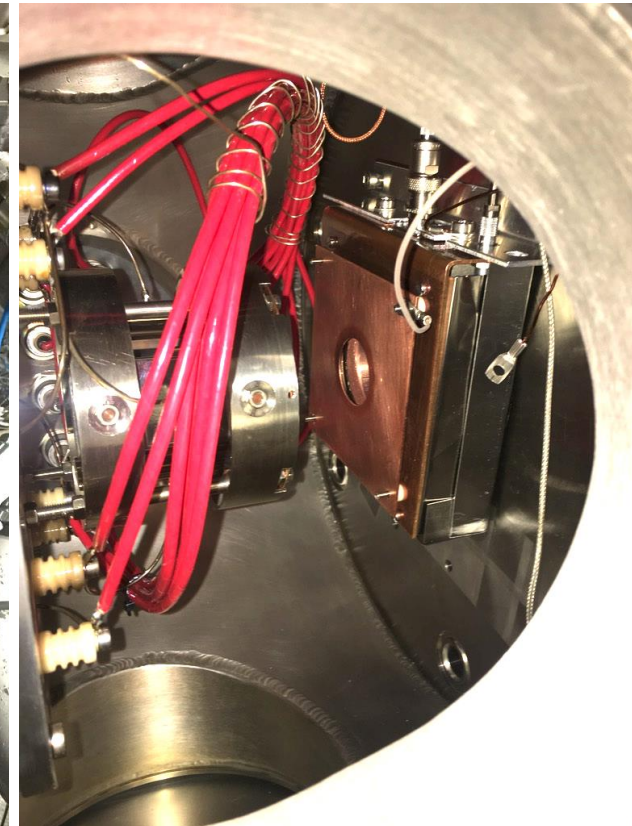
New camera setup

- New digital camera that can be triggered
- 700 nm (10 nm FWHM) filter (**694 nm filter ordered**)
- New screen with hole (10 mm diam) **still to come**
