Results of the laser-polished sample B-5.5 test (preliminary)

ARIES WP meeting

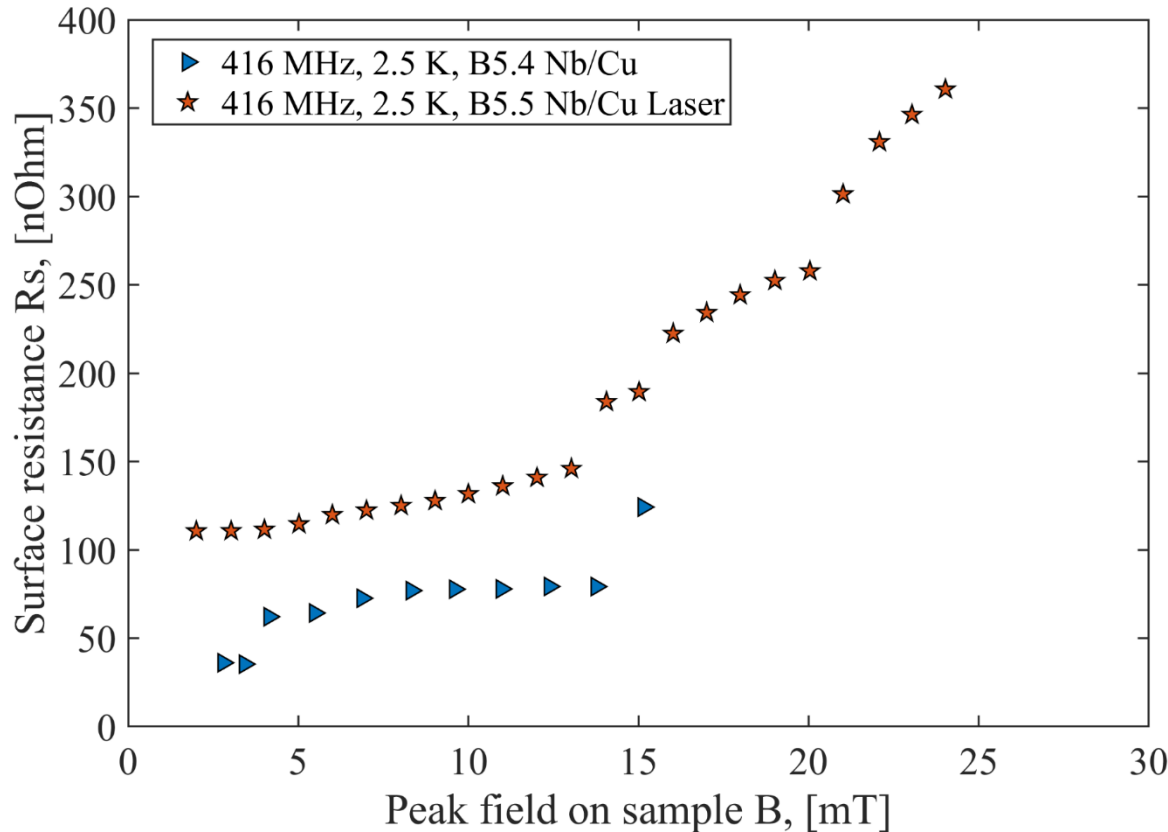
Results for pre-laser polishing and after for 2.5 K, ~400 MHz:

- Higher surface resistance

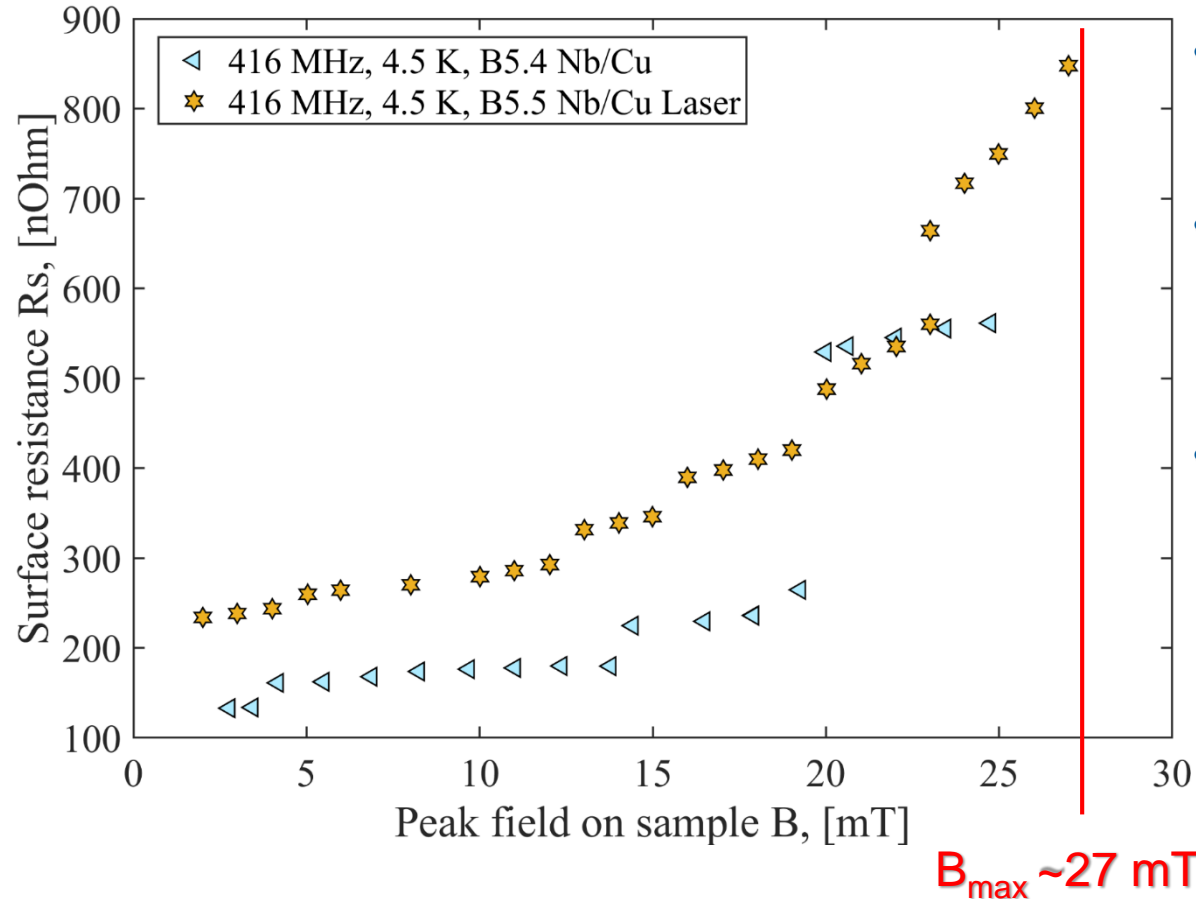
Results for pre-laser polishing and after for 4.5 K, ~400 MHz:

- Rs vs B is more “smooth”, one spot is better
- Possible problems: problematic spot could be at higher field region
- Maximum film is about same as previously tested (27 mT). Probably, problematic spot was not reached by laser.

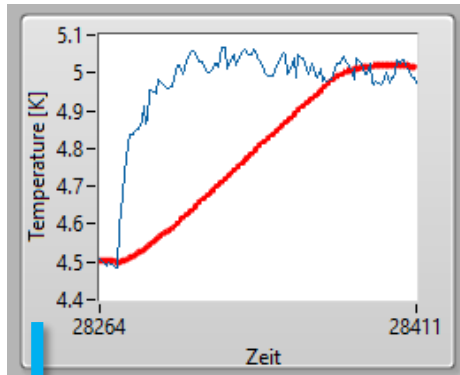
Pulse shape (transmitted)

- At max field 27 mT, 416 MHz: Temperature significantly increased (but not complete quench)
- Only part of the film quenched (not full film because temperature stays <9.3K)
- Quench field depends on temperature:

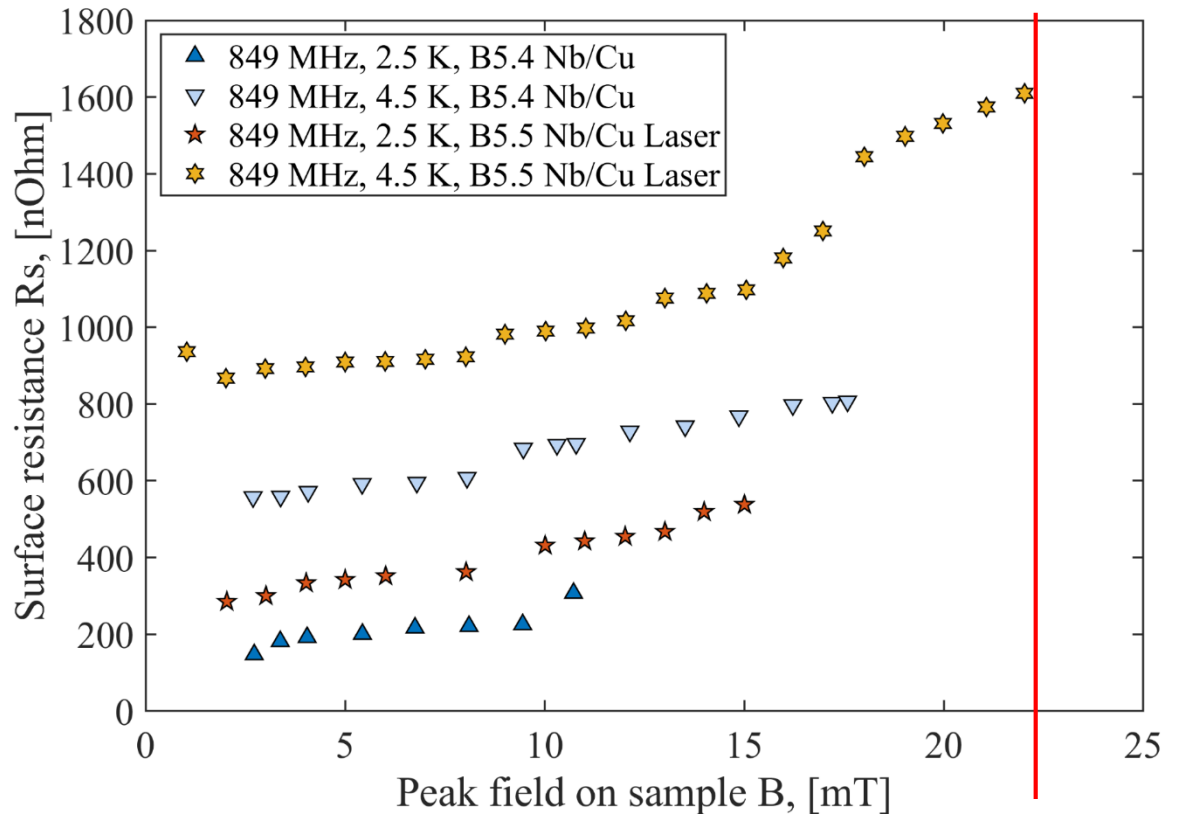
Results for pre-laser polishing and after for ~850 MHz:

- Maximum film is about 22 mT.

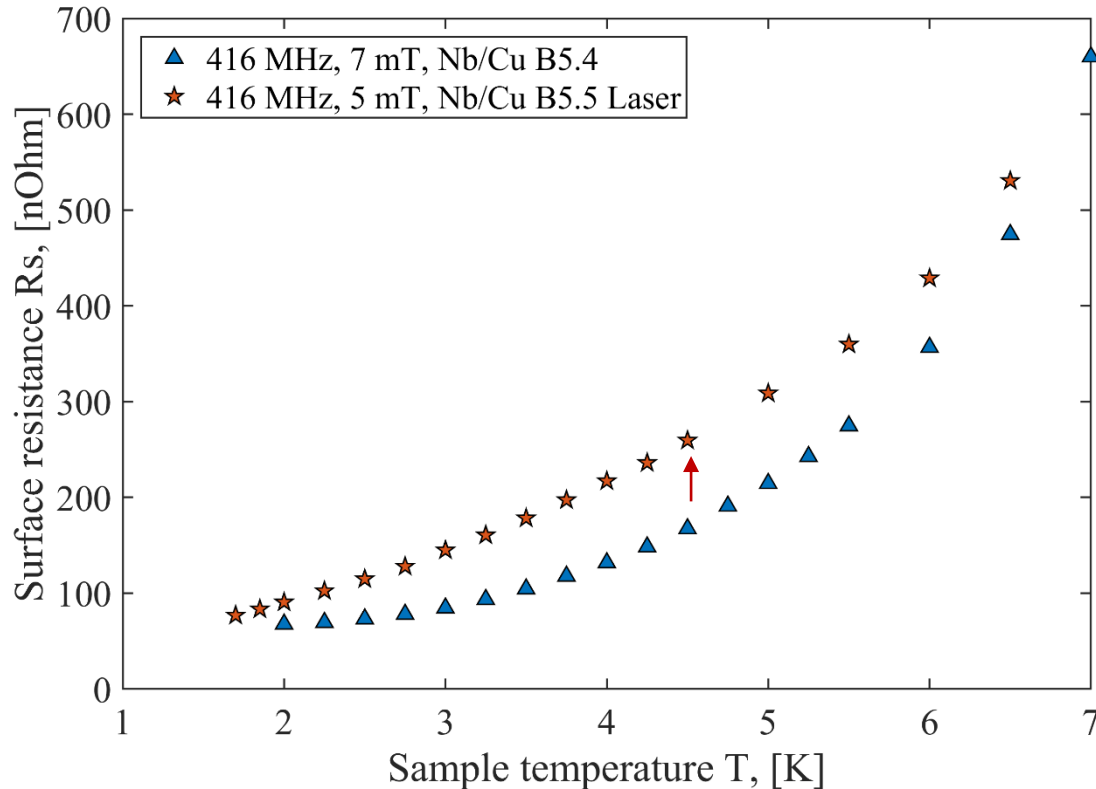
Rs vs T results for pre-laser polishing and after for ~416 MHz:

- Rs vs T: Most of the 'additional' resistance come from temperature-depend part
- Residual resistance is approximately same:

R_{res}
B-5.4	~67 nOhm
B-5.5	~76 nOhm

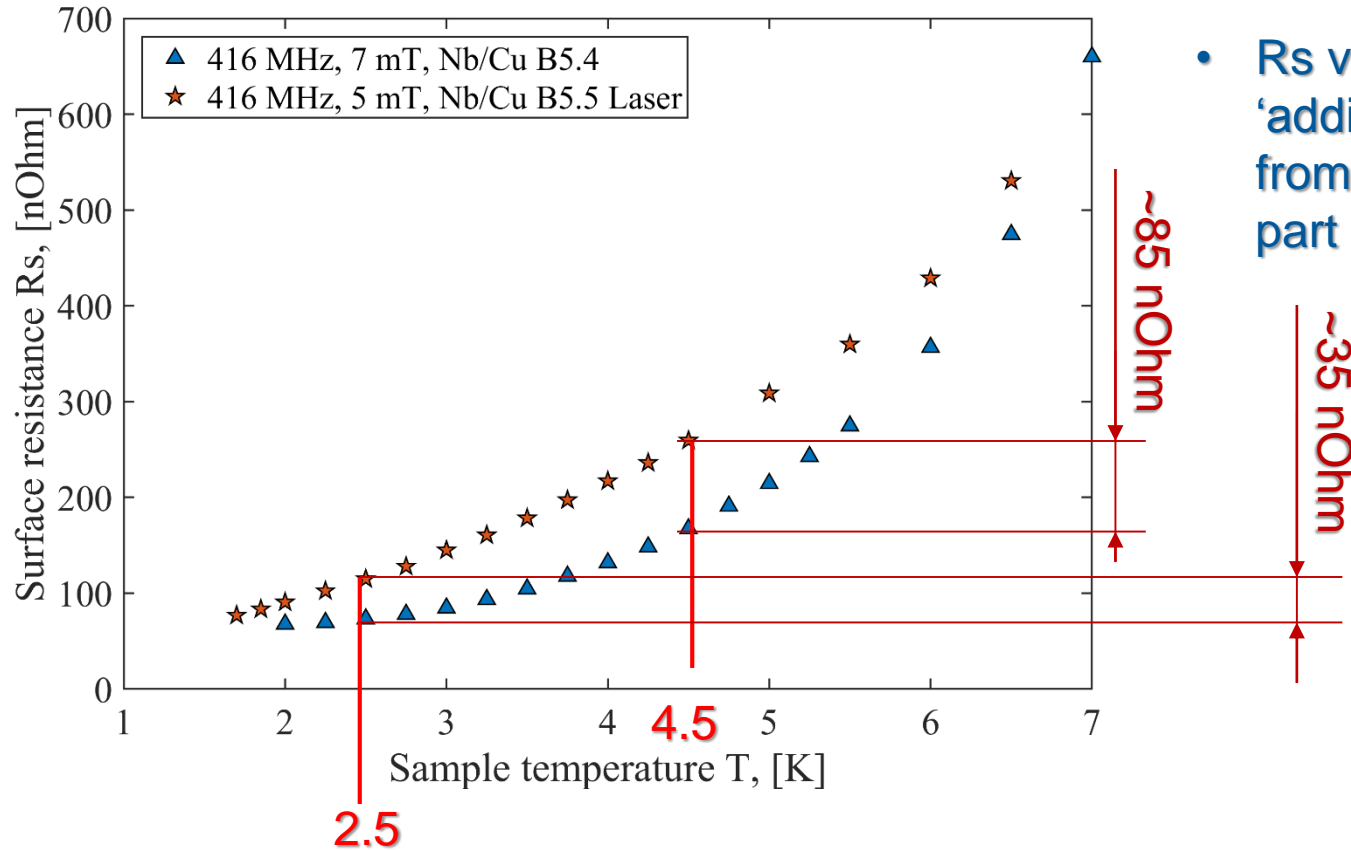
Rs vs T results for pre-laser polishing and after for ~416 MHz:

- Rs vs T: Most of the 'additional' resistance come from temperature-depend part

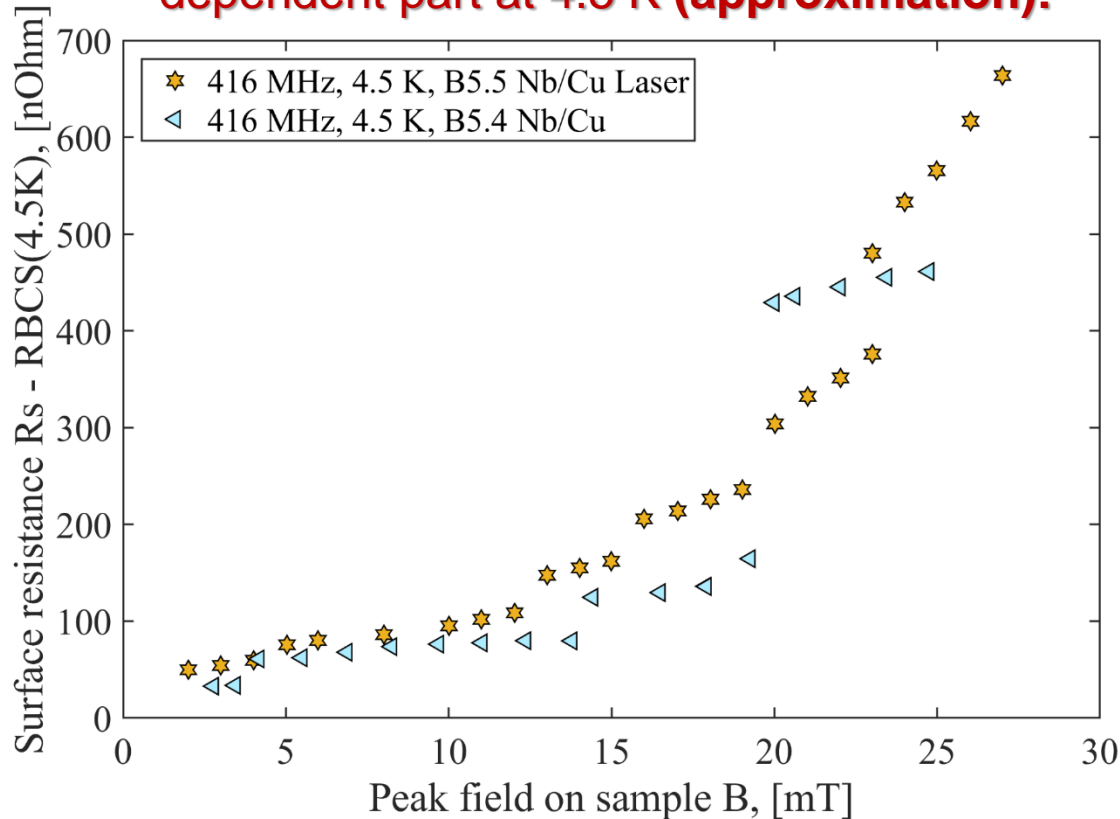
Rs vs B results for pre-laser polishing and after for ~416 MHz:

Rs with subtracted ~BCS temperature dependent part at 4.5 K (approximation):

- Probably increased BCS came from impurities and defects due to wrong polishing procedure
- With subtracted BCS contribution from both tests the field dependent part is more or less comparable except higher field 'jump'

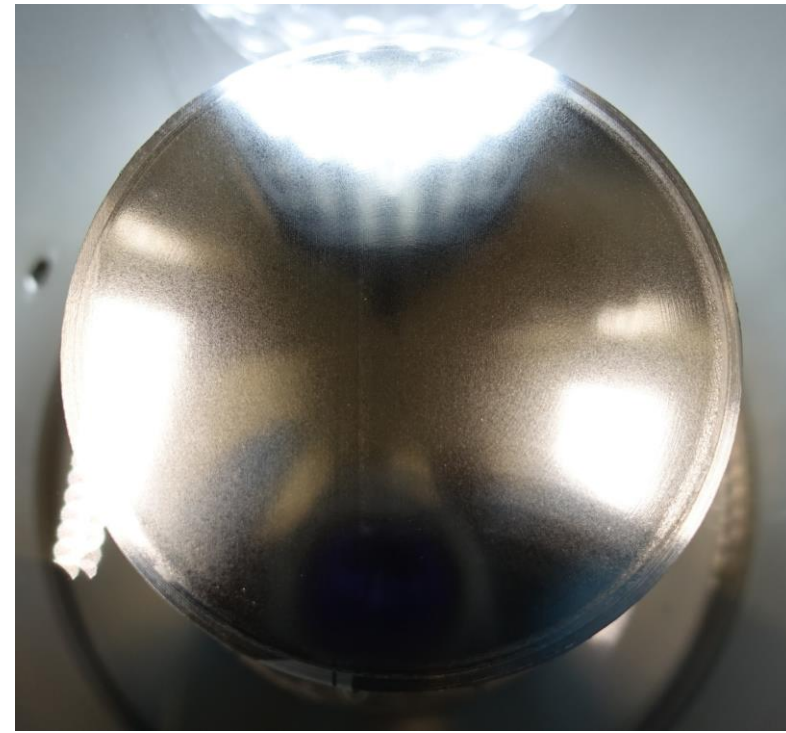
Post LP:

- Some defects removed or partially removed
