SuperFGD box thermal tests and review

Davide Sgalaberna SFGD mechanics group meeting 8th March 2021

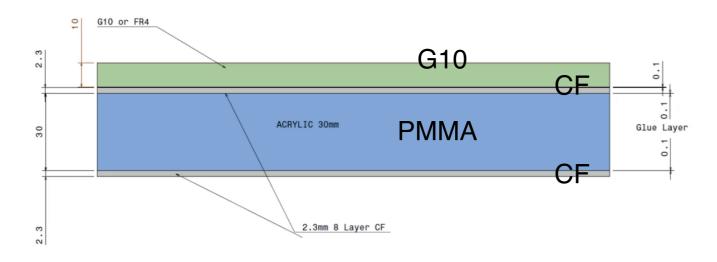
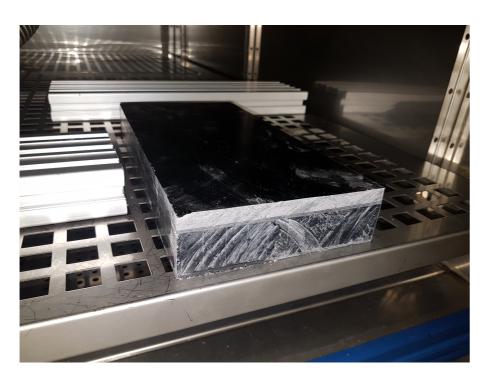
- Purchased a 2.3m sandwich G10-CF-PMMA-CF
- Cut 1.9m sandwich to fit the thermal chamber
- The core is made of PMMA bars of 15 x 30 mm2 cross section

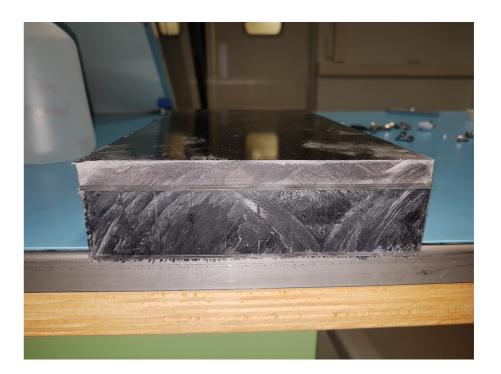
- Quite extreme test were performed
- From room T to 40° C —> no visible problems were found
- From room 40° C to 50° C and then down to -10° C
 - + Apparent failure of glue joint between likely CF and PMMA on the G10 side
 - Visible crack in the upper part of the plate but it seems on the glue coating, not through the PMMA. We will examine this crack in more detail, but it may not be a problem
 - + Permanent deformation of all the materials on one extreme of the panel

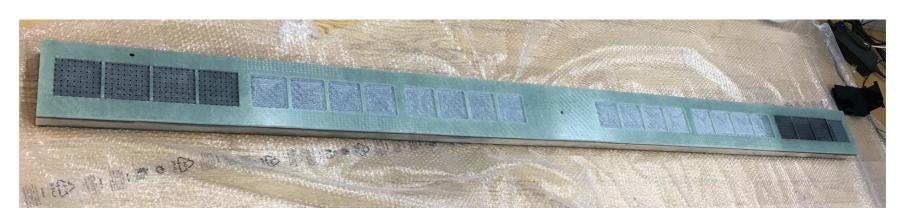
- Thermal tests with
 - 1. 40 cm long plate of CF-PMMA-CF-G10 plate (cut from sample in previous slide to fit the thermal chamber)
 - Cross-check results, measure allowed T range for a safety transport, storage and installation
 - 2. ~2m long plate of CF-Foam-CF-G10
 - + Verify if the problem is on PMMA or G10

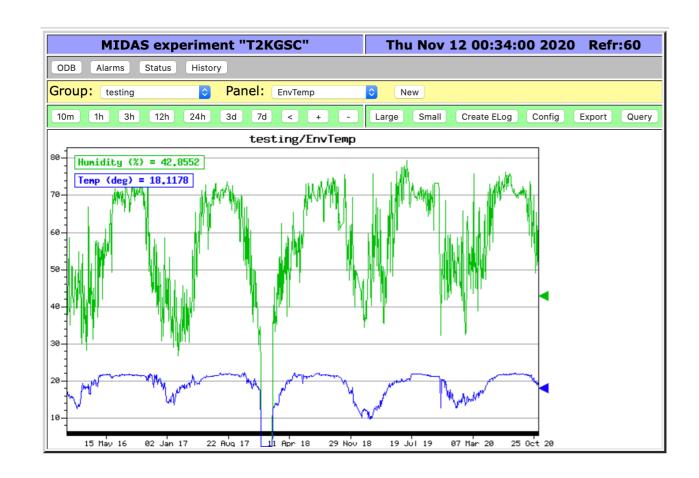
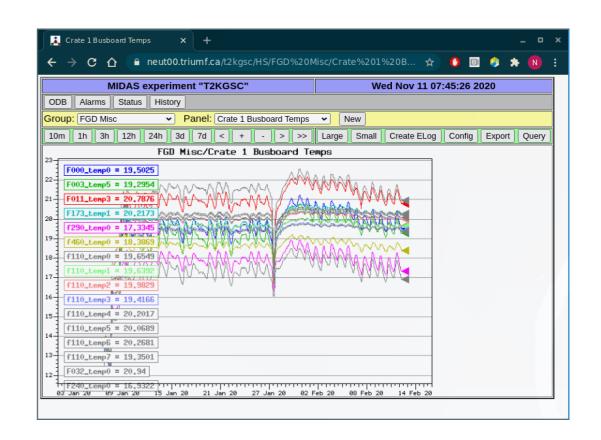
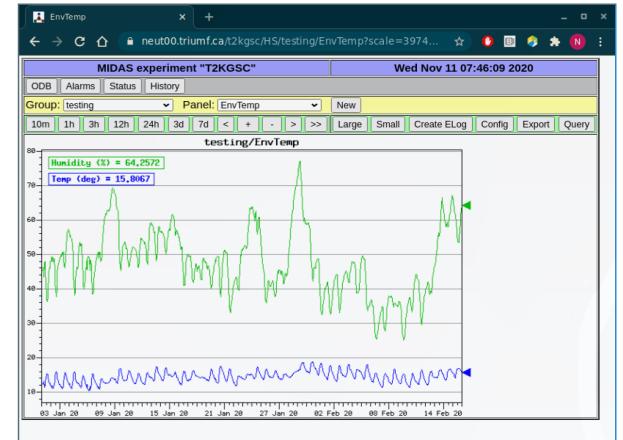
- Largest temperature variation seem to be $< 10^{\circ}$ C from a sensor in the ND280 pit
- Not clear where it is exactly but it should be indicative of the temperature range in ND280 also when the detectors are off, i.e. no detector cooling
