Processing and testing of AUP prototype #1 NRFDP001

Paolo Berrutti– Fermilab

WP4 collaboration meeting: AUP-Canada-CERN-UK

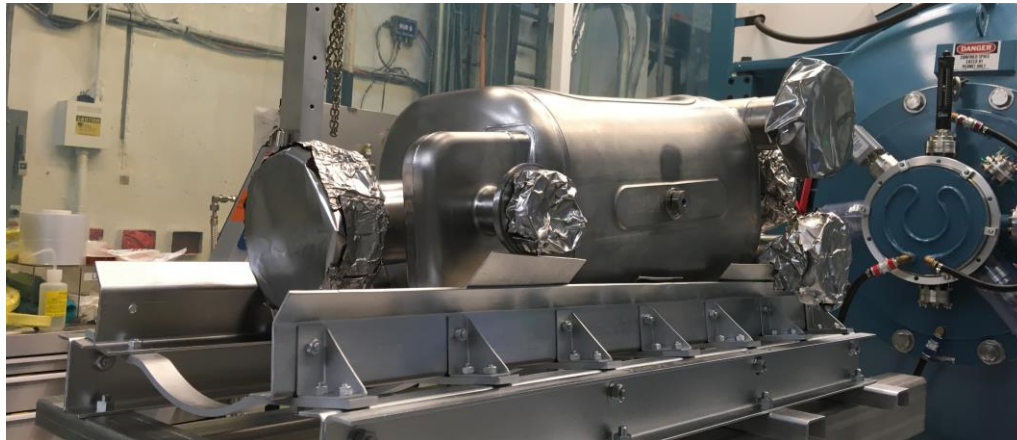
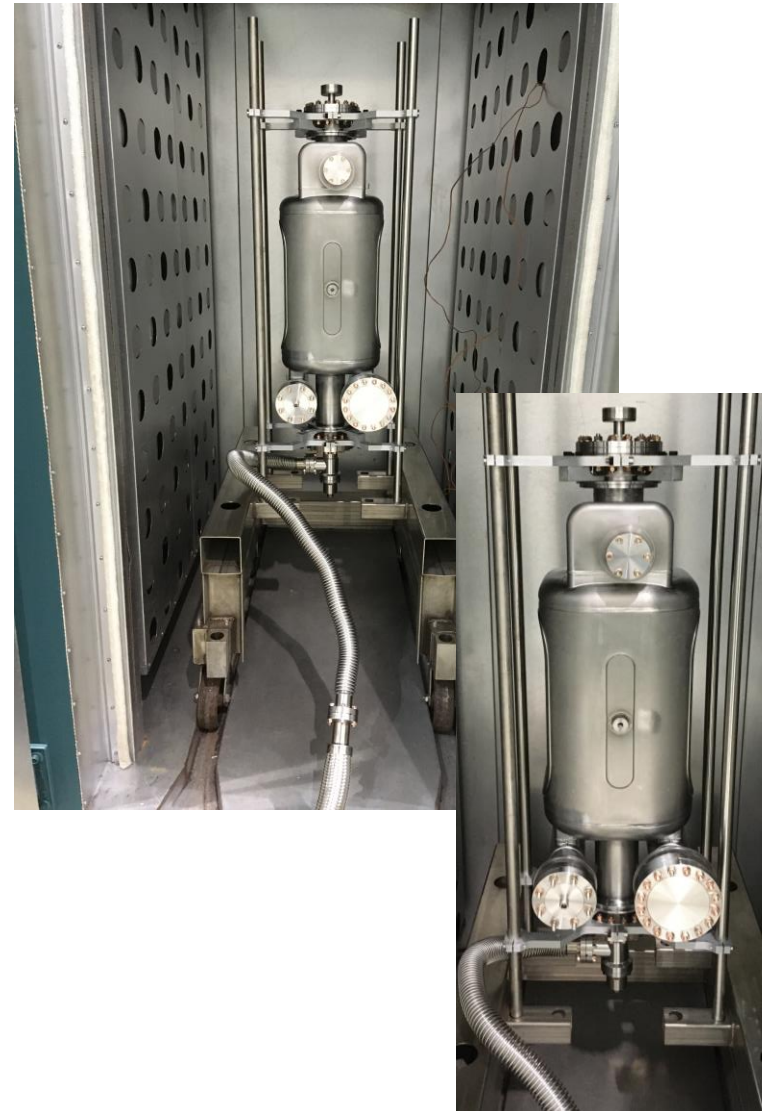
Processing III: Problems with CF flanges assembly

- Multiple times fully assembled bare cavity has been leaking due to a combination of:
 - Knife edge defects
 - Differences in the gasket sizes and tolerances between CERN and US standards
- Problems seemed to be resolved with:
 - Thorough flange inspections followed by knife edge polishing (if needed)
 - Custom gasket machining
- No leaks for prototype #1 at 2K
- Prototype #2 leak test went well: no leaks @ RT

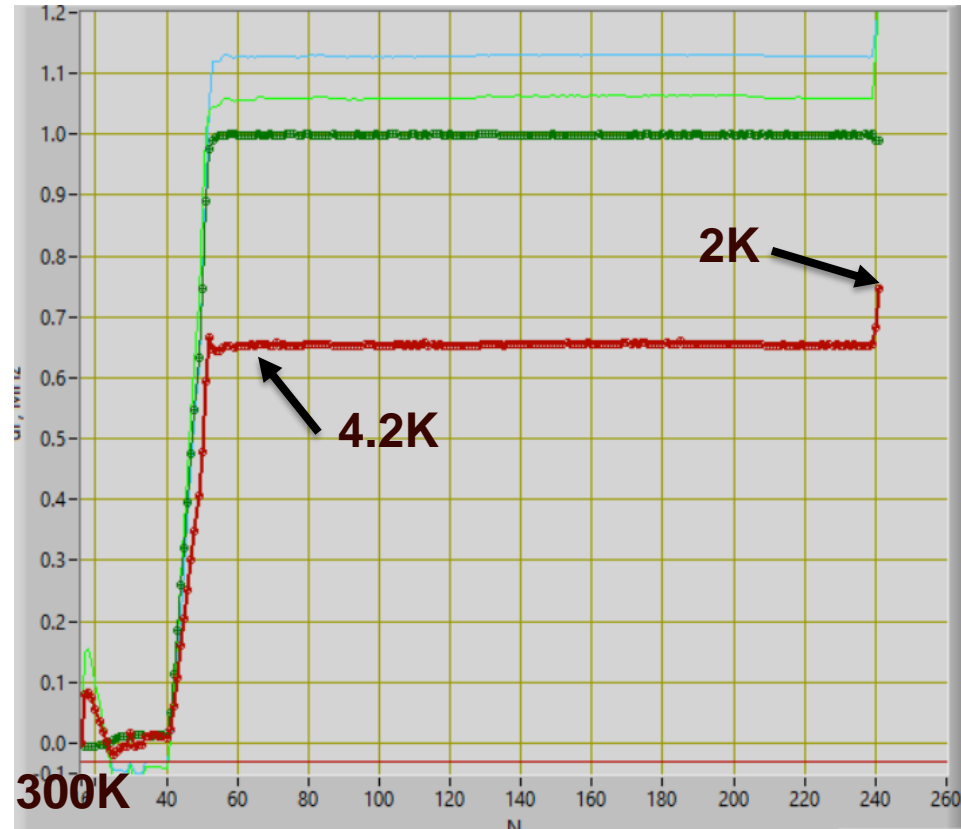
- Four modes have been tracked during cooldown up to first dangerous HOM around 748 MHz
- 300 K \rightarrow 2K shifts:
 - fundamental mode: $\Delta f = 746$ kHz, 2k frequency 400.449 MHz.
 - 748 MHz HOMs: $\Delta f = 1.23$ MHz, 2k frequency 749.316 MHz.
- 300K \rightarrow 4.2 K in 3.5 hours
