CONSEQUENCES OF A HYPOTHETICAL INCIDENT FOR DIFFERENT SECTORS

F. Bertinelli, S. Claudet, C. Garion, J.M. Jimenez, V. Parma, A. Perin, R. Schmidt,
L. Taviani, J.P. Tock & R. van Weelderren, CERN, Geneva, Switzerland.

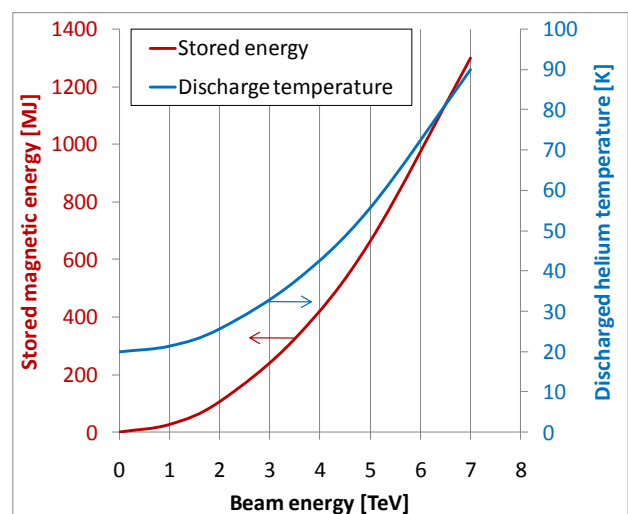
Figure 1 shows the stored magnetic energy and the discharged helium temperature as a function of the beam energy for the continuous cryostat.

Figure 1: Stored magnetic energy and the discharged helium temperature versus beam energy.

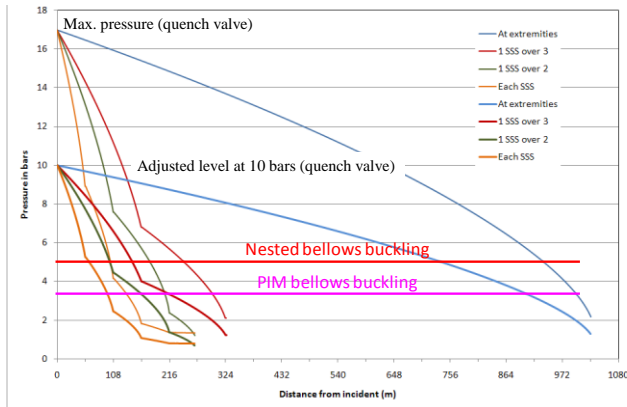
Figure 7: Pressure profile of beam pipes.
