Micromegas Commissioning status report

Athina Kourkoumeli-Charalampidi
On behalf of the Micromegas Commissioning Team

Muon Week 02-05/02/2021

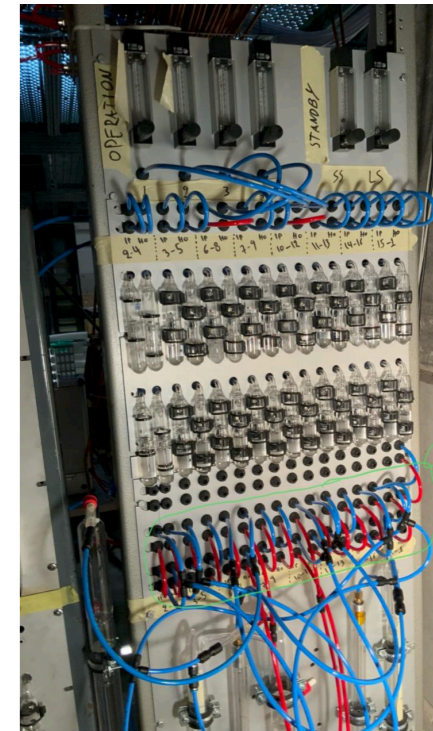
- * One gas line is connected to two sector single wedges (e.g. A14/A16 IP)
 - ▶ Two lines is one complete sector
 - ▶ Use alla BB5 portable gas leak tester
- * Gas leak tests have been ok up to now
 - ▶ All measurements are taken under stable P_{atm}
 - ▶ We are performing leak vs. P_{atm} correlation investigation to apply as a future correction to gain time
- * We can currently flush 40 L/h on two sectors
- * We bought larger output bubblers to set the P_{out} limit up to 7 mbar

Sector	IP (mL/h)	HO (mL/h)	Comments
A14	70	78	
A12	56	10	Underestimation on HO due to P_{atm} variations
A16			
A10	63	120	Overestimation on HO due to P_{atm} variations

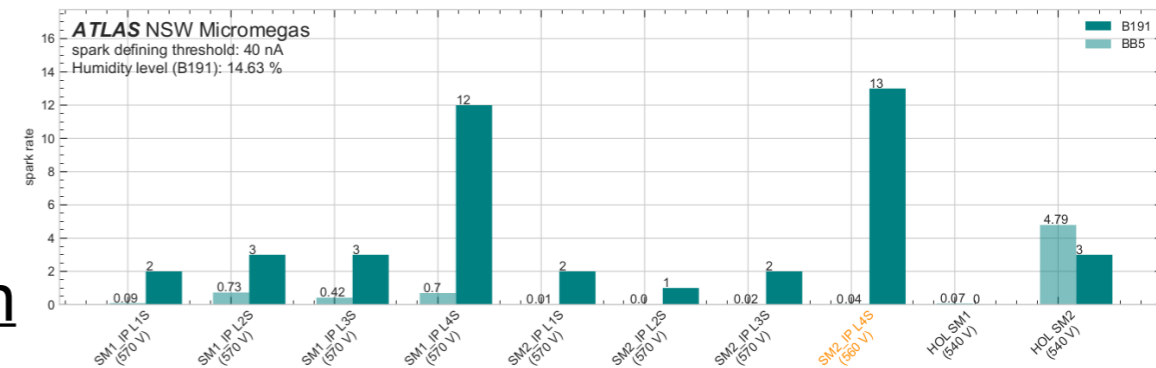
- * We migrated to the high granularity system in the beginning of January
 - ▶ We have a system with 2 splitter boxes, a 7038 AP power supply
 - ▶ We use extra DB 37 and coaxial cables to not stress the SB connectors
- * DCS and analysis: We use the BB5 DCS and analysis code for now
 - ▶ We are working on updating our summary plots
- * We compare our data to the BB5 sign-off documents
 - ▶ OK PCB:
 - ▶ max 6 s.p.m above 100 nA
 - ▶ Average current 40 nA

A14 has been validated and A12 is under validation

Qplet	Improvements	Deteriorations
SM1 IP	L3P3: 530 (525)	
SM1 HO		
SM2 IP	L3P7: 530 (520), L4P6: 525 (520)	
SM2 HO		L1P6: 560 (570), L1P7: 545 (570), L2P7: 565 (570), L3P6: 555 (570), L4P7: 535 (560)

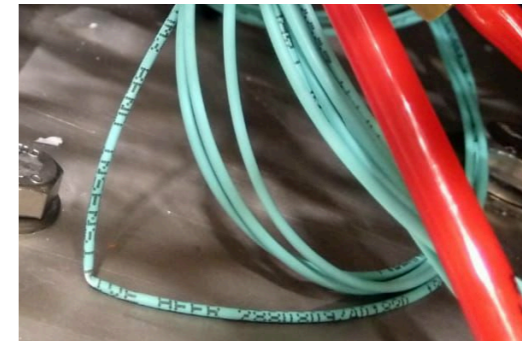
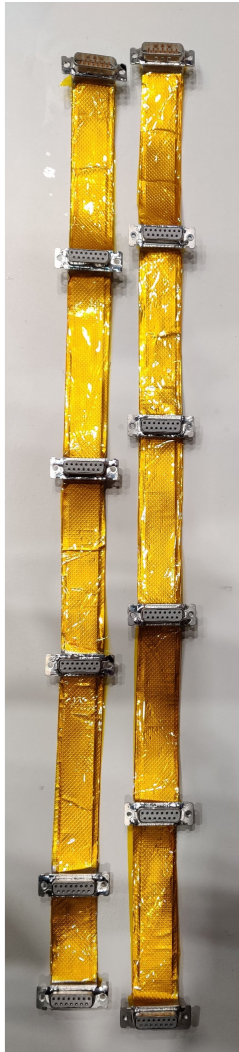
- * Test contact between sTGC/MM and MM/JD before and after services
 - ▶ Issues in next slide
- * Perform polarity checks on all cables coming from the ICS
- * Check cooling and surface temperatures, and keep an eye on elx T
- * Issues encountered:
 - ▶ Branch controller flat cable shielding: Improved version
 - ▶ Short fibers
 - ▶ Re-routing needed
 - ▶ A bent ADDC fiber in A08
 - ▶ Unaccessible due to Faraday cage
 - ▶ Sector was brought down for replacement and re-installed again (thanks to Theo V. And the NSW TC team)
 - ▶ White connectors overheating
 - ▶ New 13 A connectors were installed on side A, to
 - ▶ Broken T-sensors
 - ▶ It is a usual issue even if BB5 protects them in transportation
 - ▶ Trained Panos how to remove the sensor and clean up the holes
 - ▶ Stelian replaces them and adds glue

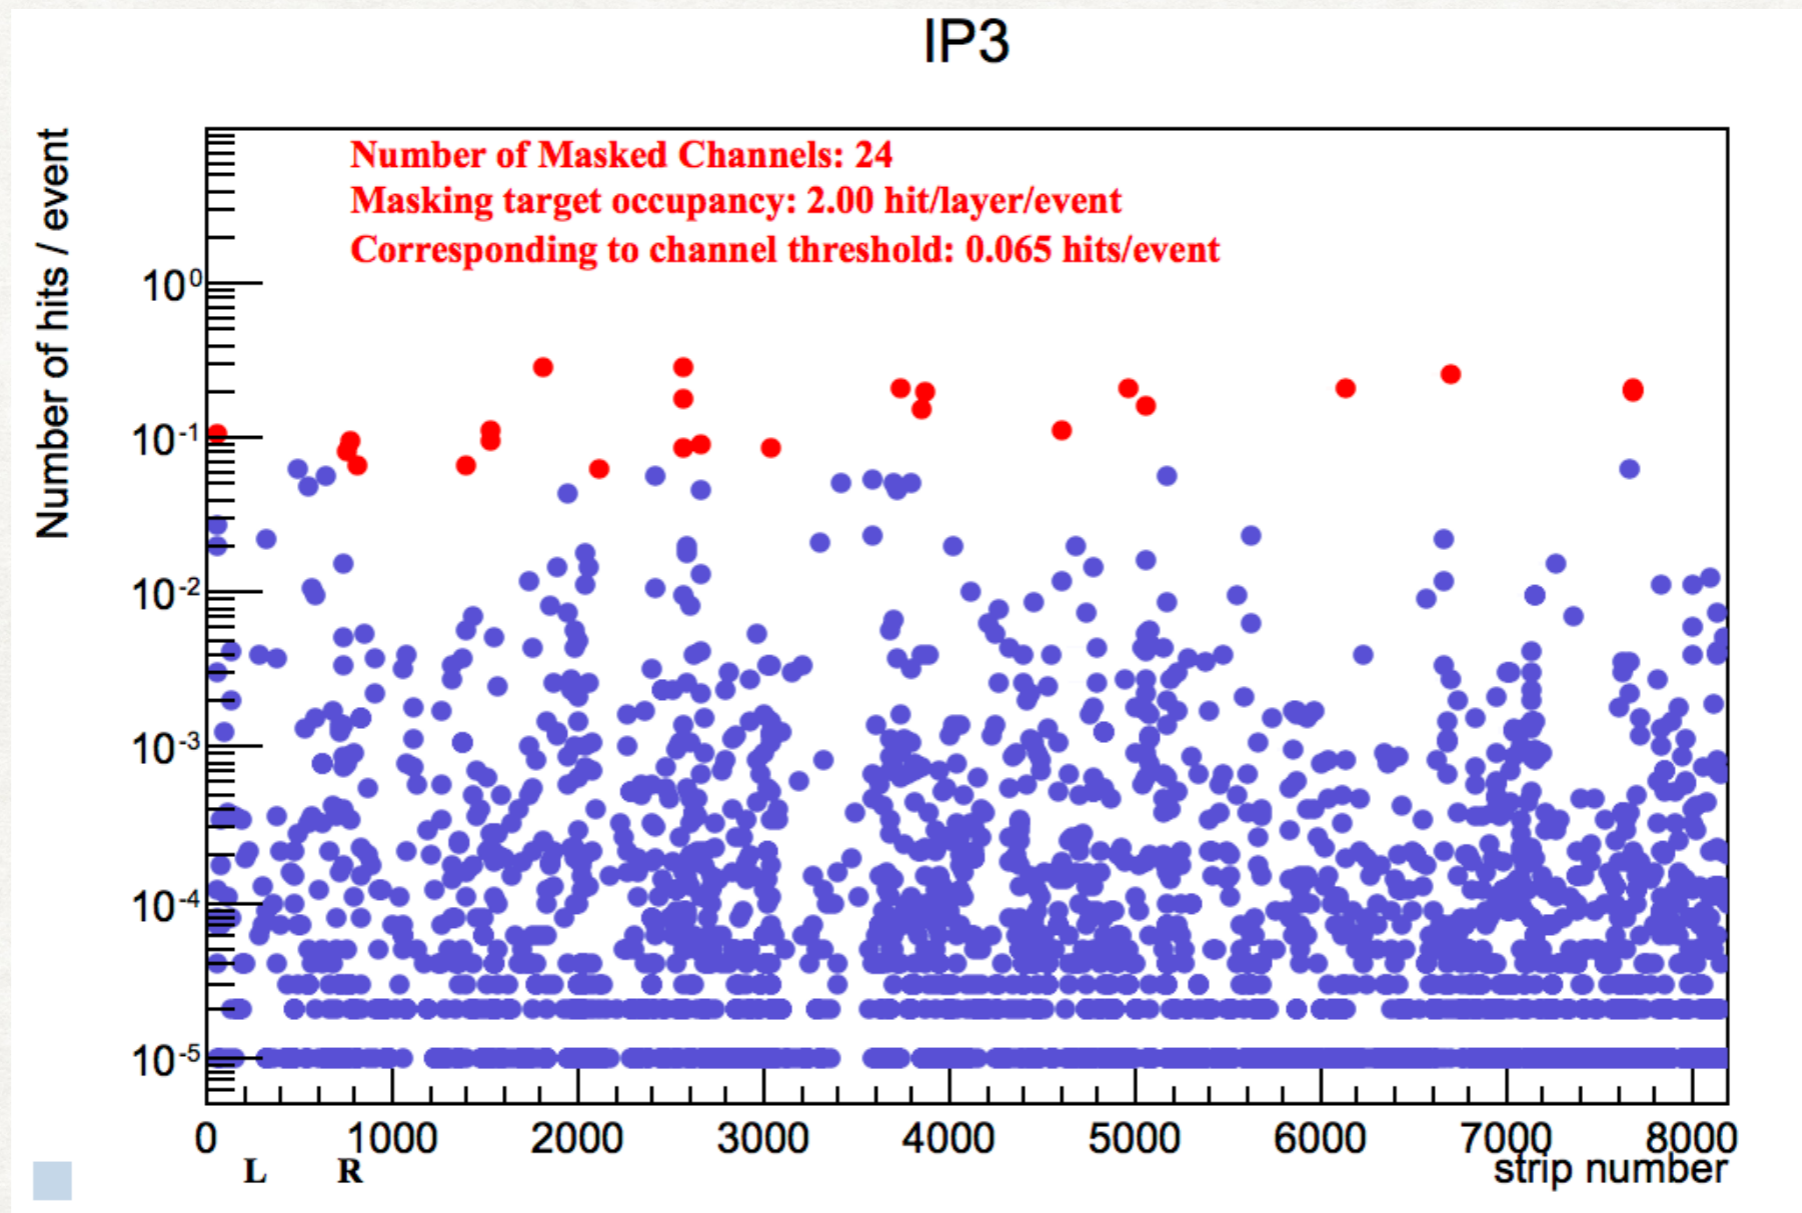
LATEST NOISE RESULTS (NOISE RUNS)

Noise occupancy after masking < 2 hits/layer/event
(~ 70 from cavern BG)

Max 1.5% masked channels/layer for all sectors !!!
