3rd IFAST WP9 meeting

D. Tikhonov

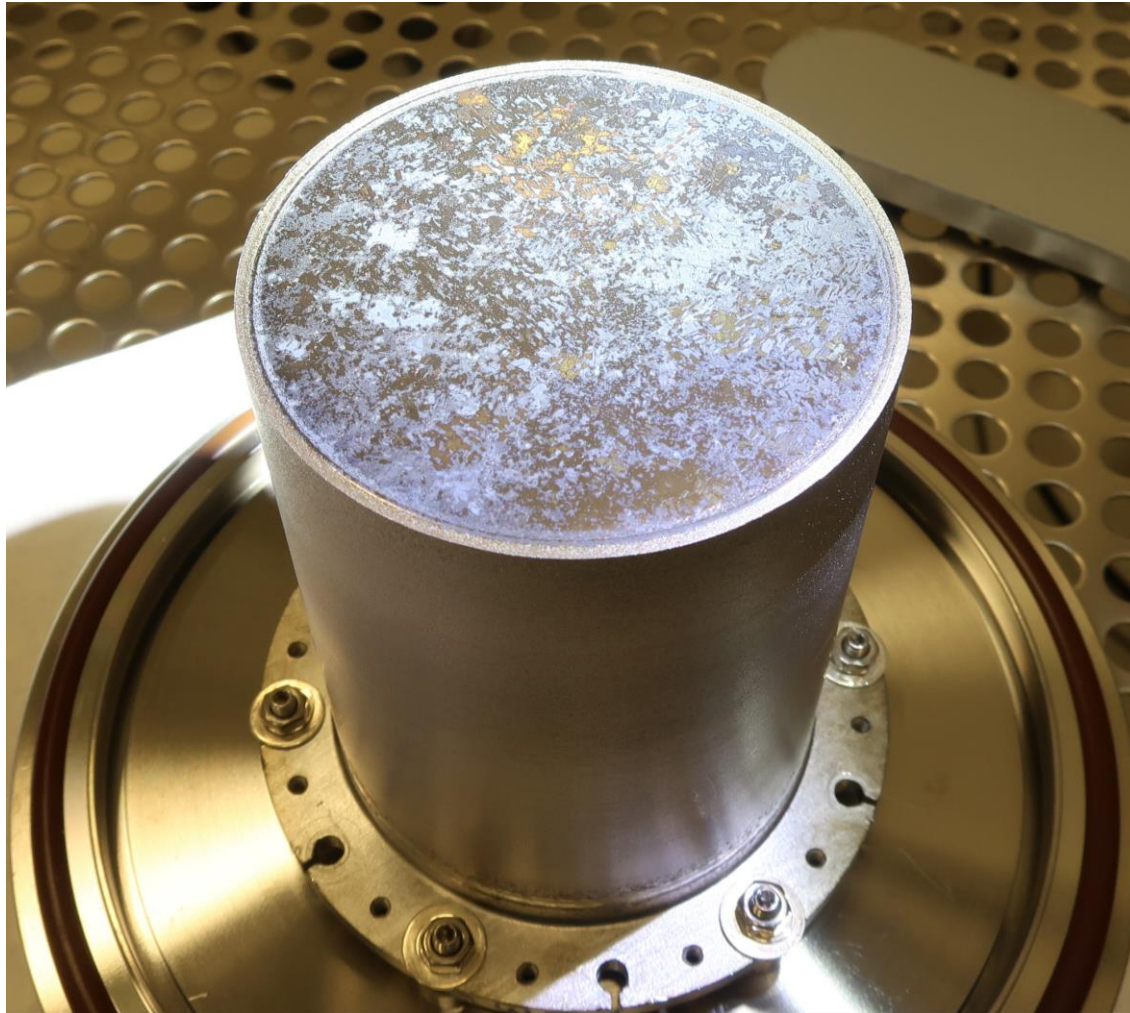
Measurements at 410 MHz already shows poor performance of the film with **Superconducting coated flange**

The maximum field achieved is a limitation from heating due to high R_s

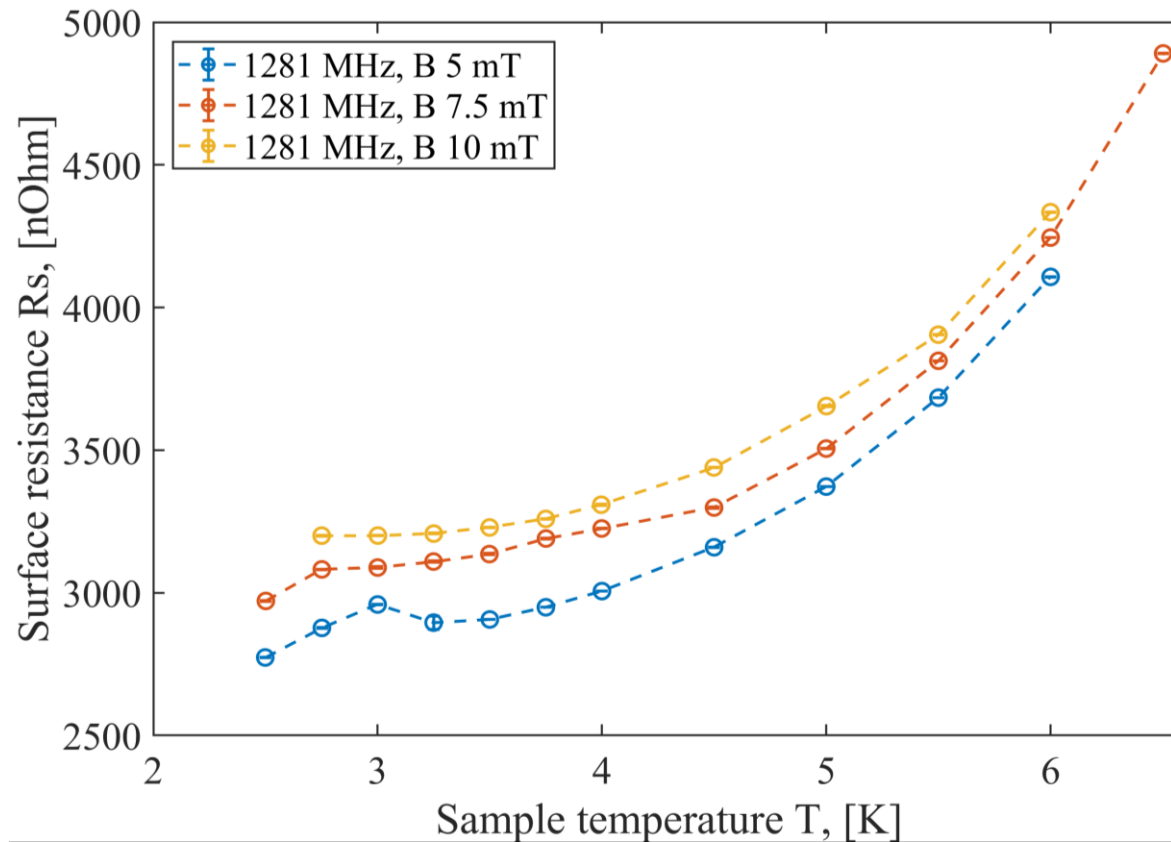
Data for 1280 MHz

Values are very approximate due to poor film quality and large field dependence

Despite of poor performance the BCS scaling with frequency is approximately follows quadratic trend

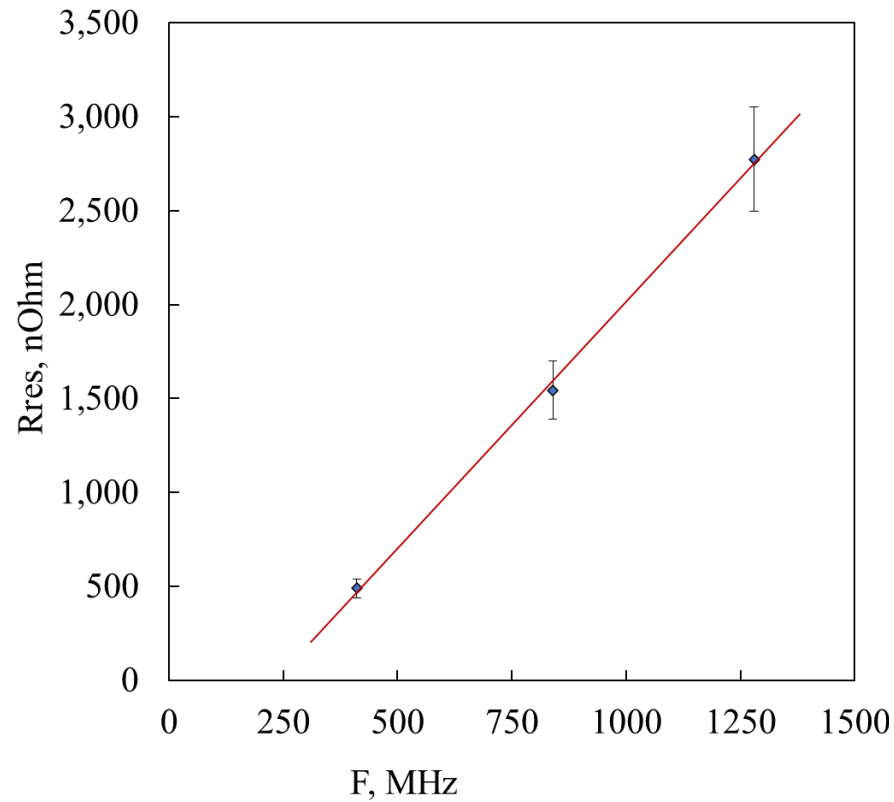
Residual R vs Frequency

Residual resistance is linear with the frequency

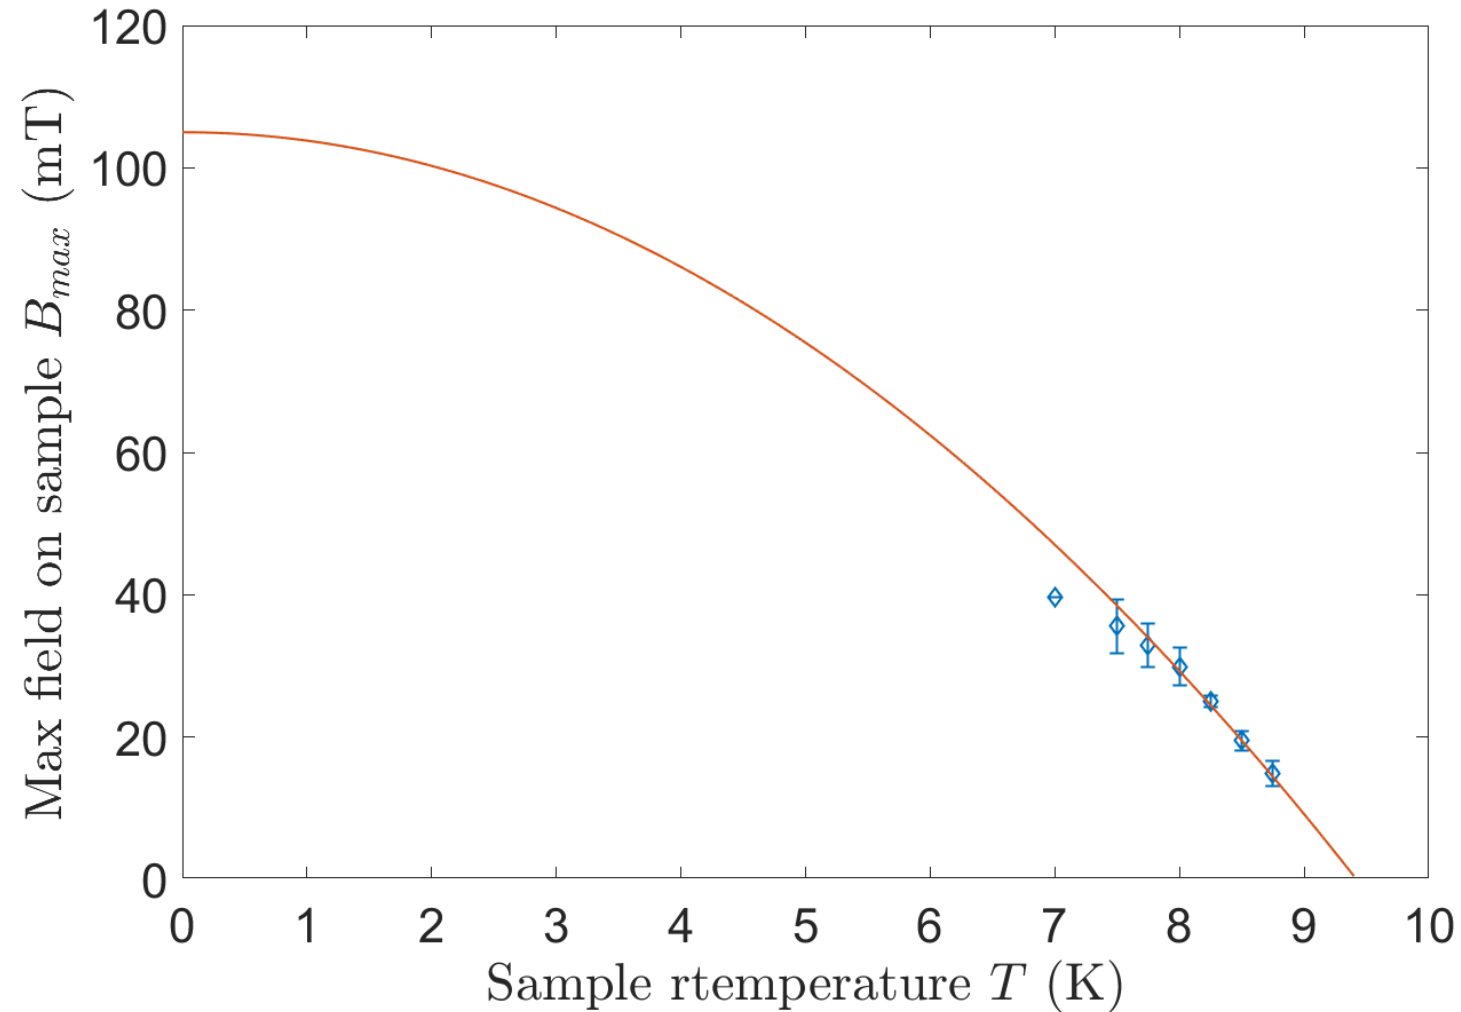
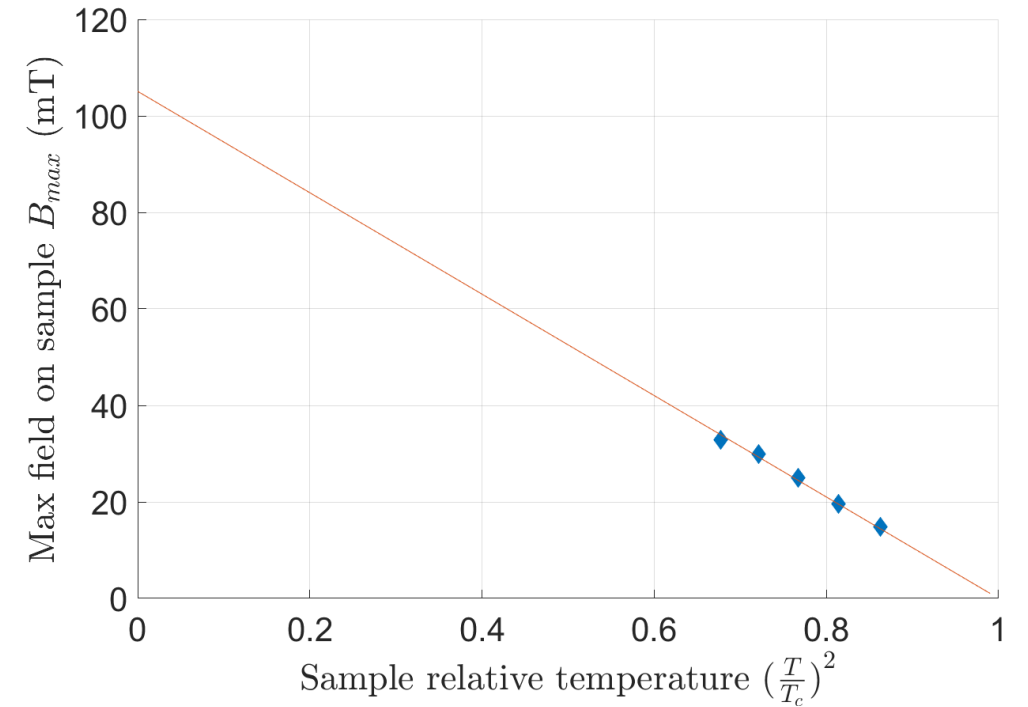
B quench as a function of T shows B₀ around 105 mT, however not clear if the quench comes from NbN layer or Nb

T_c used here was 9.4 K

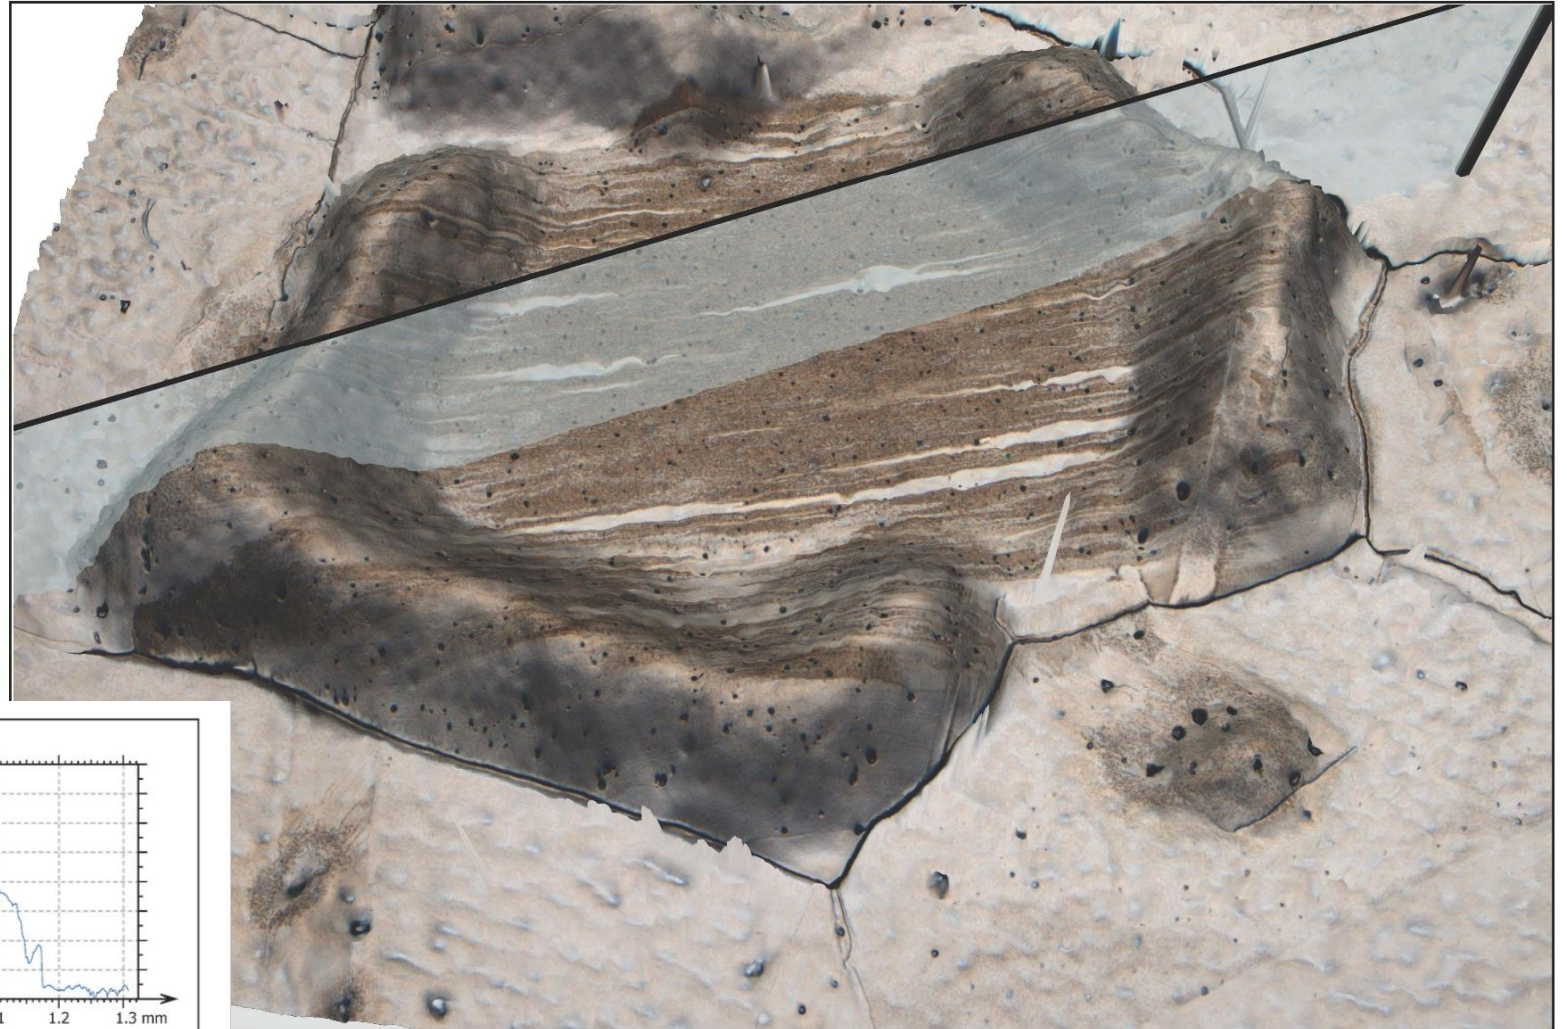
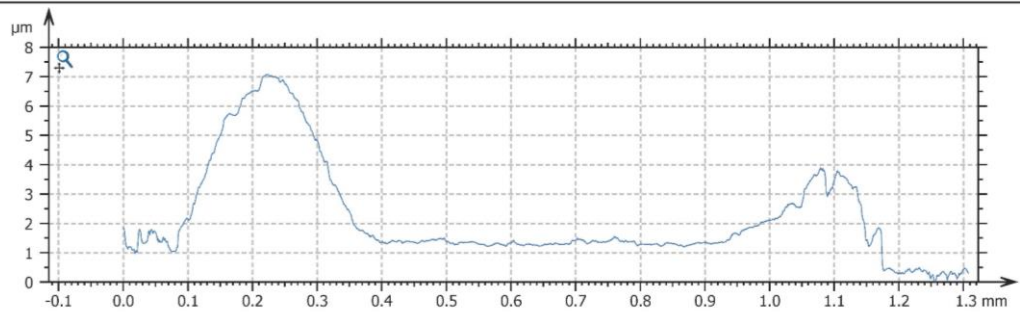
- 6 mkm hills with observable pitting on them

- Film is very defective (in future we should consider if to test films with so many visible defects)
- Hills could be delaminated film or anomalous film growth or defects on copper due to **high heating**.
- Film performance is quite poor
- We should use HIPIMS method rather than DC MS
