Rich Wall Status for 2022

M. Alexeev & colleagues

Università di Torino & INFN Torino

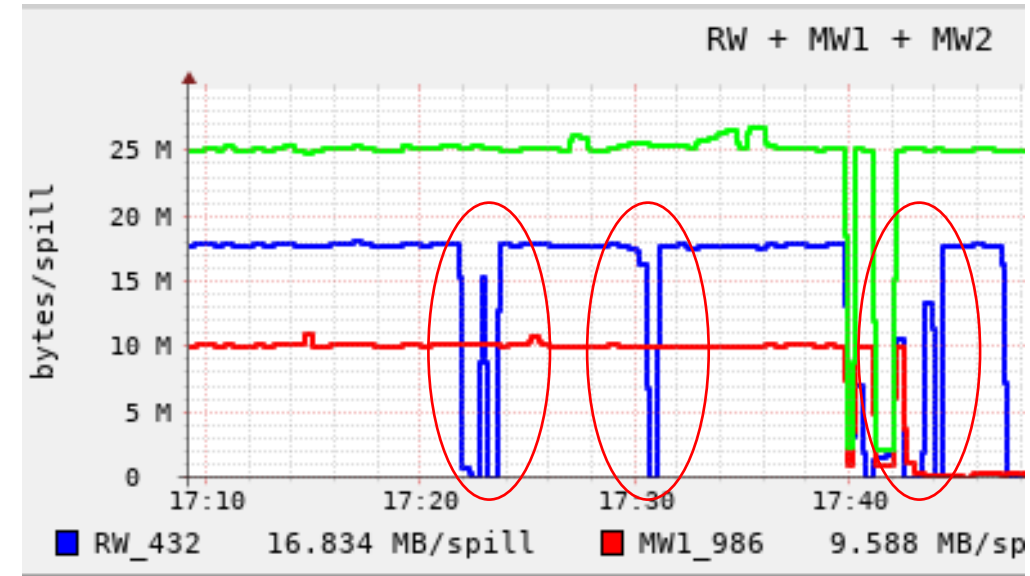
- Unfortunately when we went to nominal triggers it was found out that the RW is **missing ~15% of the data**
- The investigation restarted and from the looks of the problem most probable cause were the trigger delivery or sporadic R/O modules failures due to FE malfunction or a problem of the module

- First the **trigger was tested to be OK**, then preparing to test the FEs, suddenly **the detector stopped the data communication and came back to the May situation**

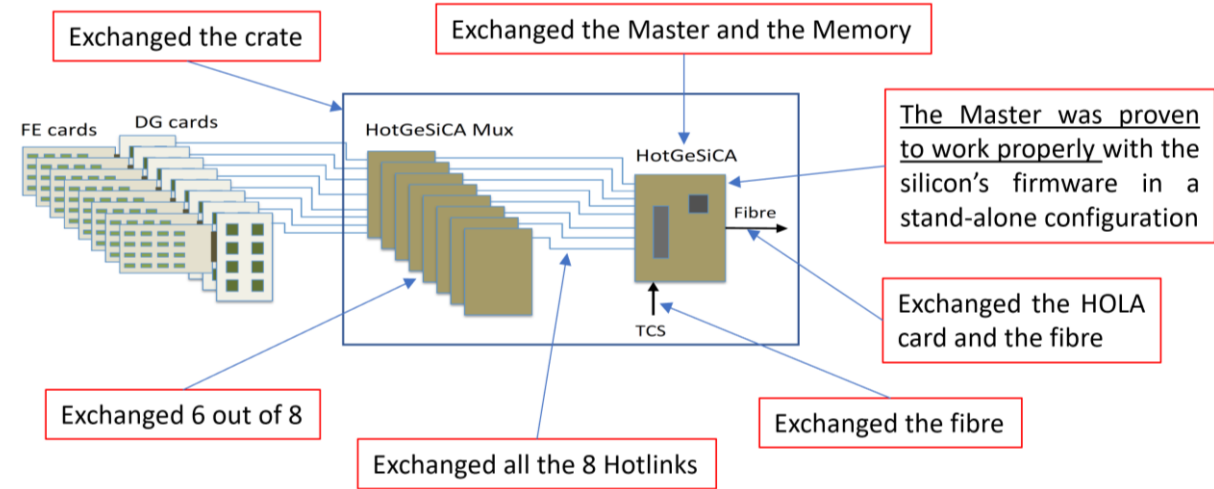
- ✓ Physical exchange of the components
- ✓ New Master modules creation
- ✓ Check of **the Master module** with a Silicon firmware -> **it is working**
- ✓ Check of the whole data chain till the DAQ barrack and in the barrack
- ✓ Attempt to modify the firmware to monitor the internal software situation -> **Failed due to the age of the modules**

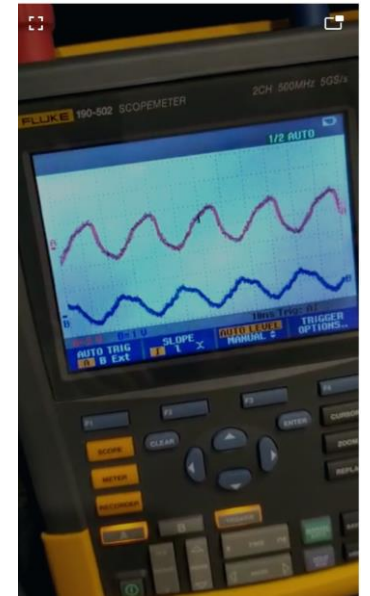
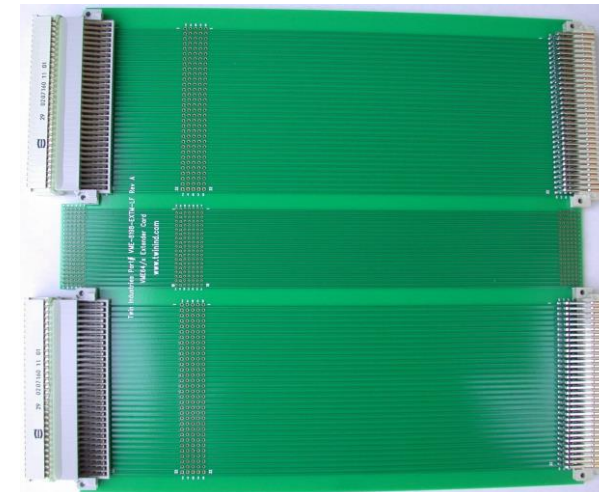
It seems form the first observations that there is the **trigger on all the elements** of chain but it **might not be properly "read"** by the GeSiCas and the FE cards

- ❖ We plan to proceed this investigation during the next MD
- ❖ If confirmed, that would indicate we have some generalised problem
- ❖ It could be an electrotechnical problem
