The 1MV MITICA power supply beyond the modern technologies limits: first experience during integration phase

M. Boldrin (Consorzio RFX - Padova) on behalf of NBTF Team

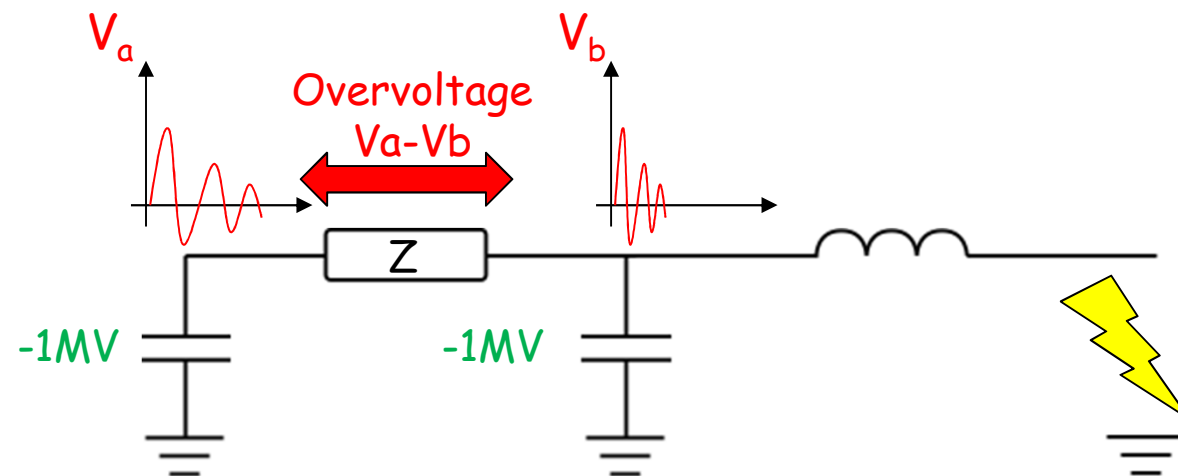
Overvoltages are generated by different LC transients:

MITICA HV system is characterized by physical and stray capacitances **charged at -1 MV**.

When a breakdown occurs in the accelerator or in another upstream place (short-circuit between 1MV and ground) these capacitances discharge with different oscillation frequencies, causing **overvoltage** on the connecting impedance Z .

This phenomenon has created unexpected voltage peaks on some components, beyond their design ratings
