# *The Curious Case Of The* **VTR<sub>x</sub> RECEIVER FAILURES**

EP-ESE Electronics Seminars  
18 January 2022

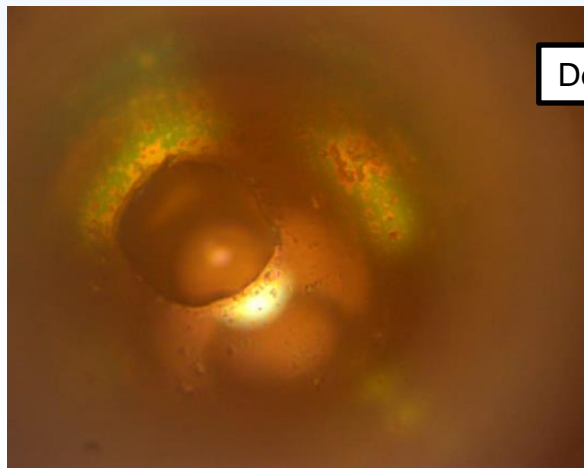
Device returned from ALICE ITS

- User observed contamination the surface of the ROSA ball lens
- Concern was that the glue that holds the ball lens in place or some other residue could soften and/or move when the device is operated and therefore cause varying attenuation
- None of the returned samples had enough contaminant to explain observed drifts in the RSSI
- All bad looking samples that had caused problems in the experiment had also been wet cleaned by the user
  - Impossible to say what was residue of the cleaning process and what was real contamination

- Dozens of modules imaged and no contamination that could cause significant signal attenuation observed
  - Ball lens receives the expanded beam from the fiber
- 64 ROSAs (4 from each production lot) were imaged, kept at 85C for 120 hours, and imaged again
  - No changes in contamination observed

Not enough evidence for ball lens contamination theory

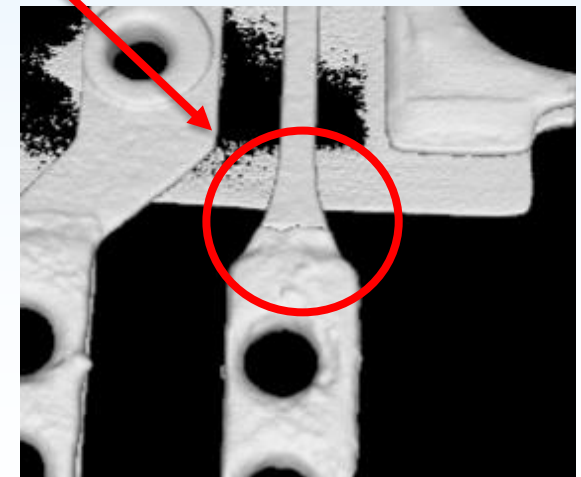
Cross-sectioning

- A weakness in the flex design was identified
  - Cracking possible at the edge of coverlay
- 140 VTRxs tested in thermal cycling
  - -40 to +85°C, 500 cycles
  - 12/140 (8.6%) showed issues at some point in the testing
  - 11/12 failures directly due to flex
- New flex designs where the discovered weaknesses fixed
  - 160 VTRxs (3x40 with new flex versions and 40 with old) samples through same temperature cycling
  - No failures
  - New version easier to assemble
    - Preferred for repairs

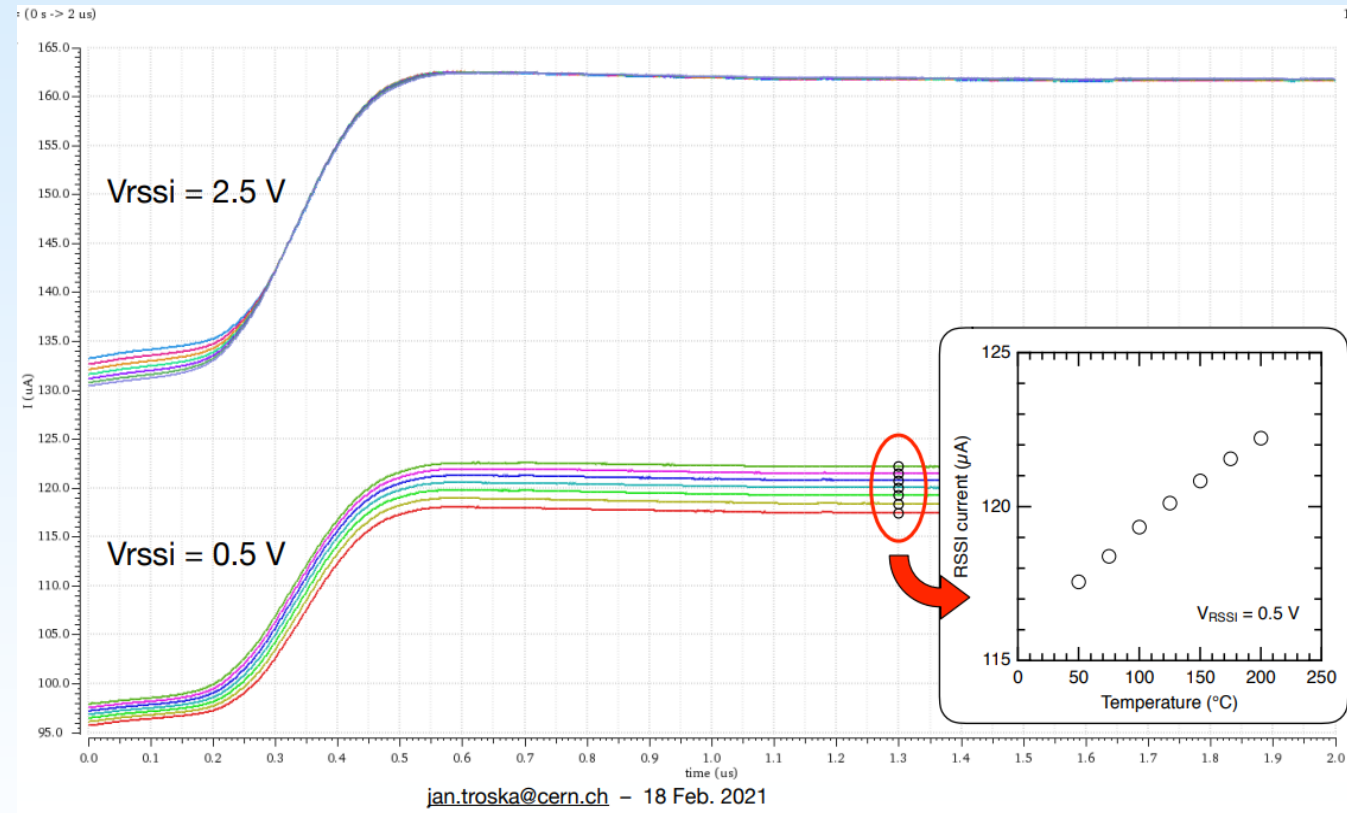
- Issue known to occur at elevated temperatures
  - GBTIA overheating?
- Schematic-level simulation over temperature
  - ASIC works well up to 200°C junction temperature
  - No significant effect on high-speed performance
  - No influence on RSSI output for nominal voltage
  - At lower RSSI pin voltage, the current increases with temperature so cannot explain RSSI drop
- Lab tests pushing GBTIA even out-of-spec conditions did not produce results resembling anything observed by the users

After investigations, there was no evidence to support GBTIA theory

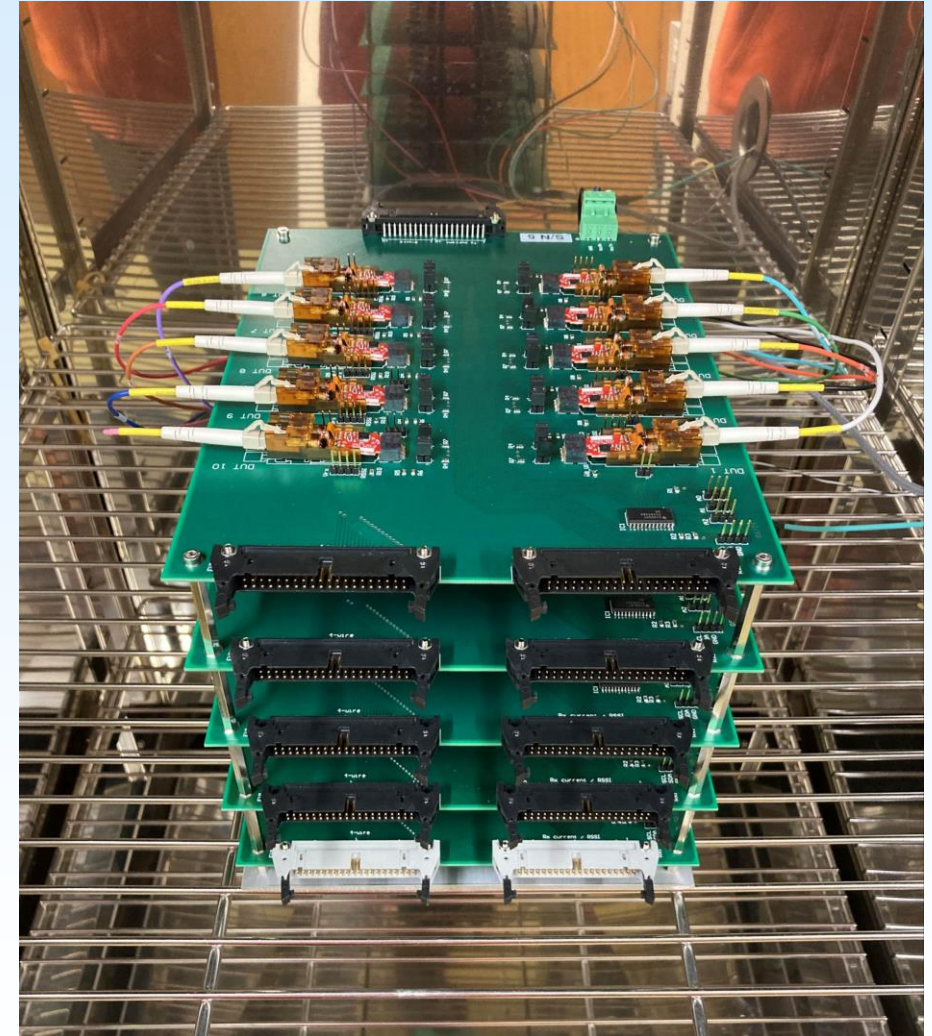
- **Reminder:** at this point we were still struggling to reproduce the problem in our lab
- We had started to prepare large scale setups
  - If enough samples are running, we must observe this issue at some point!
- 50 devices running continuously inside a temperature chamber
  - We could control the temperature and try to provoke the failures
- And this happened without even turning on the chamber:

- This setup was left running to collect failure statistic and another similar setup was right away prepared...

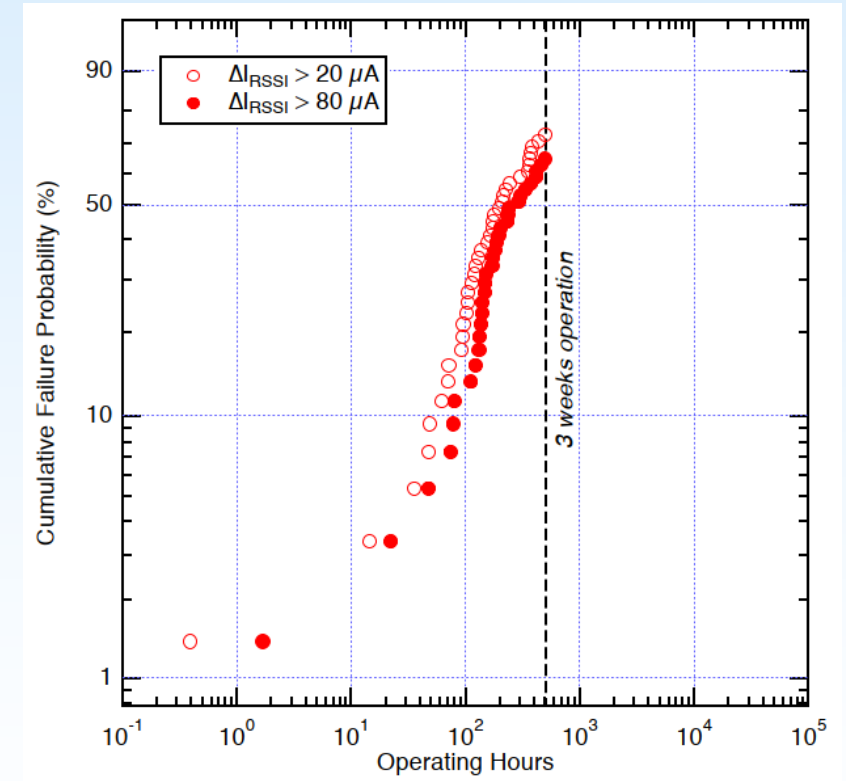
- The RSSI drift shows almost identically in the sensitivity!
- We are losing the light input somehow

*In right conditions it looks like the whole (at least almost) population can be affected!*

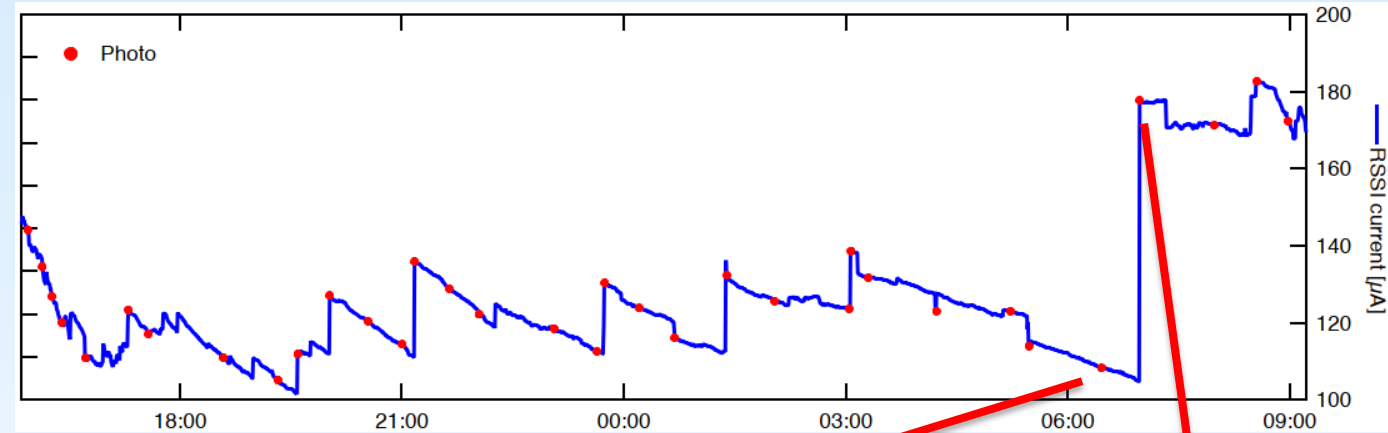
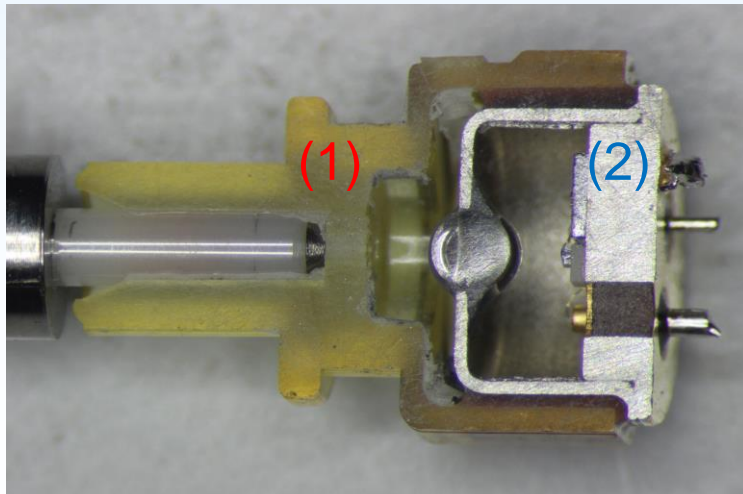
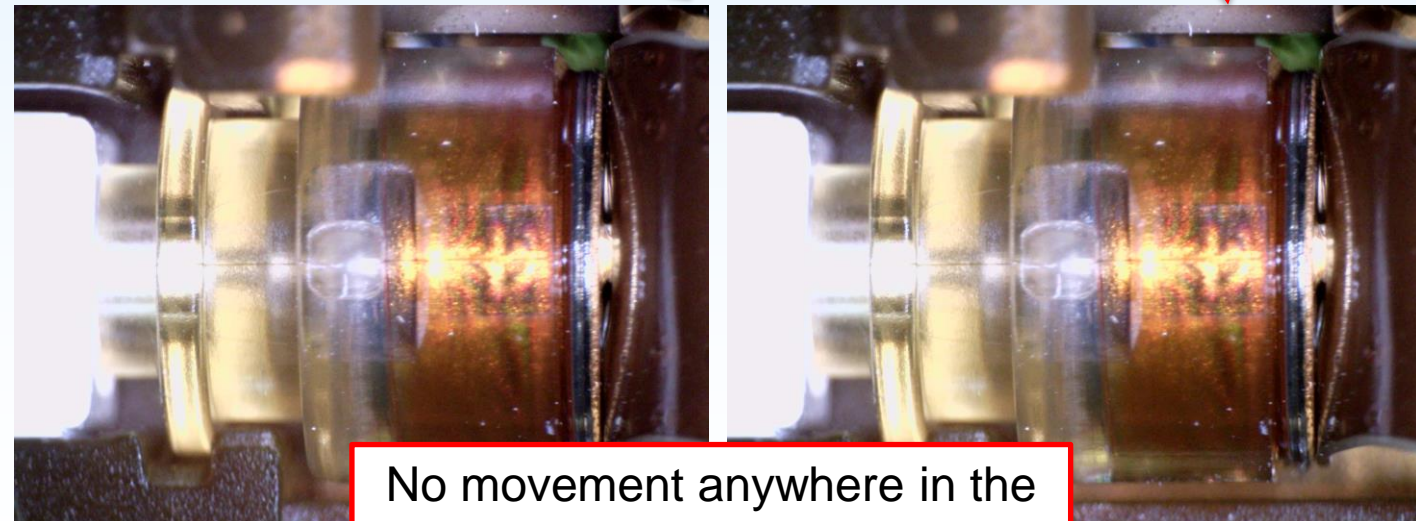
- With simple optics simulation one can estimate that some tenths of a degree movement between the plastic receptacle (1) and metal TO-can (2) could cause observed losses
- This was then tested in two ways
  1. Movement is small but could be detected under a microscope: VTRx and a microscope inside insulated box and recording images and RSSI
    - No movement observed even when RSSI jumped almost 50%

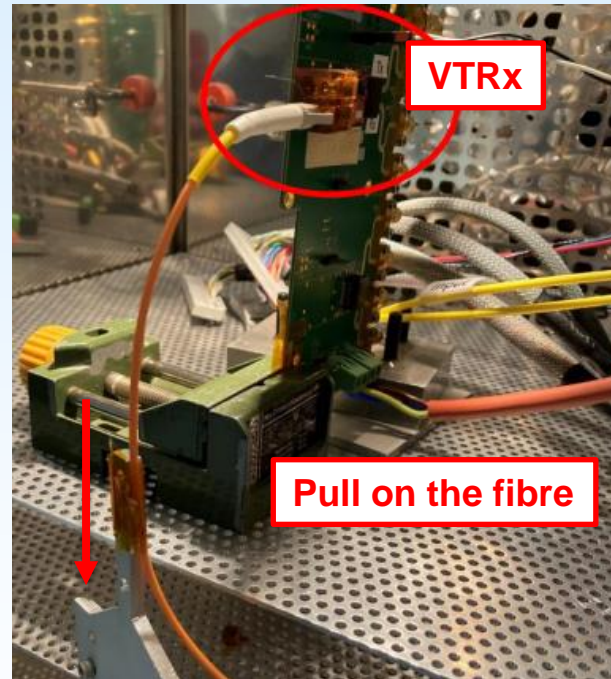
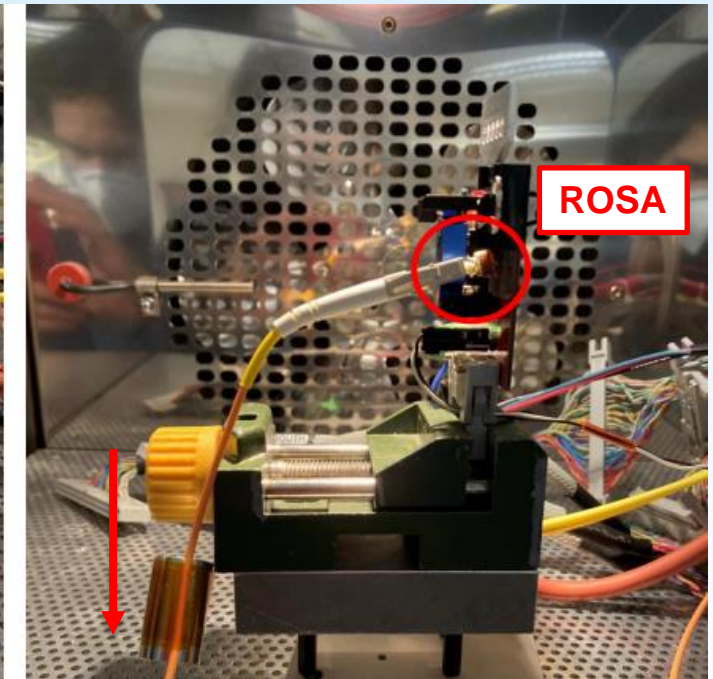
- With simple optics simulation one can estimate that some tenths of a degree movement between the plastic receptacle (1) and metal TO-can (2) could cause observed losses
- This was then tested in two ways
  1. Movement is small but could be detected under a microscope: VTRx and a microscope inside insulated box and recording images and RSSI
    - No movement observed even when RSSI jumped almost 50%
  2. Weights pulling the fiber in different directions either using VTRx or bare ROSA while whole assembly heated in temperature chamber
    - We definitely exceeded realistic mechanical forces that a ROSA would be subject to in a real application
    - And still no changes in RSSI observed

No, misalignment theory does not work

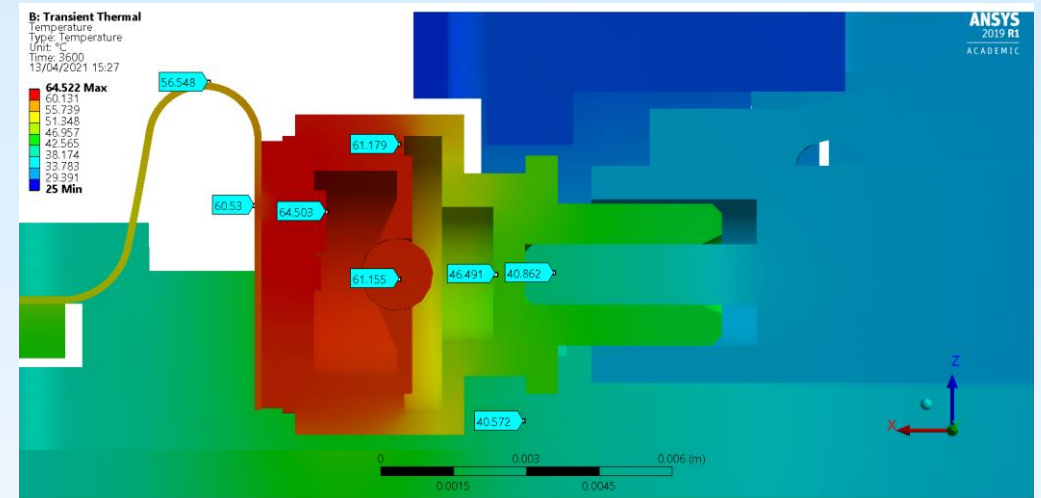
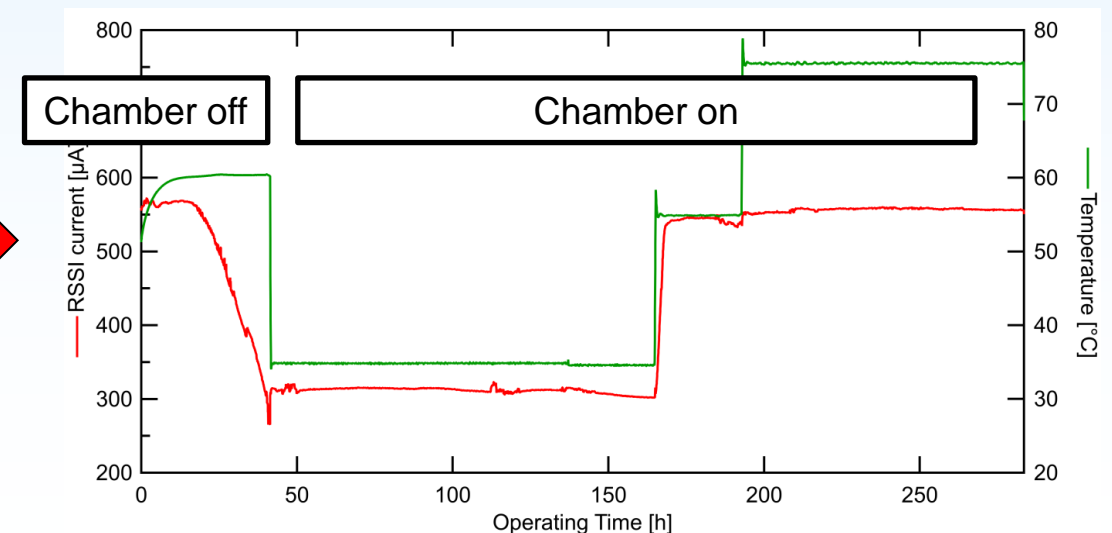
- Now the earlier observations about the weird temperature behavior, where cooling helped but heating solved the problem started to make sense:
  - In order to out-gas the device must be hot enough
  - In order to condense the fiber end-face must be cool enough
  - **Temperature difference is the key!**
- These conditions can often happen in experiments, where VTRxs are on a motherboard with other warm electronics but the fibers are on the front panel in cooler air
- Not the case in our typical temperature testing, where the temperature differences are created with a temperature test chamber
  - When device is heated, fibers are heated as well

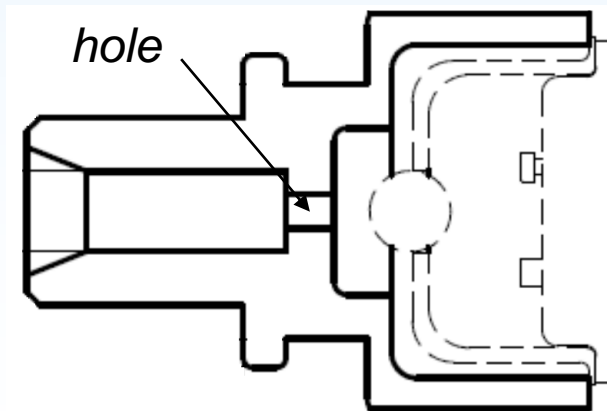
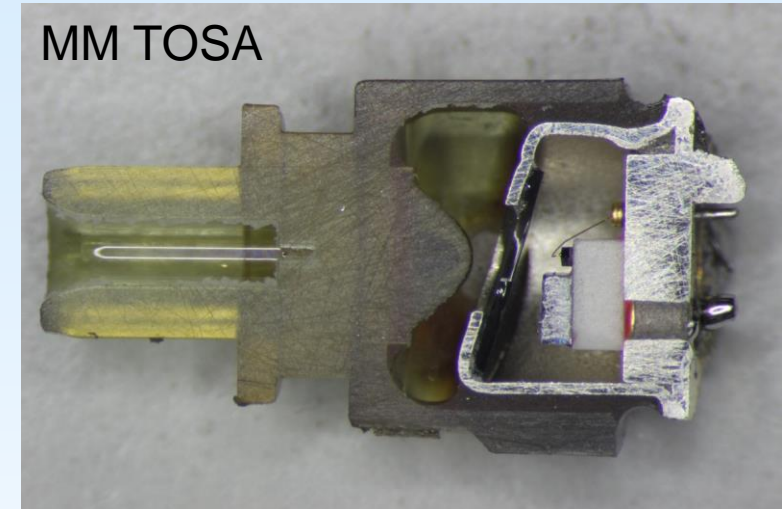
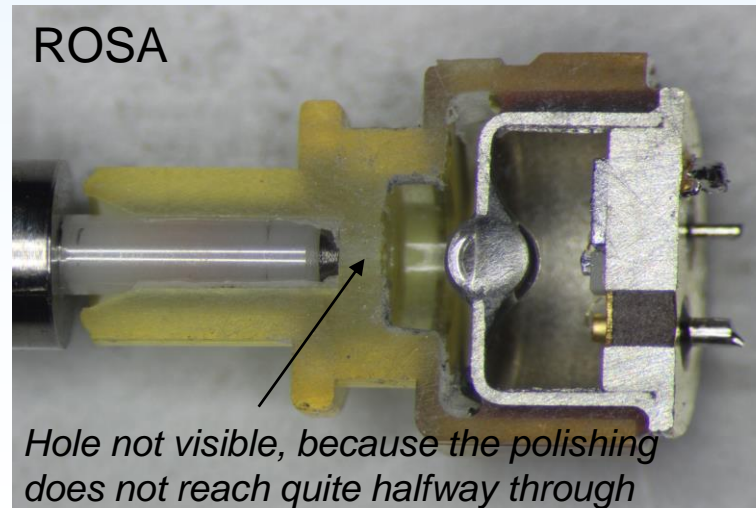
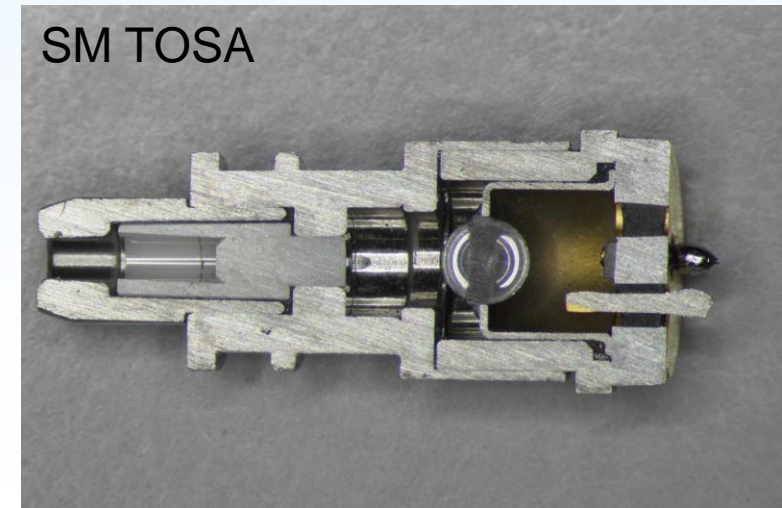
- OSA (optical sub-assembly) can be designed in different ways
- V in VTRx stands for Versatile
  - One aspect of the versatility is options for 850 nm and 1310 nm wavelengths
- The same supplier provided both ROSA versions and their design decision was to use a receptacle with a hole for the light path
  - If light travels in air the wavelength does not matter and the same design suits for both versions!

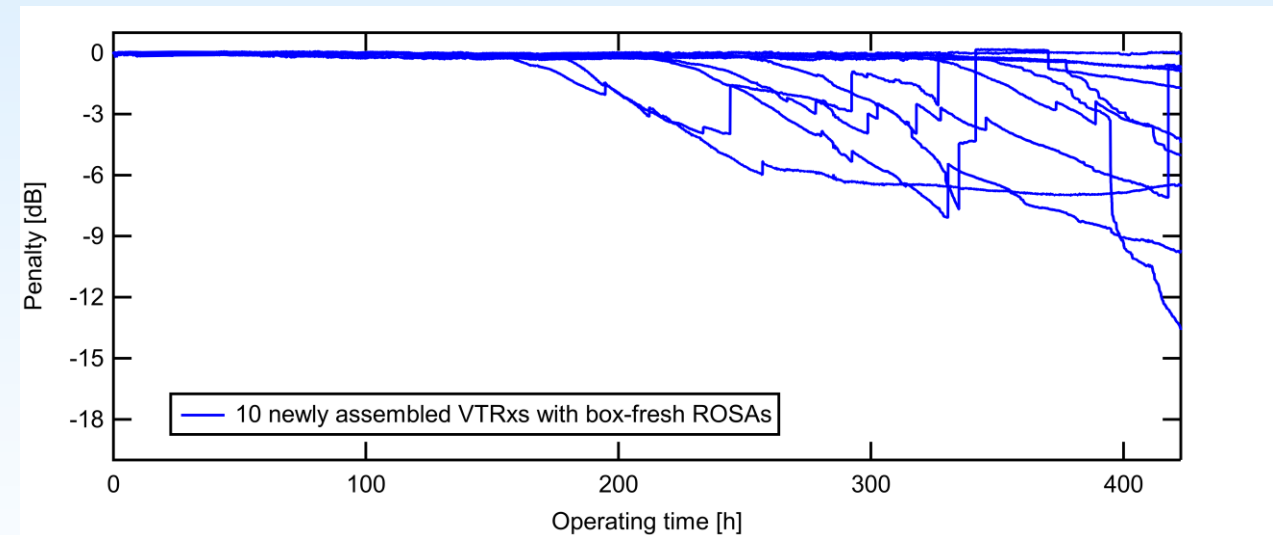
- In order to determine at which stage of the assembly process the contaminant was introduced different sample sets were tested
  - Samples from different times in the series production
  - Samples that had been in contact with the dust caps and without them
  - Samples with box-fresh ROSAs straight from manufacture's original packaging
- All above, even the box-fresh ROSAs, showed typical drifting, which meant that the contaminant was present already from the ROSA manufacturer

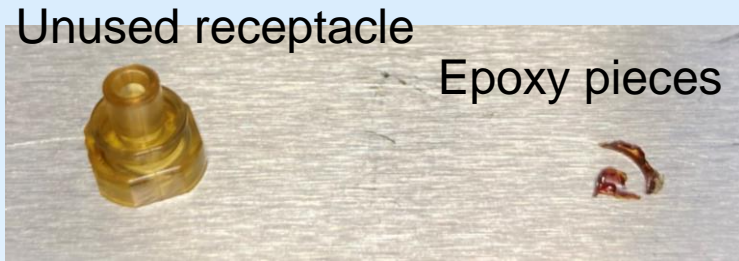
- Epoxy sample from ROSA heated on a hot plate and collected on a clean fiber using a new receptacle
  - Looked like the contaminant observed in our lab and at the experiments
  - Also stuck on the fibre end-face for longer time
  - We were also able to change the epoxy colour with extra curing, which could be a sign of insufficient initial curing

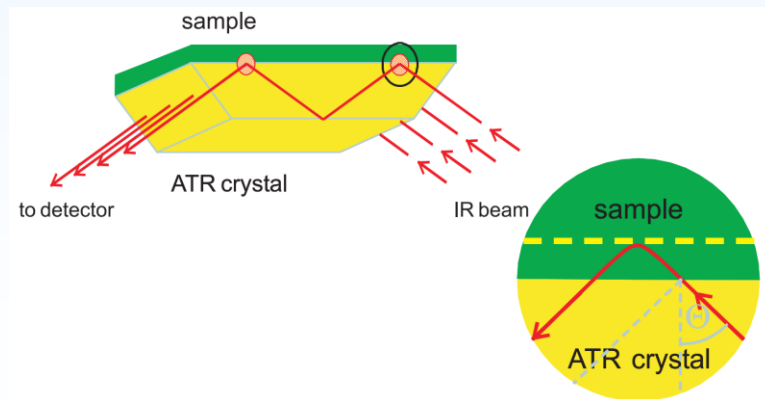
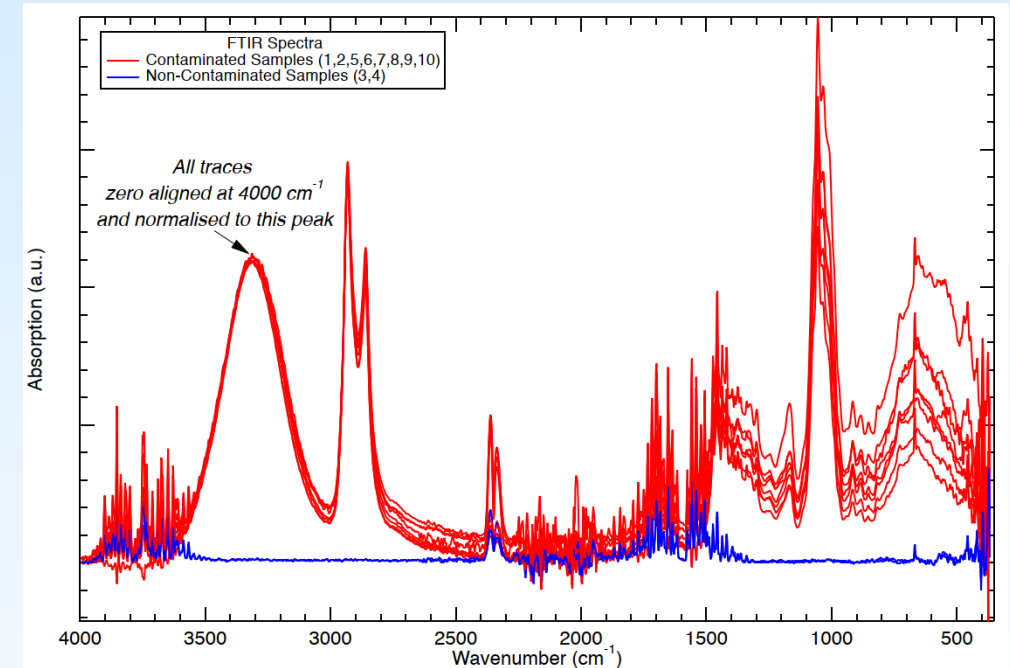
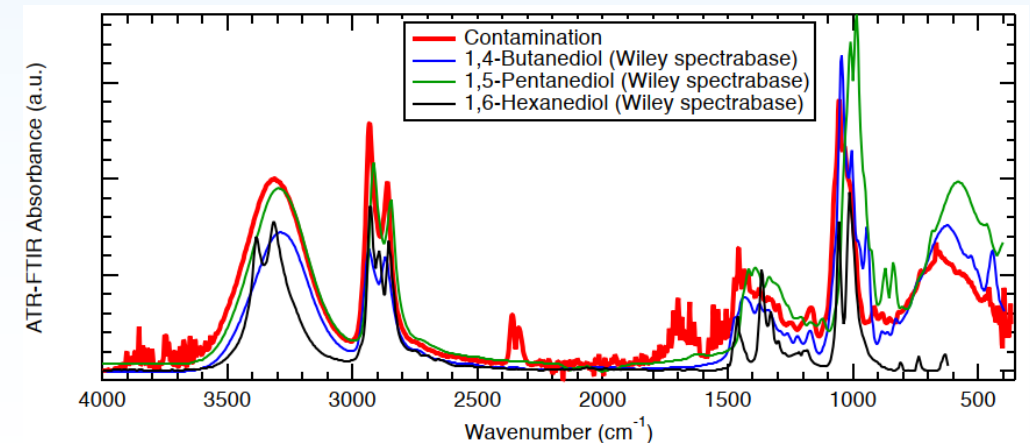
- FT-IR instrument available in CERN Chemistry lab
  - First attempt at identifying the contaminant
  - Directly wiped contaminant off of the fibre ferrule onto the ATR crystal for analysis
- **Data best match with a diol**
  - FT-IR identification is a bit difficult, especially for mixtures

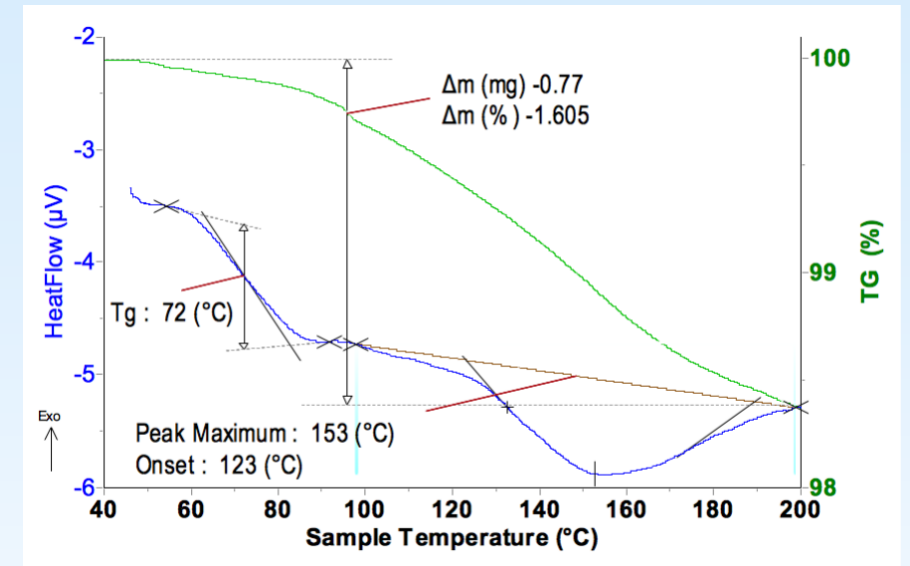
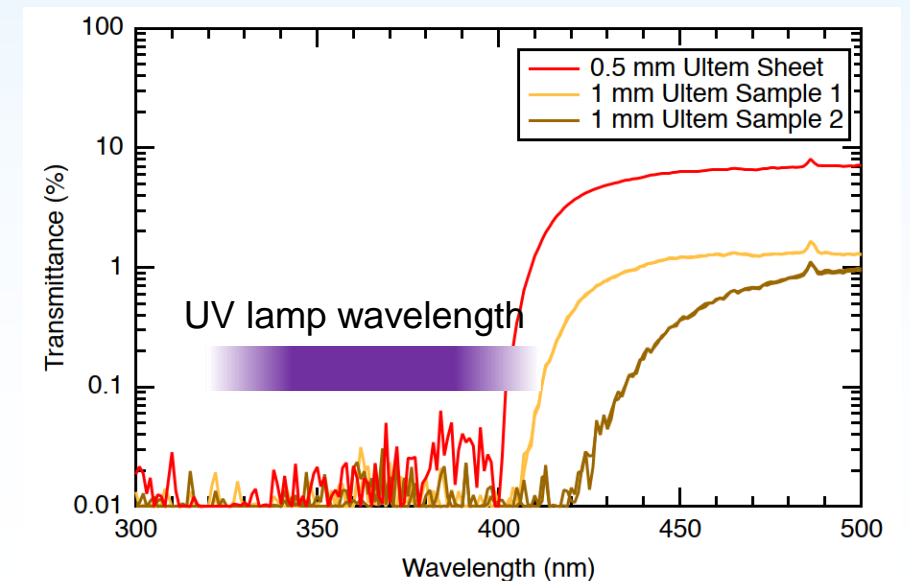
- DSC on epoxy from ROSA shows a relatively low Tg (glass transition temperature)
- Epoxy can be further cured using additional application of heat
- DSC on UV adhesive technically challenging
  - The Tg is low, and not well defined
  - Too small samples for other methods
- Why could the UV adhesive be not properly cured?
  - Ultem (receptacle material) absorbs UV very strongly
  - UV-adhesive harvested from ROSAs often found to be still “tacky”, as if not entirely cured
- **Signs of insufficient curing of both epoxy and UV-glue**
  - **This could allow unwanted reactions and mixing of the two adhesives**

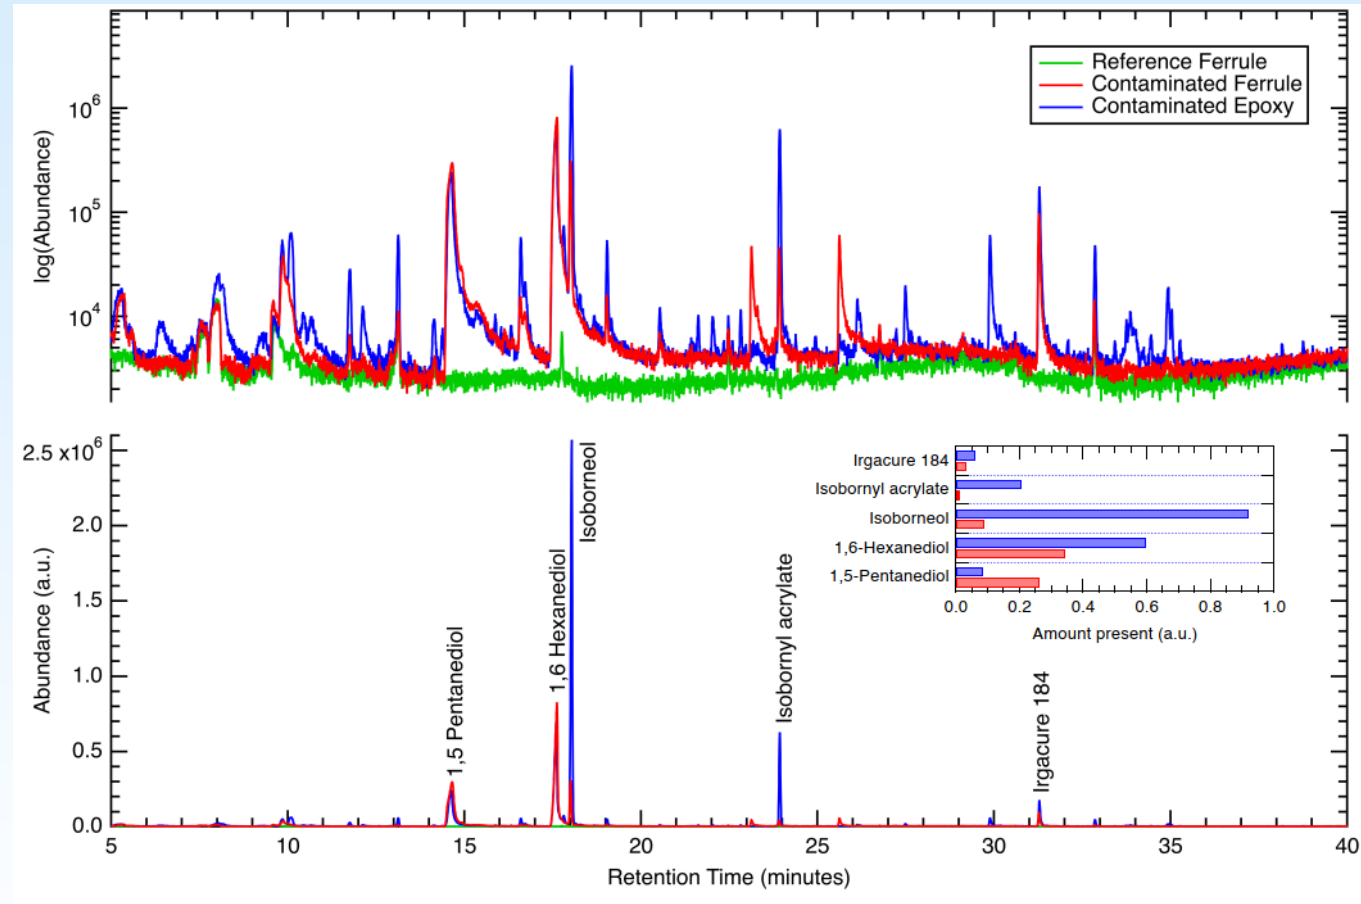
- **The contaminant is clearly a mixture of two diols**
  - Isoborneol, Isobornyl acrylate, Irgacure should not be present in the epoxy, they come from the UV adhesive
- **Compounds in the epoxy that should not be there → mixing of the two adhesives**

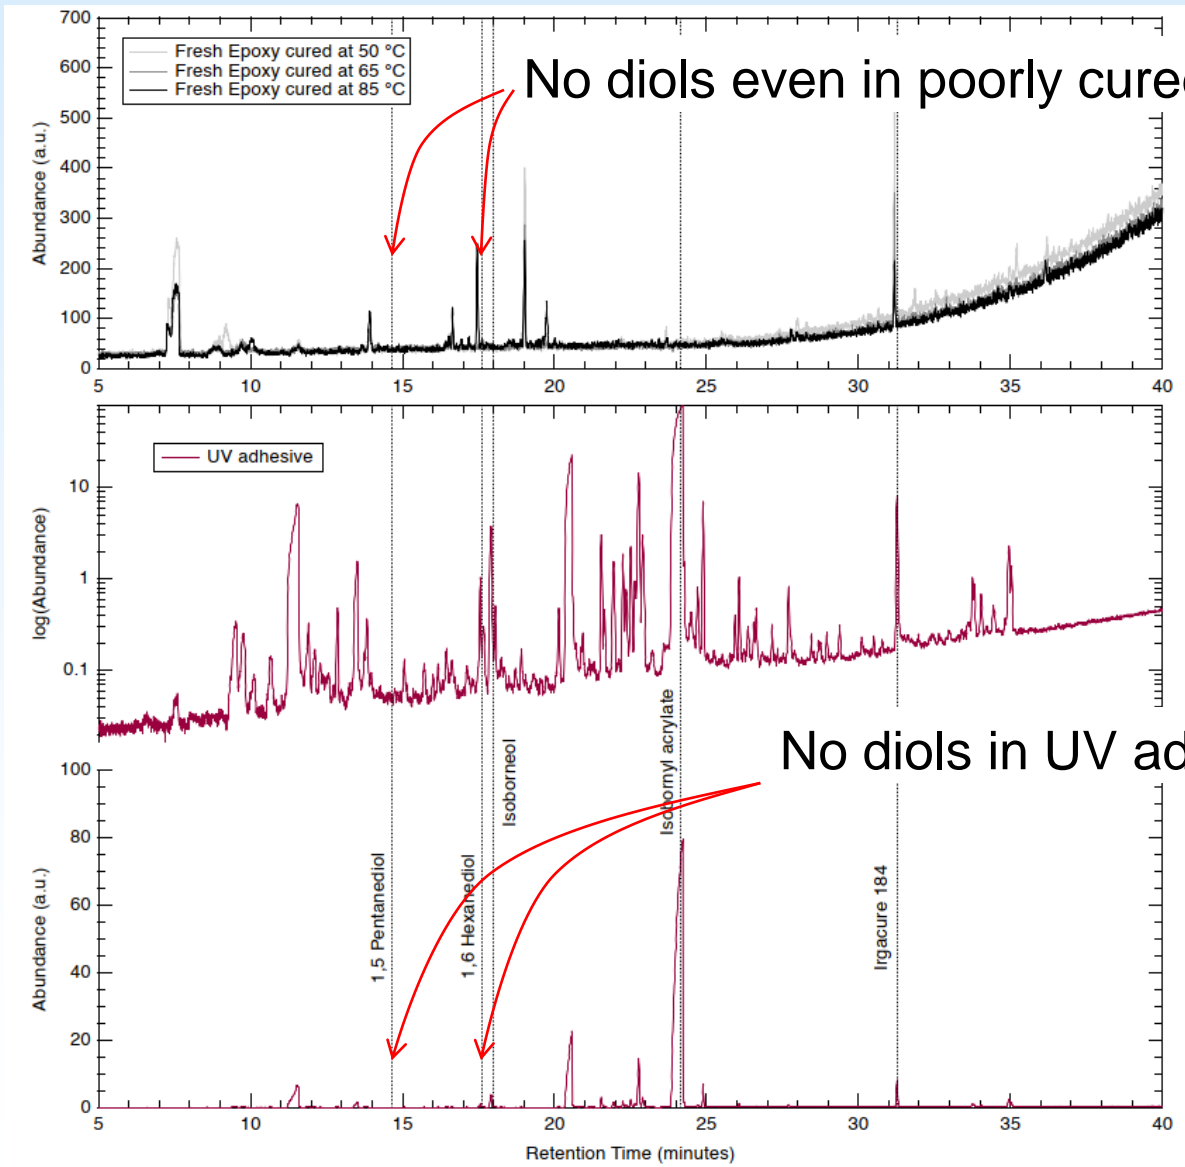
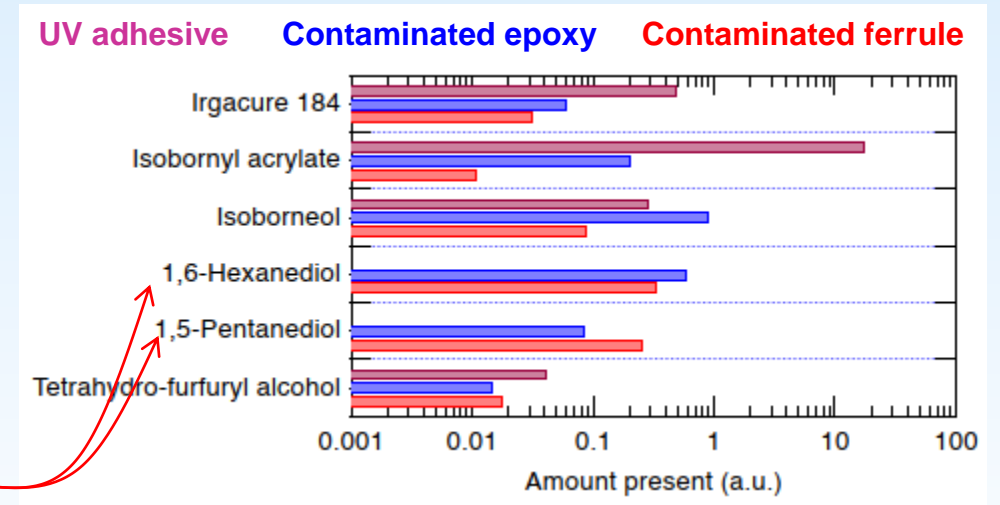
# Same test with fresh adhesives

- No diols in the fresh, “out from the bottle” adhesives
  - Some reaction is needed to create the contaminant product

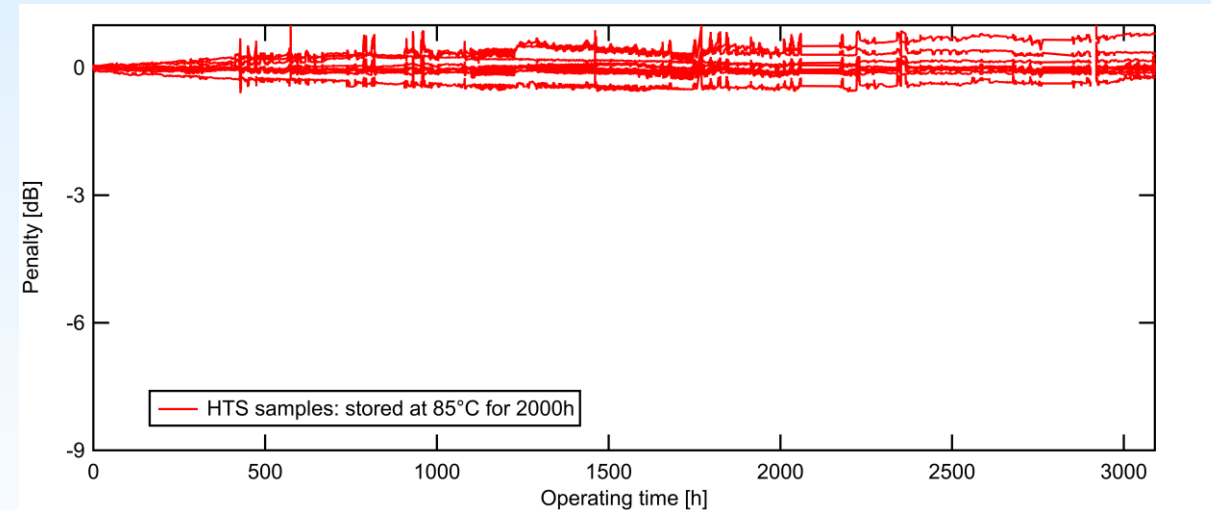
# Bake-out

- Good starting point was a sample set from the original QA
  - 10 samples that had been kept at 85°C for 2000 hours
  - So called *High Temperature Storage*, HTS, test
- Results were promising
  - No characteristic drifts after more than 3000 hours
- 85°C is still safe temperature, because devices are not powered
  - No penalty on the long-term reliability
  - Surely lower would always be better
- 2000 hours is a long time
  - Can we make that shorter?

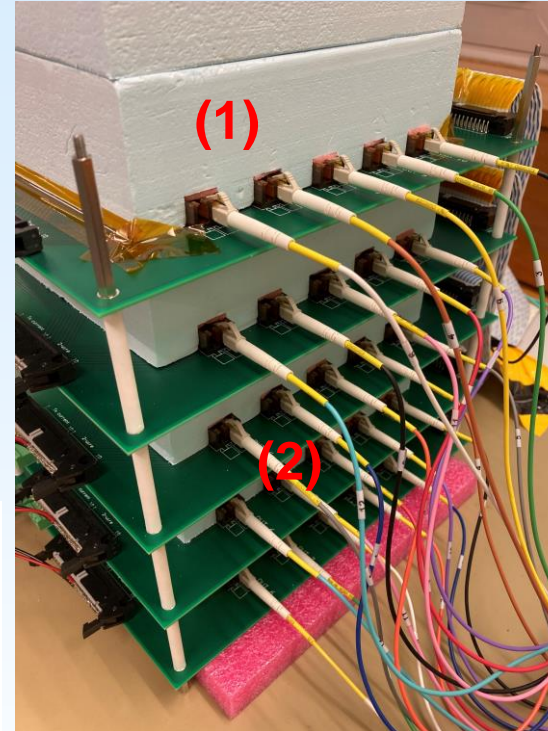
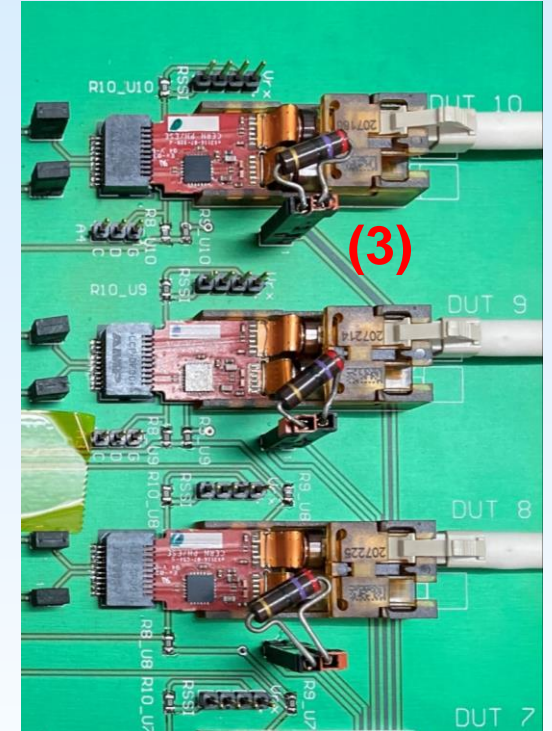
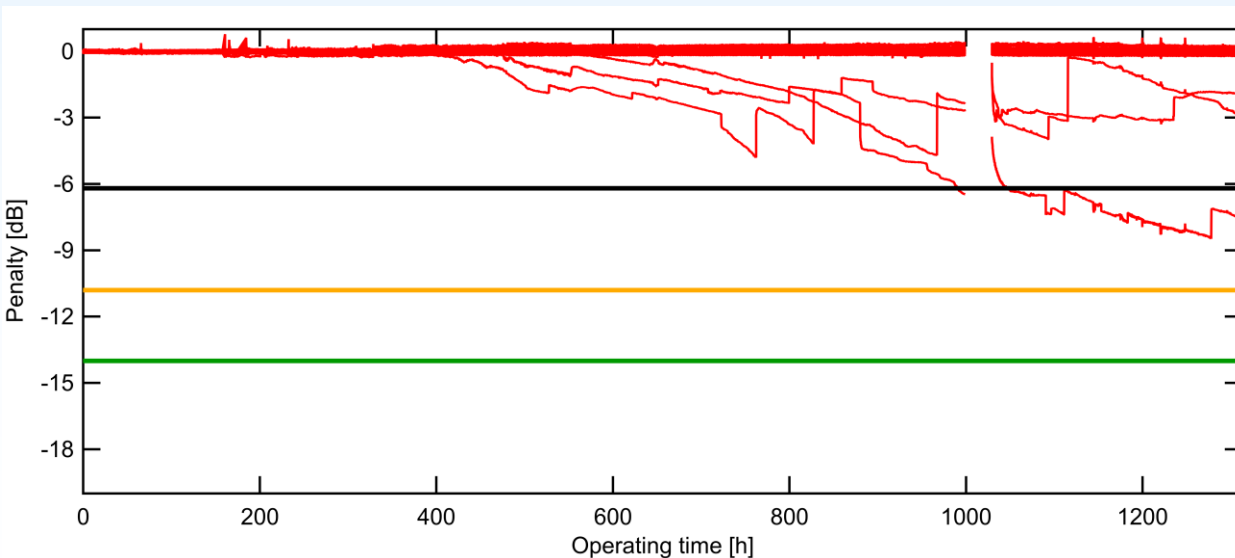
# Running test for 500h baked samples

- We have a long-term test continuously running with 50 samples from the standard 500h at 85°C bake-out process
  - This will be kept running for a long time
- We try to make to conditions bad on purpose
  1. Samples inside insulating boxes
  2. Fibers outside the heated volume in air-conditioned lab
  3. Additional heating with resistors on top of each ROSA

- Specification:
  - 272 / 65650 device hours failing = **0.4 % dead time**
- Realistic worst case (all components in the worst 1%):
  - 0 / 65650 device hours failing = **0.0 % dead time**
- Typical (50% devices):
  - 0 / 65650 device hours failing = **0.0 % dead time**
