Current Magnet Status

Spectrometer Solenoid Review

October 25, 2010

Steve Virostek
Lawrence Berkeley National Lab

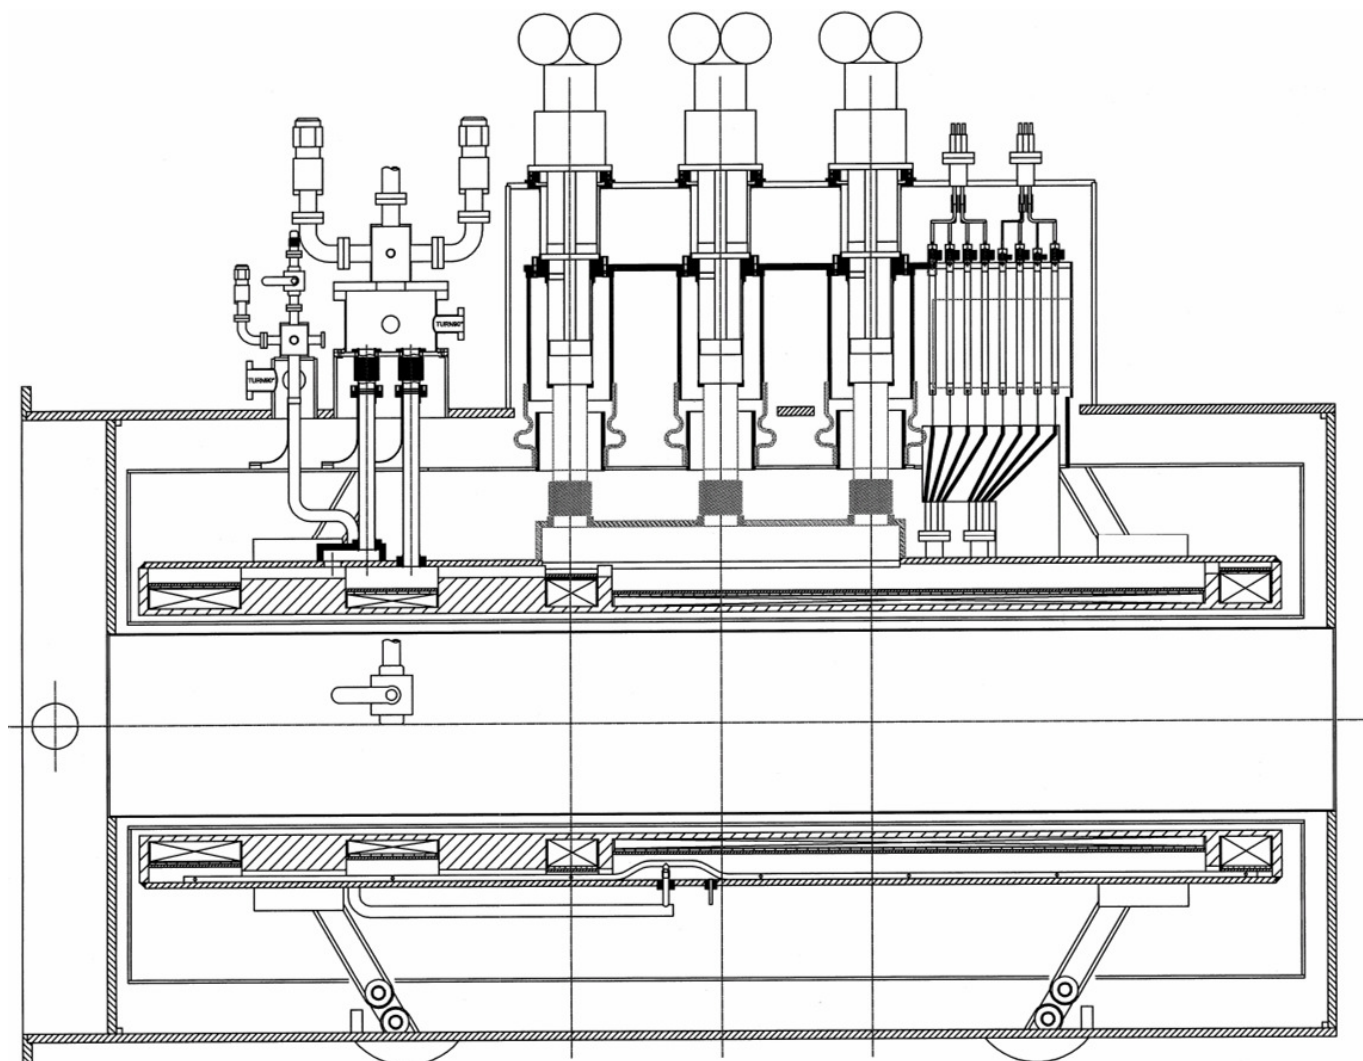
Magnet 2A Cross Section

- The second magnet was assembled with a series of design changes
 - replacement of the cooling circuit with large diameter tubes connecting the condensing cans directly to the top of the cold mass
 - addition of an LN reservoir connected to the shield
 - replacement of the thin, flexible copper straps that connected the shield to the 1st stage copper plate with thicker 1100 aluminum straps
- Upon cooldown, the cryocoolers appeared to be recondensing helium, but the magnet did not reach an equilibrium with no LHe boil-off
- The training of the magnet commenced, and a current of 238 amps was reached at which point an open circuit was detected
- After warm-up, the magnet tower was opened, and a burned out HTS lead was discovered; the failure was caused by inadequate cooling of the HTS lead upper ends at their connection to the 1st stage Cu plate

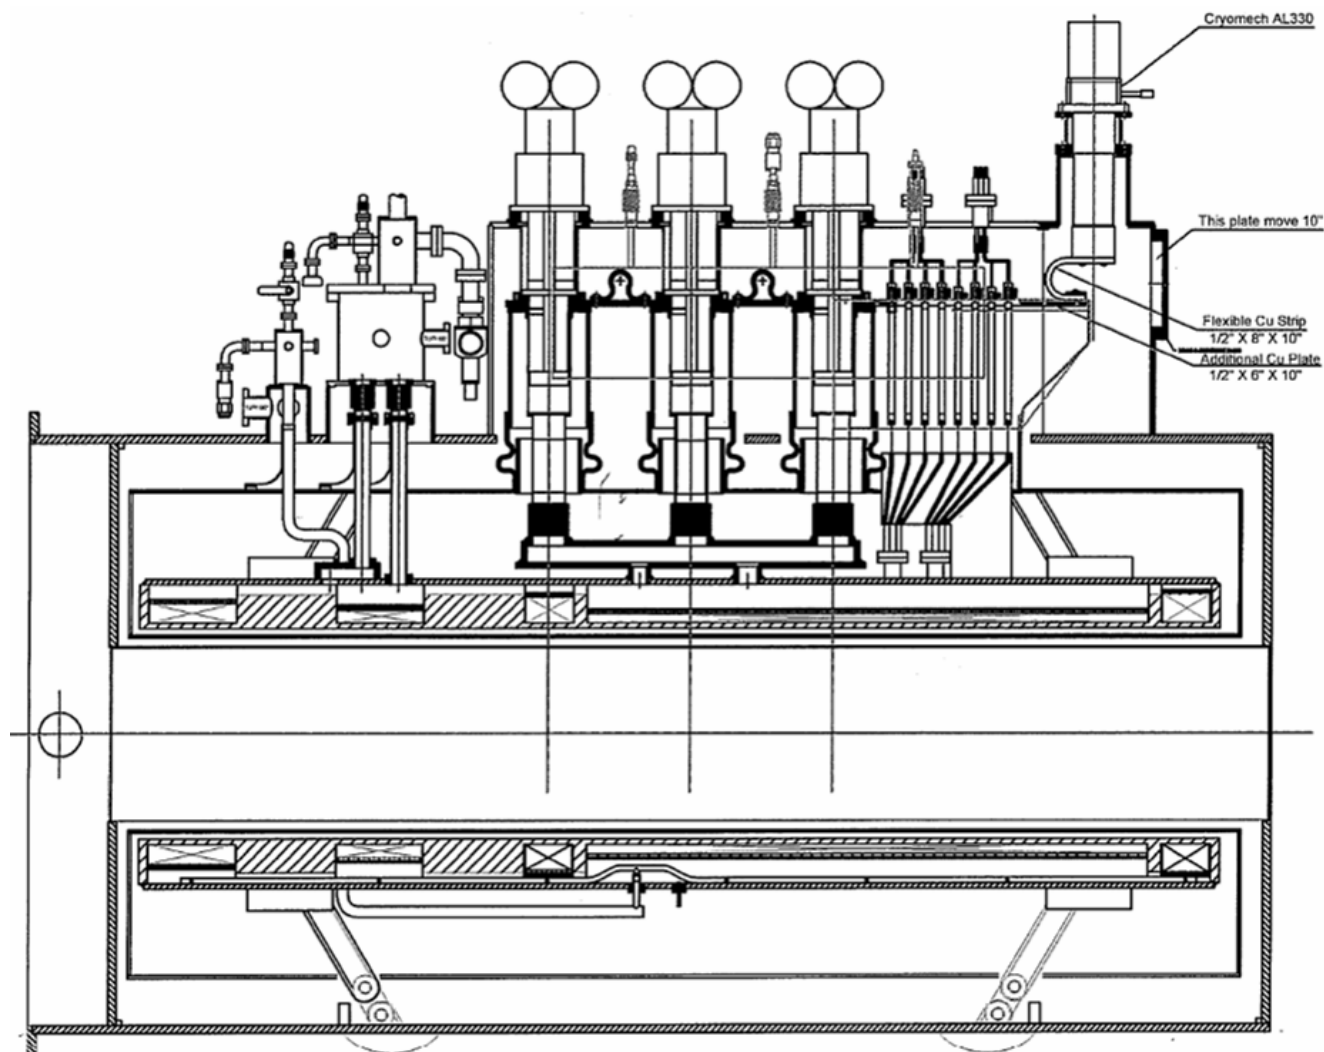
Magnet 2B Cross Section

- A review committee was convened by MICE management in 11/09 in order to assess the magnet design and to recommend modifications
- Per the committee, a single-stage cooler was added to increase cooling at the HTS lead upper ends and to help reduce the shield temperature
- With the HTS lead issue solved, Magnet 2B was trained in series to 258 amps when a coil lead was again found to contain an open circuit
- The failure was traced to the M2 coil close to the He/vacuum feedthru
- Training on the Center, E1 and E2 coils in series continued and reached a current of 270 amps
- Also noted was the fact that the three 2-stage coolers plus the single-stage cooler could not maintain a closed LHe system
