# CIBU connection Review

BT, BP & IRR AB/CO/MI 12December 2008

## 1<sup>st</sup> presentation: CIBU Failure in UJ33 *(Benjamin TODD)*

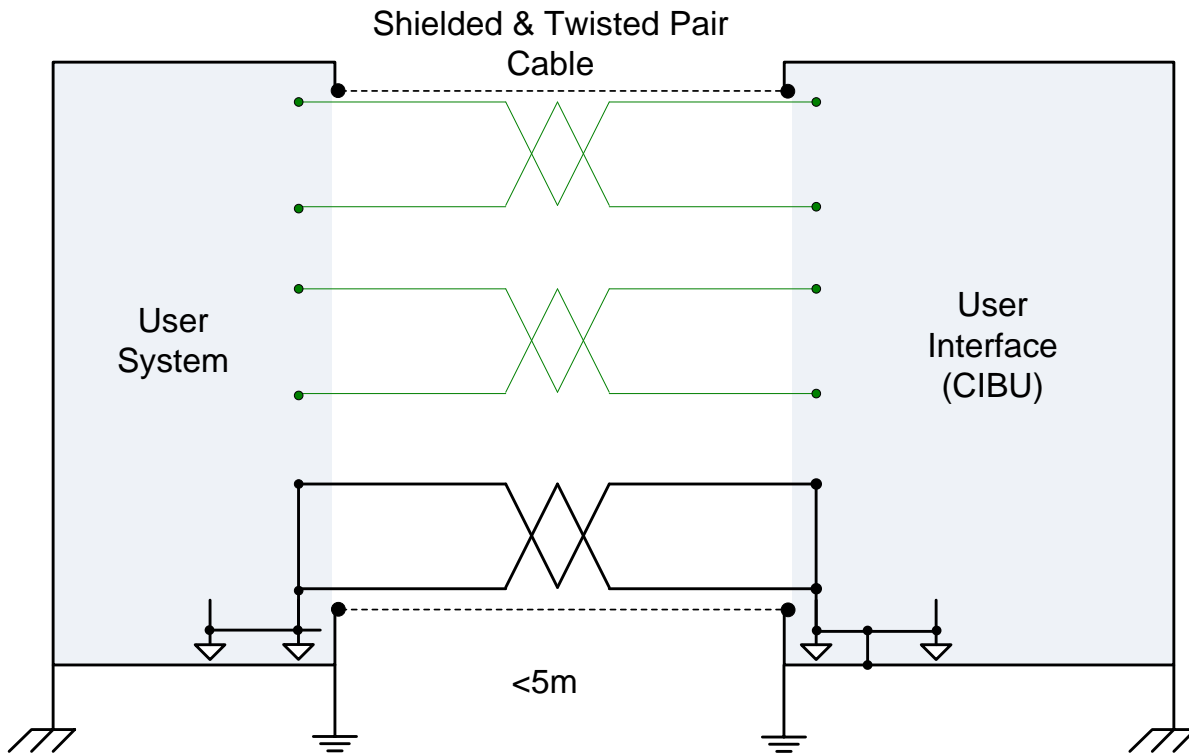
### Mandatory Circuit

1. All ground / earth / 0V connected
2. Spare wires grounded
3. Shield 360° at both ends
4. No pig-tails
5. More than 5m = FORBIDDEN
6. Cable should be:
  - a. Twisted Pair NE8/NF8
  - b. LEMO 00 from VME FP

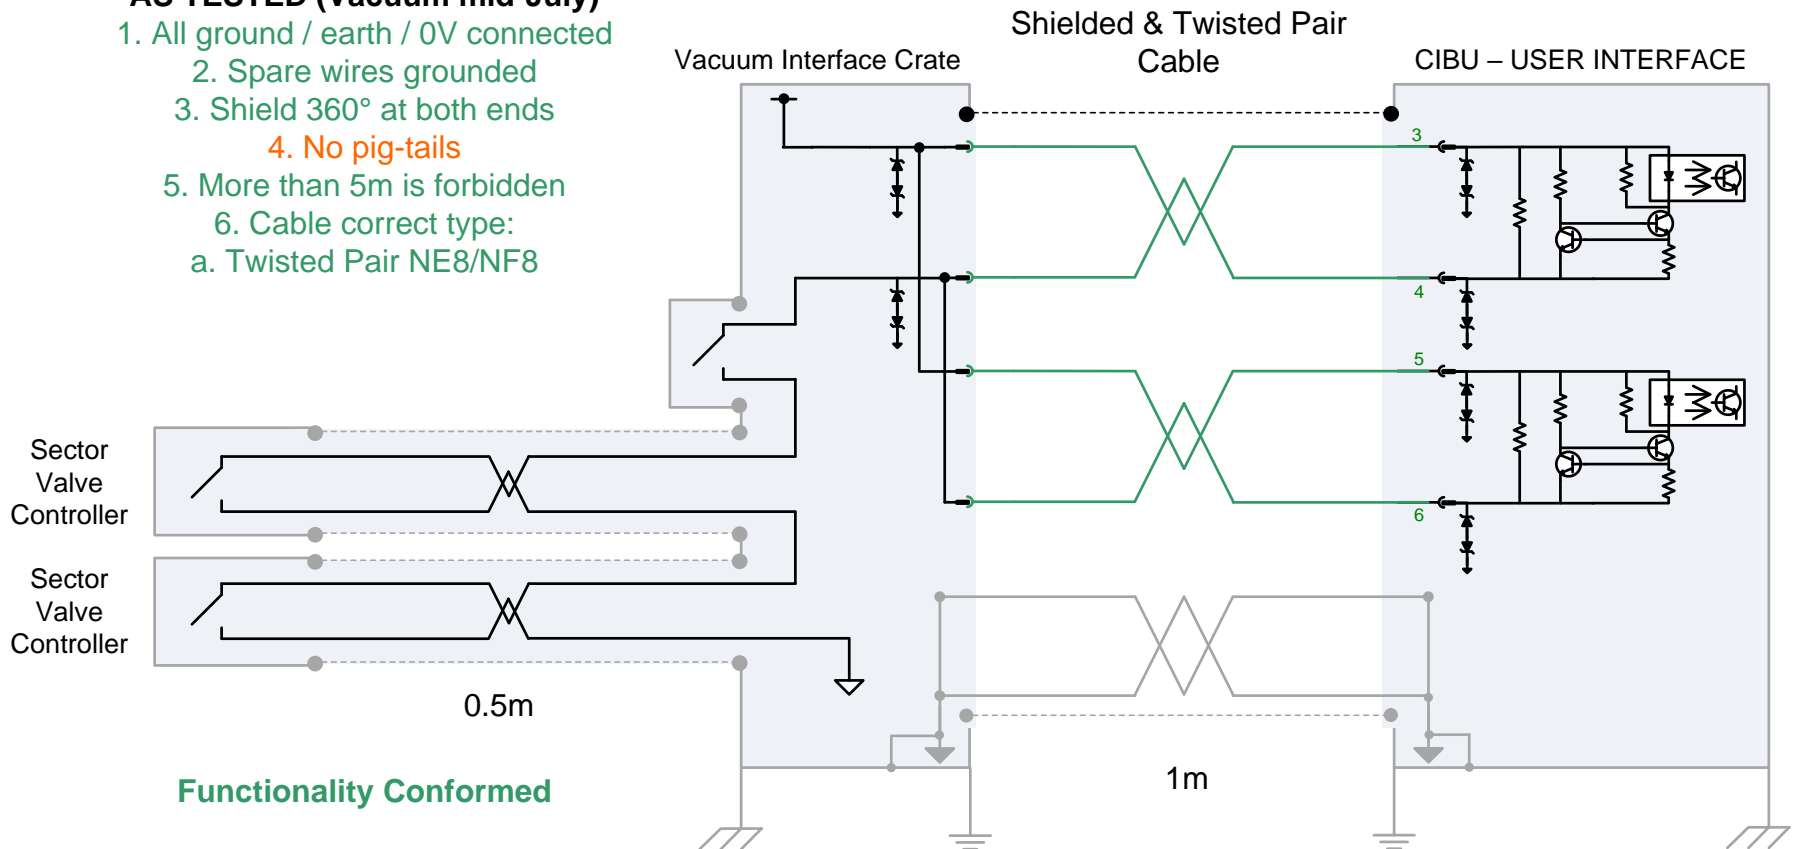
## AS TESTED (Vacuum mid-July)

1. All ground / earth / 0V connected
2. Spare wires grounded
3. Shield 360° at both ends
4. No pig-tails
5. More than 5m is forbidden
6. Cable correct type:
  - a. Twisted Pair NE8/NF8

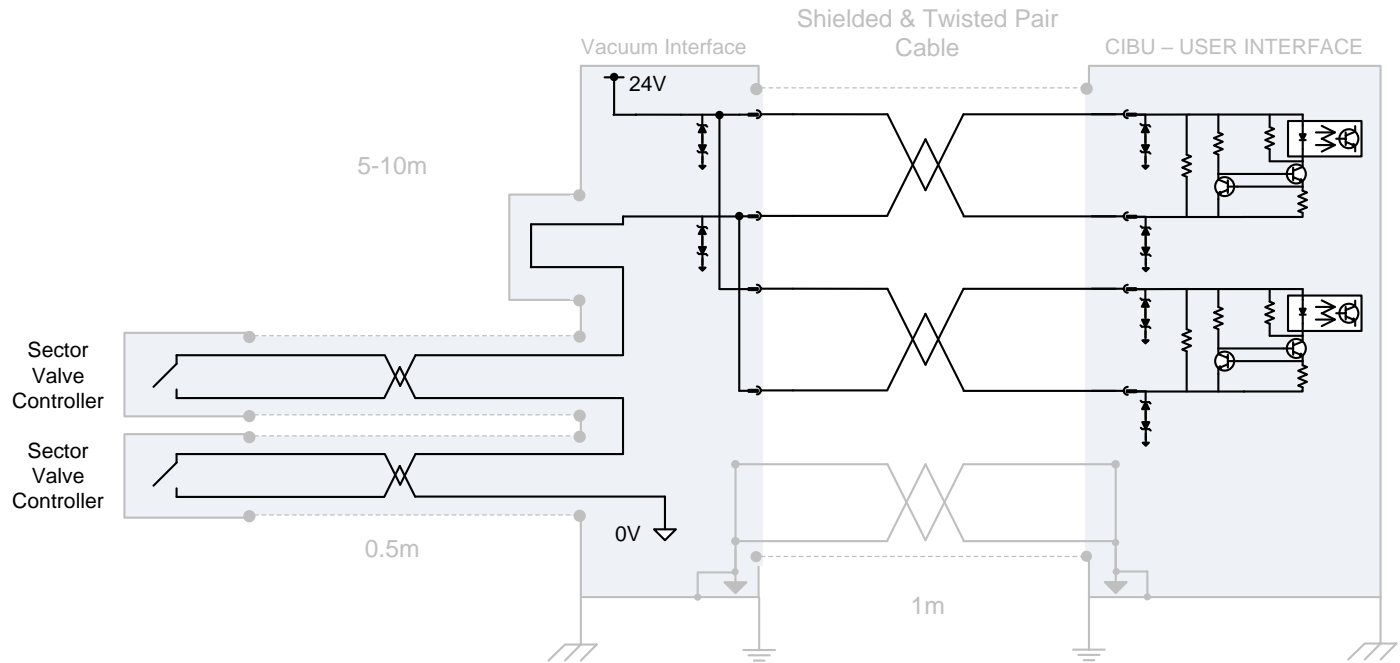
Between July and August  
EIS (Elément Important de Sécurité)

1. Added to Interlock Logic
2. EIS controlled by Access System (Personnel Protection Device)
3. Access System connected to BIS via Vacuum System

MI were not aware of this cabling change

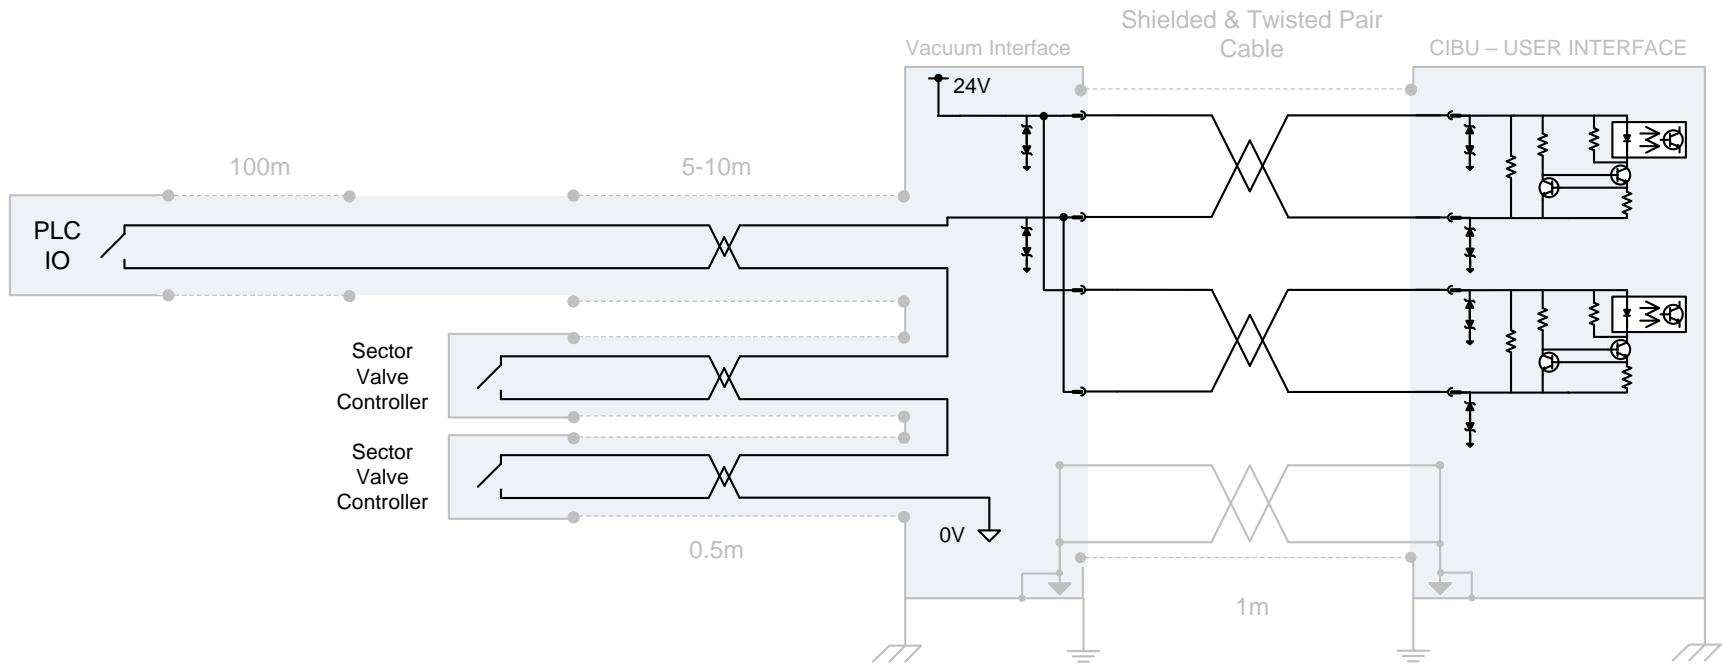
## Presumed Failure

**WHEN CONNECTED  
CIBU ALWAYS TRUE  
(next slides)**

Access – Connected Panel to Surface PLC incorrectly initially  
...took several attempts ...

### 1. Excessive Voltage

Is applied in the Access System PLC rack, due to erroneous cabling

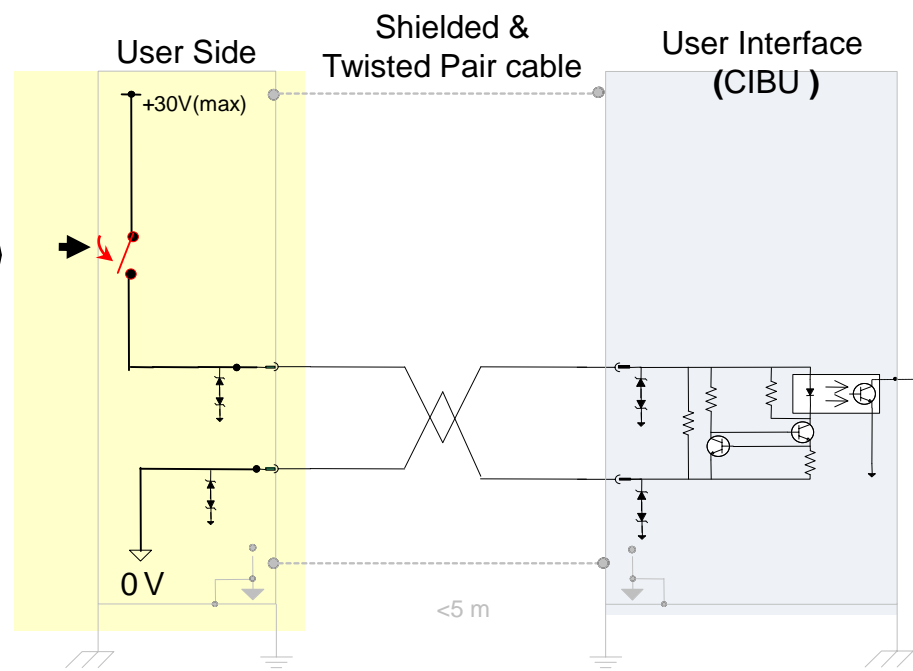
On User side, the connection should be modified in order to avoid a fail blind if GND short (i.e. a damaged TVS fuses to ground)

( Same for Input #B )

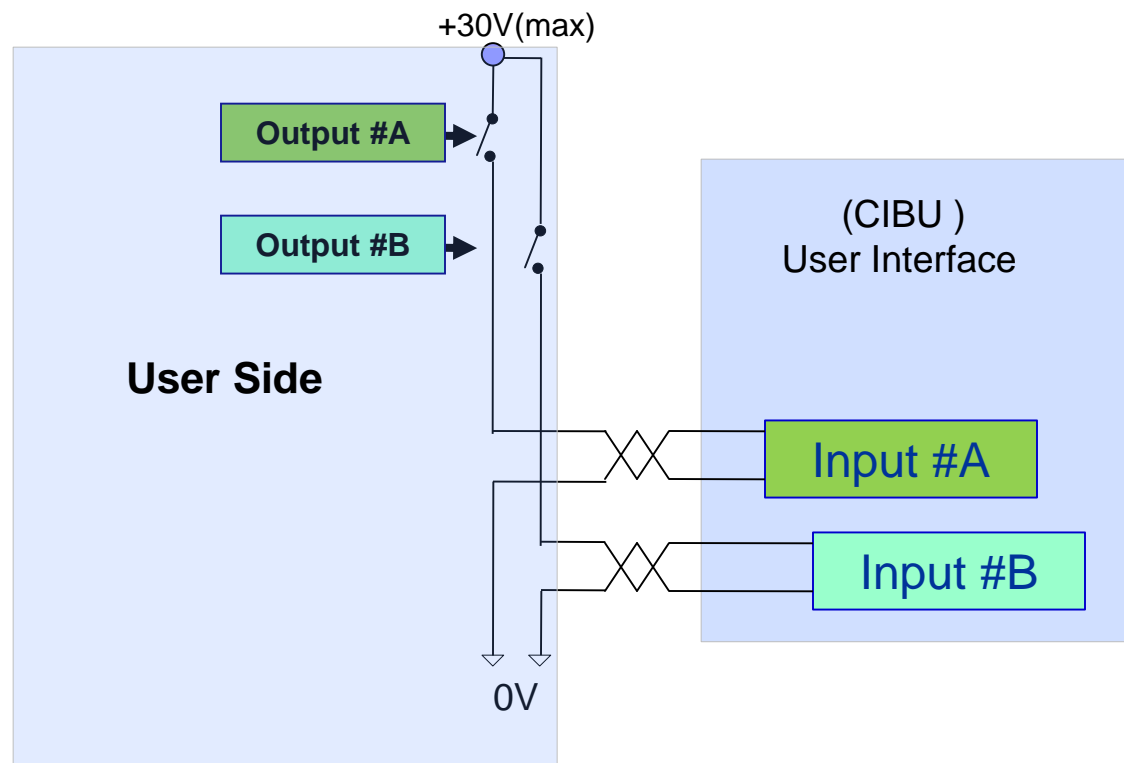
each User system has to provide two independent signals to the CIBU

Despite there is a single decision maker...

The aim is to make two physical connections....
