Summary on the LBDS triggering issues

E. Carlier
TE/ABT

MPP – 11/12/2009

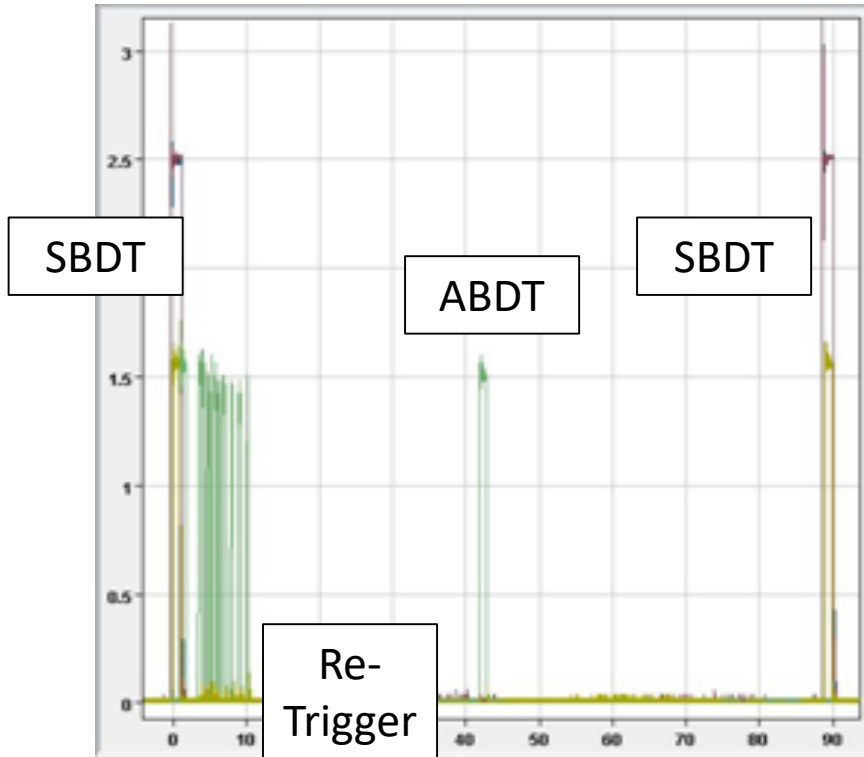
Nominal Triggering Sequence

Dump request from IP5
One TSU triggered by the BIS. The second TSU triggered by the BETS and the BIS one turn later

After TSU firmware upgrade

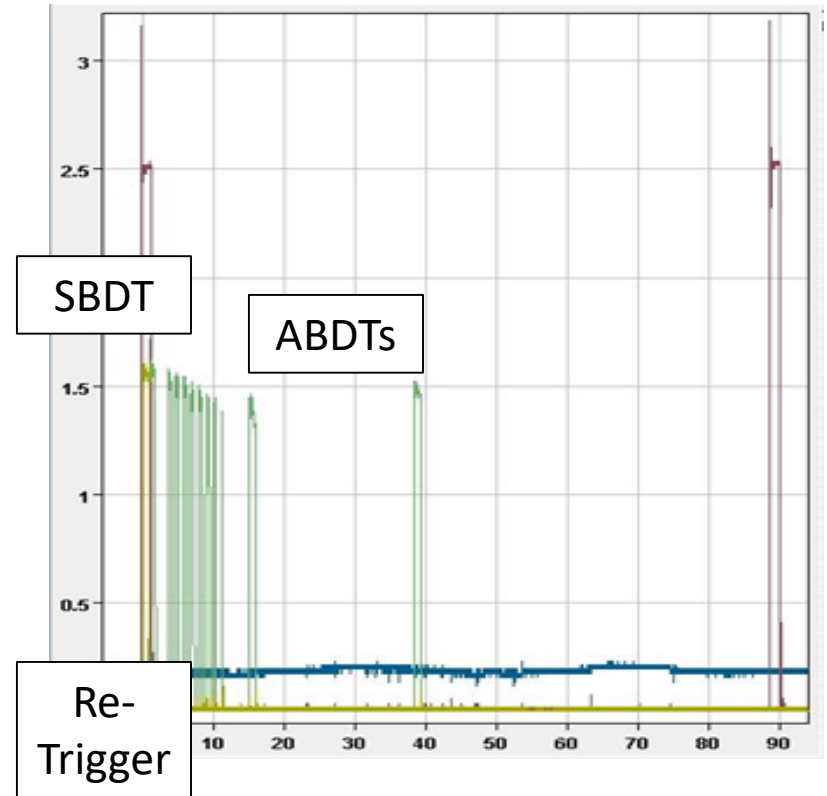
Dump request from IP2
Both TSUs triggered by the BIS on the same turn
