Asynchronous dump @ 450GeV 19/11/2010

C.Bracco, E.Carlier, B.Goddard, J.Uythoven

Real Asynchronous dump

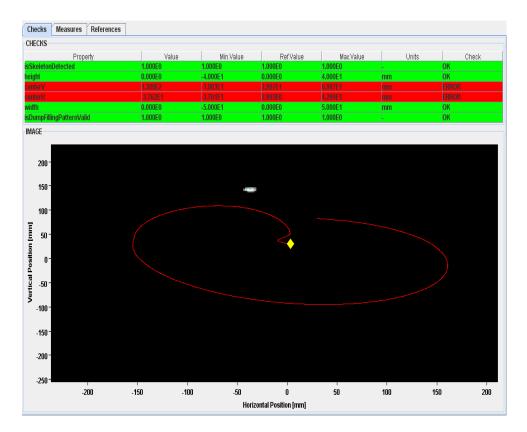
- Asynchronous between kickers and relative to abort gap
- Friday evening 19/11/10 @ 21:23, Beam 1
- Single ion bunch of 1e10 charges
- Properly extracted, but not at the correct position ob BTVDD
- XPOC errors on MKD, MKB and BTVDD but BLMs ok

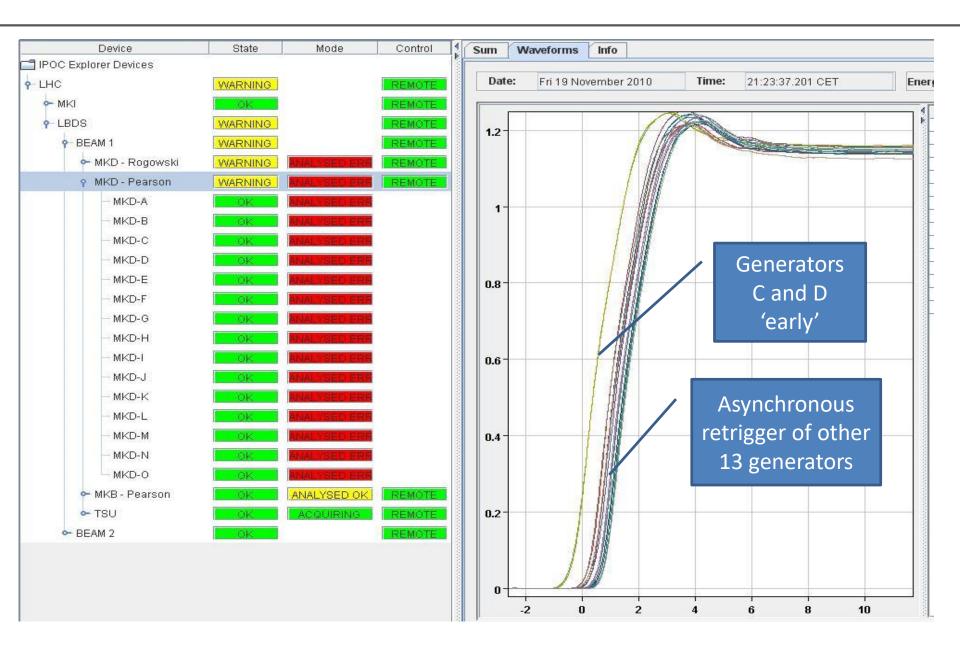
Relative delays of 15 kickers

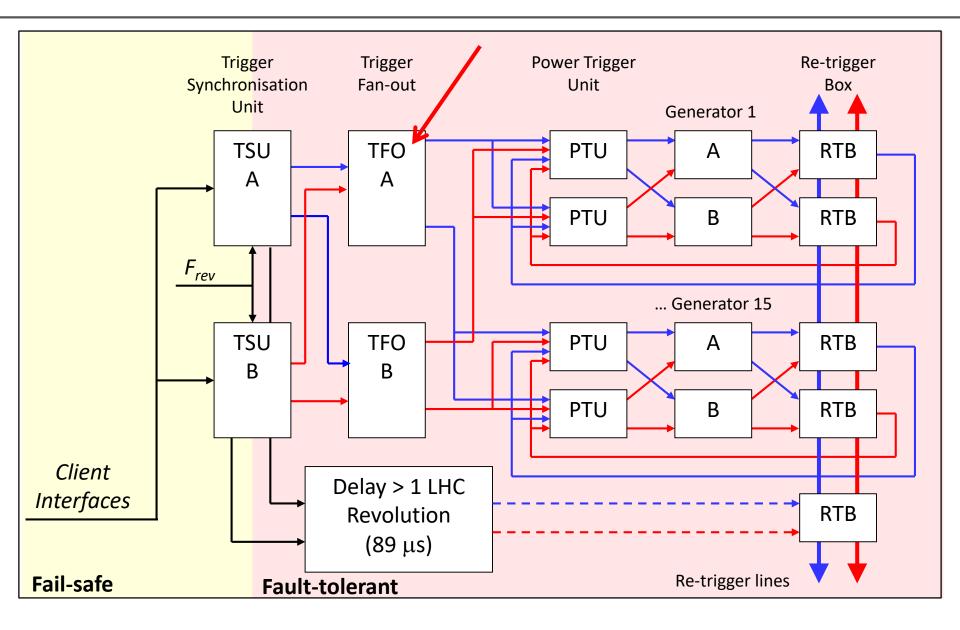
Failure Source

Failure of a MAX4429EPA driver (single power driver) in one TFOT module

- Dual secondary transformer used in TFOT in order to guarantee the triggering of both PTUs of one generator (kick rising edge and synchronization issues)
- MAX4429EPA is oversized for its use in this application (voltage & Current)

- MAX driver breaks... probably initially to short-circuit and finally to open-circuit.
- Power pre-loaded in blocking capacitor discharges in the primary winding of the pulse transformer and generates glitches at the secondary outputs.
- PTU1 of generators C & D triggered on reception of the "trigger" glitches
- Generators C & D pulsed asynchronously with beam on reception of the PTU pulses
- Re-trigger signals sent from the pulsed generators to other generators
- Remaining generators pulsed
- Asynchronous pulse recorded by IPOC
- Asynchronous pulse recorded by XPOC
- Bad trigger signals detected by PTU monitoring system because glitches were smaller than nominal trigger pulse length
- Generators in fault status

- Validation dumps performed after the asynchronous dump where correctly synchronized (no IPOC error)
- Acknowledge still requested due to missing trigger pulses on "PTU1- Trig IN1" for generator C & D (faulty driver circuit)
- 2 options
 - Mask the interlock channels (redundancy exist)
 - Repair the fault (access needed)
- Decided to make an access in UA63 to properly repair the fault
- Trigger signal switched to spare outputs of TFO system (same cabling logic)
- System pulsed in local to validate the intervention
- Faulty TFOT still in the machine
- Procedures for re-commissioning of the system after this type of intervention are missing but the right actions were taken
