SEU Risk Analysis of the LHC Collimators low level control rack in UJ14,UJ16,UJ56

A. Masi

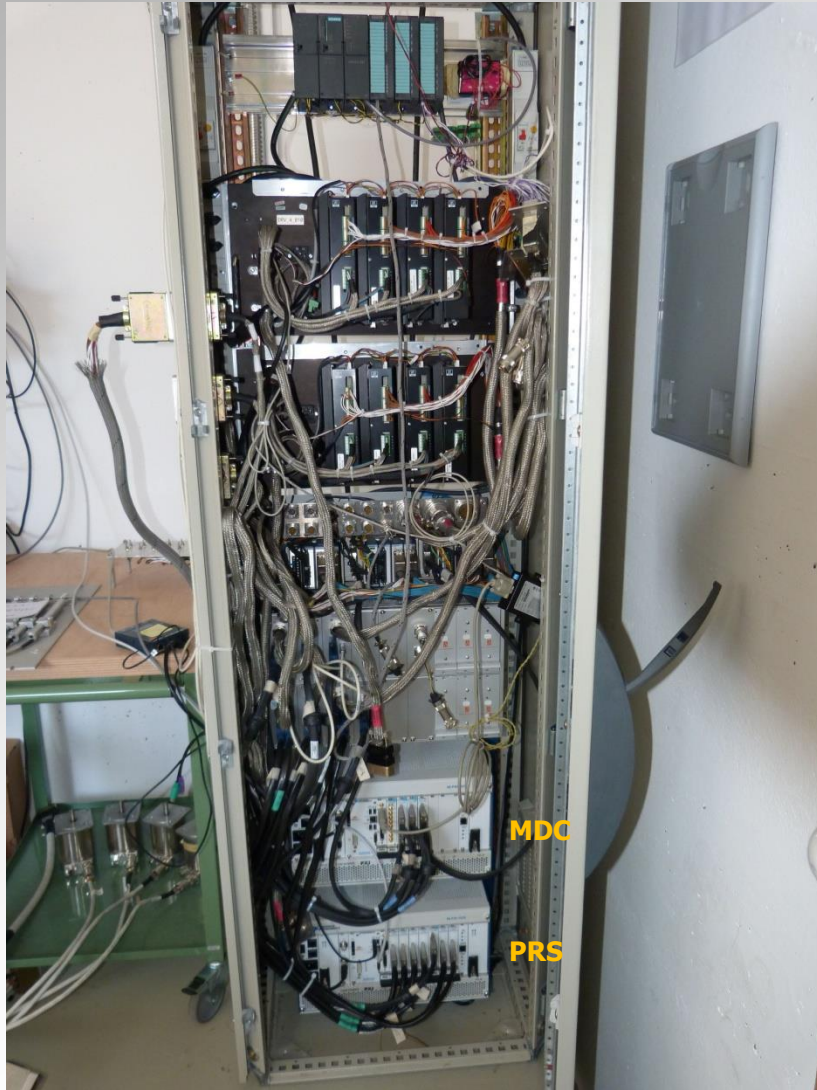
5-How the SEU critical effects can be prevented: PXI power supplies failure

Two prototypes of the new PXI chassis successfully tested in a lab collimator rack

The 12 PXI chassis in the sensitive area will be likely replaced with new High Reliability PXI chassis during next Xmas break

Two redundant hot swappable power supplies and 6 redundant fans

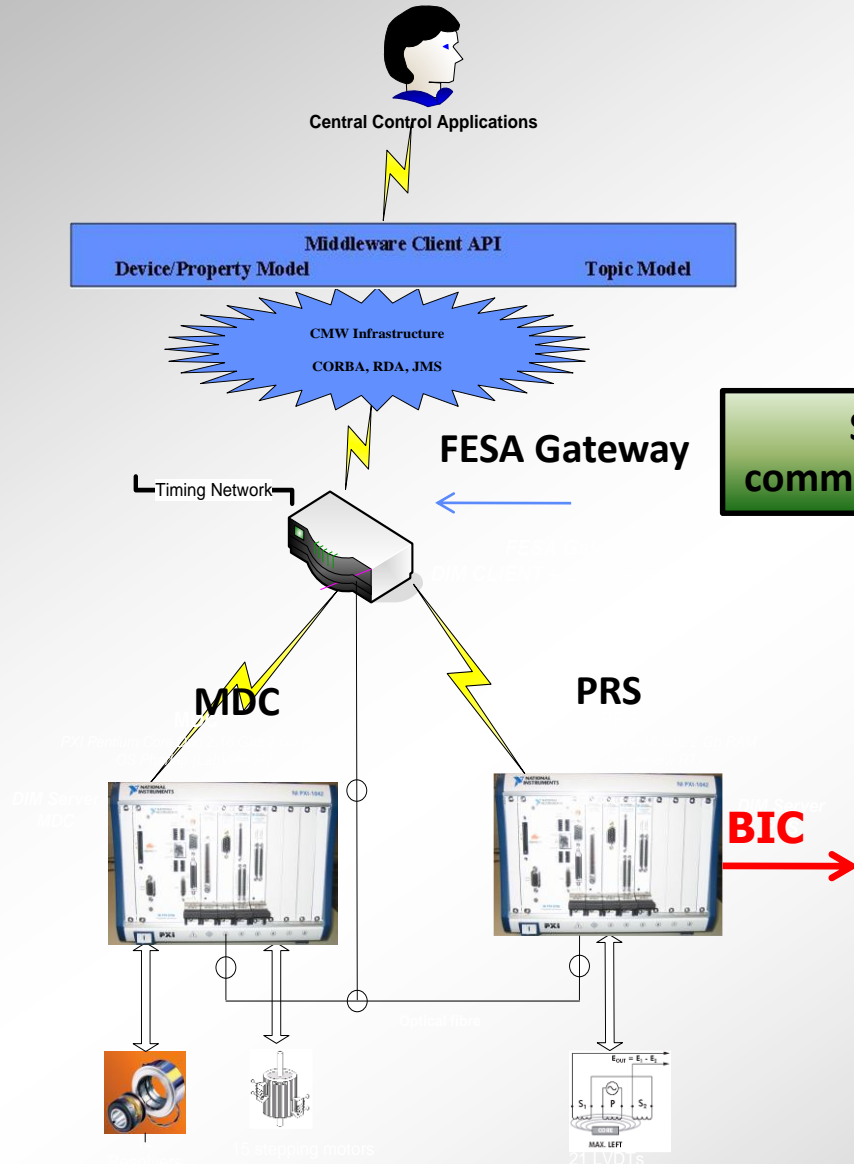
6-Improvements of the control system reliability against SEU

Software interlock in case of PRS communication lost and/or FPGA stuck error

- PRS software mitigation techniques:**
1. CPU and Survey loops watch dog timers implemented on FPGA triggering a dump in case of time out
 2. FPGA stuck watch dog timer implemented on the CPU arising an error to the FESA server
 3. TMR on the interlock logic on the FPGA

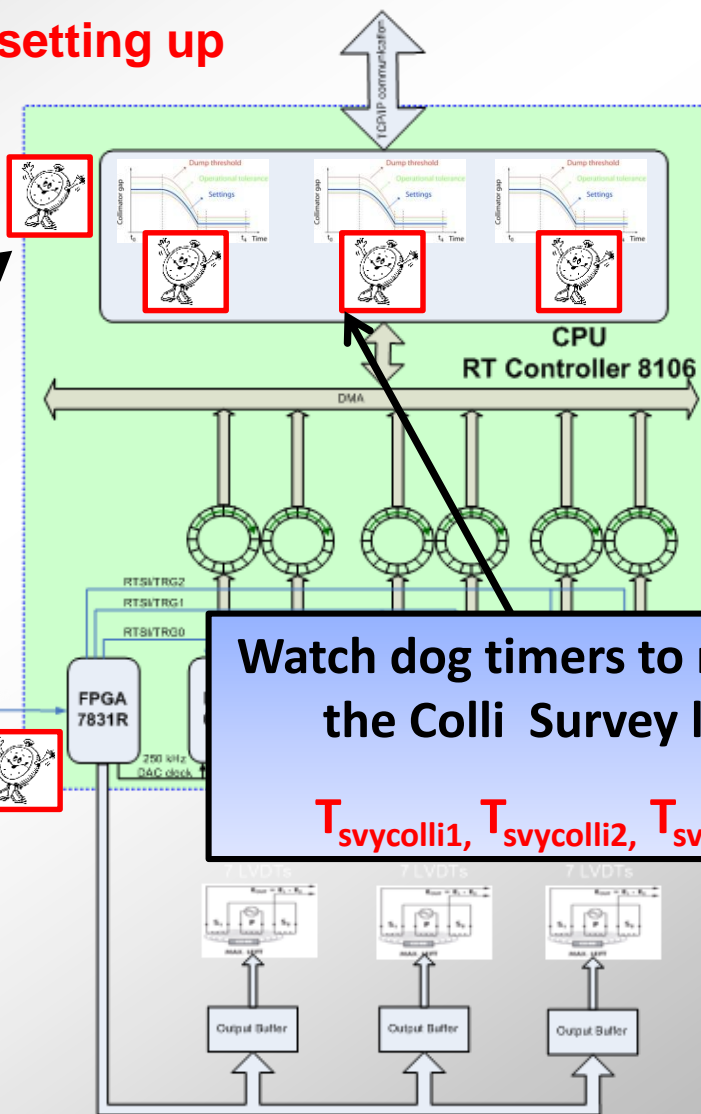
Watch dog timer to monitor the FPGA communication

The CPU Watch dog time out values must be accurately set to avoid from one side false dumps in the cases of CPU overcharge conditions and on the other side to not compromise the machine safety. The values to set up

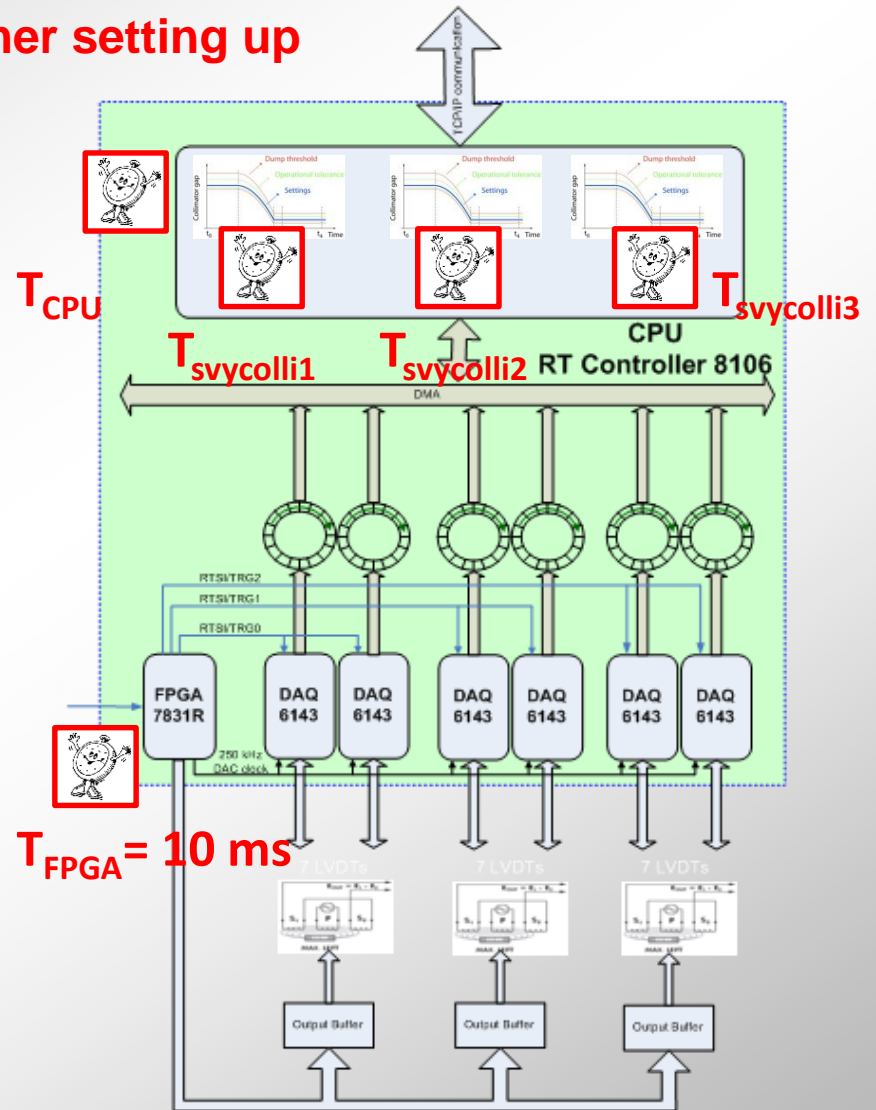
1. These time out values should ensure the detection of an axes positioning error greater than 100 μm
2. This time depends on the maximum speed the axes can move.

In normal operation the maximum speed is 2 mm/s but the worst case is the autoretraction

$T_{FPGA} = 10 \text{ ms}$
