Powering interlock changes during LS1

I. Romera
on behalf of TE-MPE-MS...

Beam dump after losing PP_60A

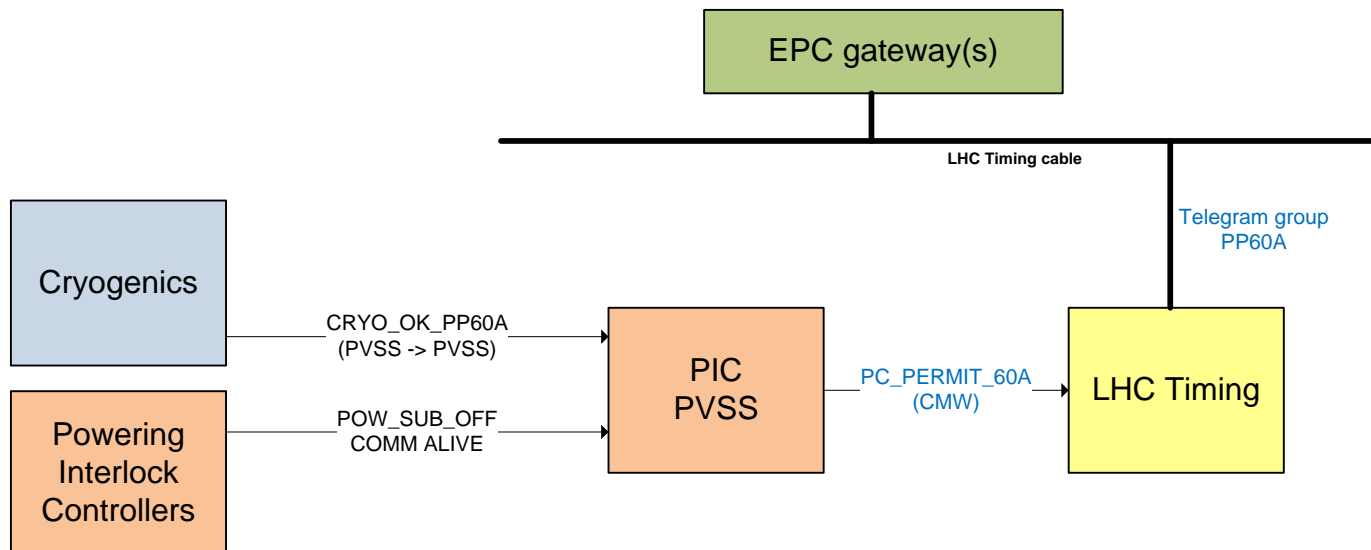
60A interlock implementation

- **No hardware interlocks** for 60A orbit correctors
- Protection **guaranteed by Power Converters**
- Interlocks **to avoid unnecessary quenches** of magnets and current leads and to help operations
- **PC_PERMIT_60A** derived from cryogenic and powering conditions and **sent via GMT** to EPC gateways

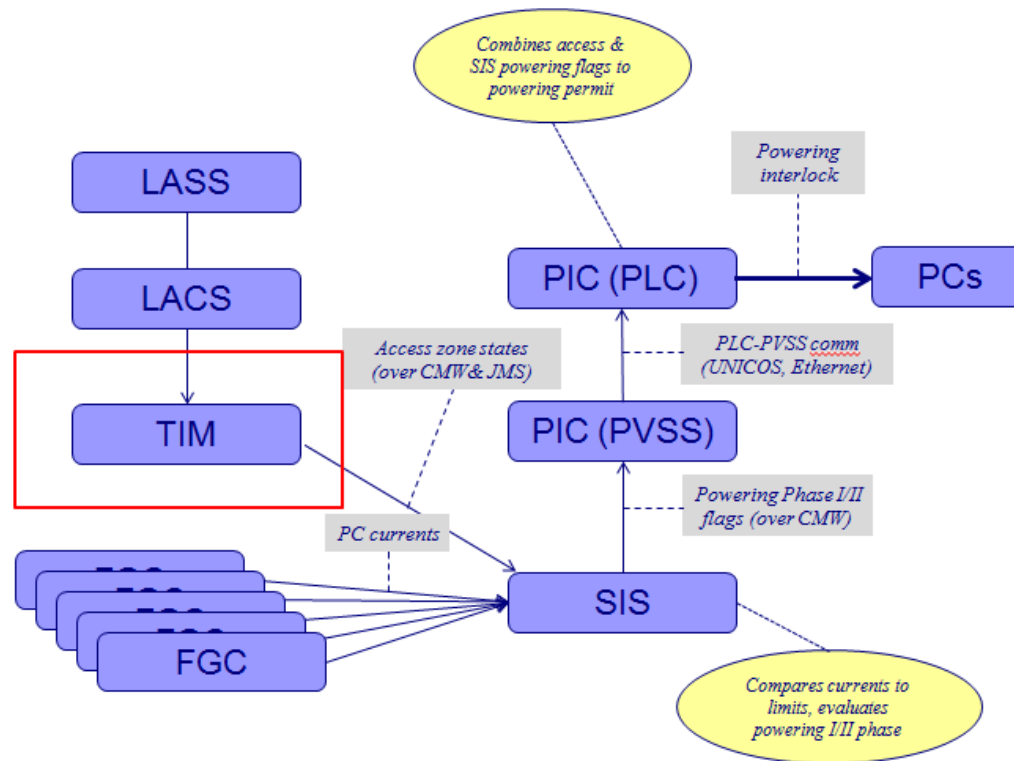
Access Powering Interlocks

- After the incident in September 2008, **new rules for access applied**
- Existing software interlocks **prevent powering above phase I current limit** (1kA all circuits, 100A for RB) and send slow power abort on PIC if needed
- Logic based on a sector-by-sector basis, i.e: 8 independent signals...

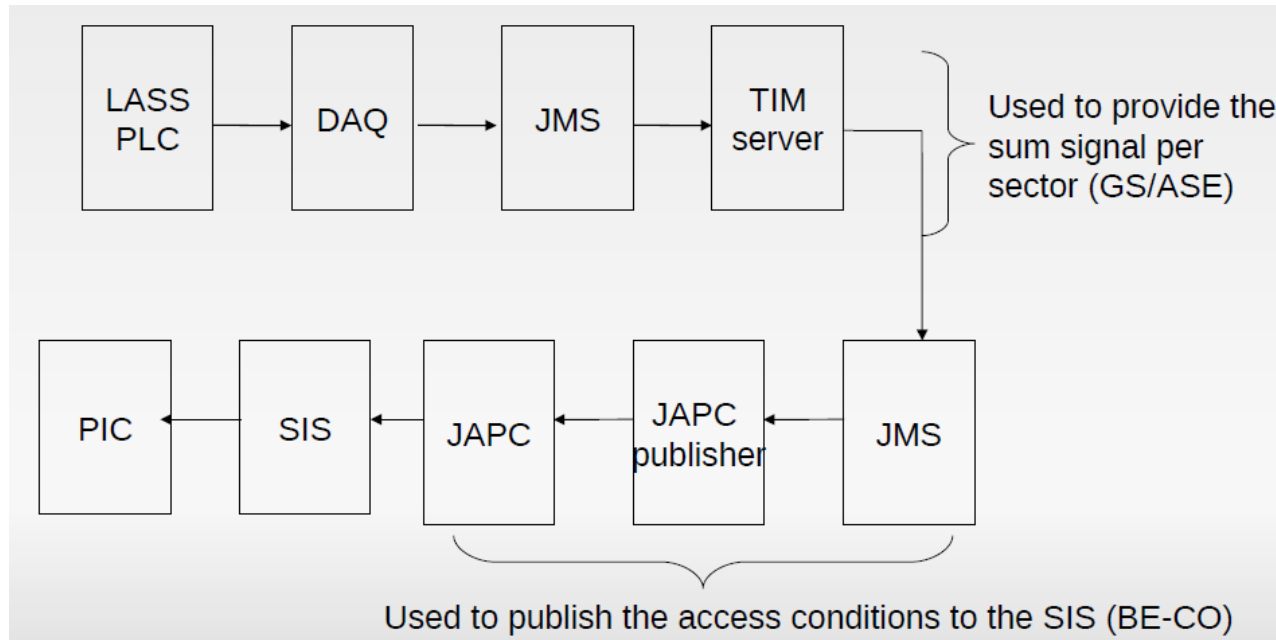
Weakest link...

- Main problem: **Long (unreliable) chain of different SW** components to connect to ACCESS signals
 - Still, **interlock worked always** as expected (fails safe)
 - Improvements done: Masked when BEAM ON
 - Possible further improvements: Shorten SW chain by including JAPC publisher in TIM server

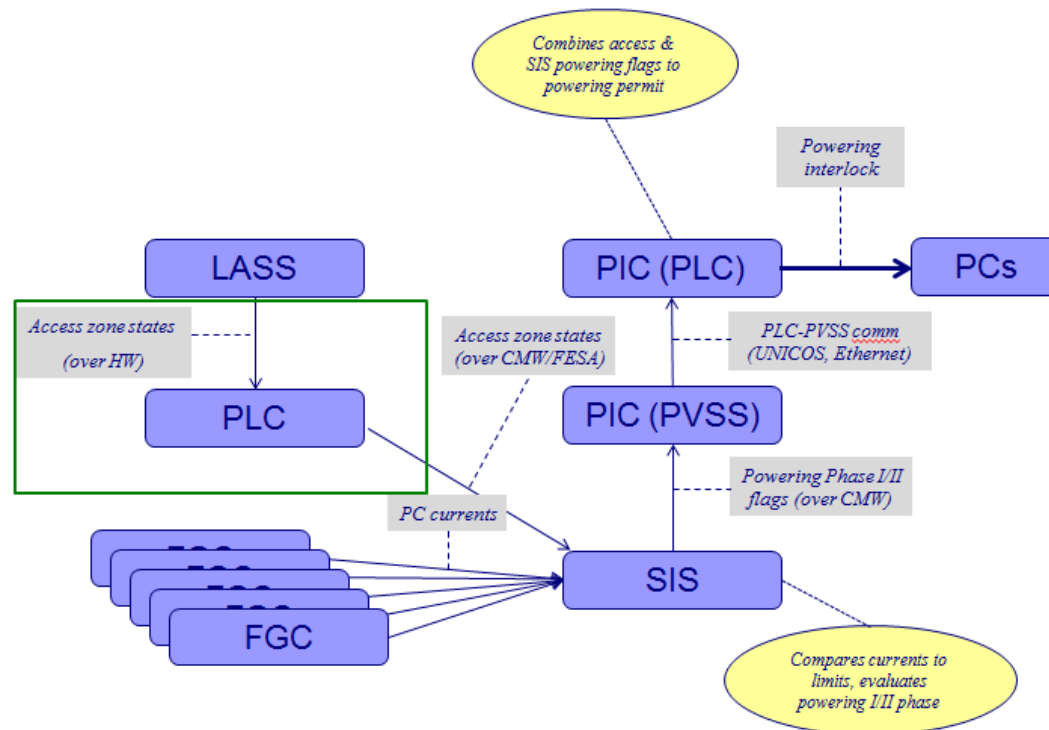
Interlocks renovation

- It requires an **additional PLC** at the PIC side (CCR)
- Communication between **LACS** and **PIC-PLC** via **hardwired signals**
- PIC-PLC will publish access status to **CMW**
- PIC-PVSS will log all access **interlock transitions**
- ECR approved ([EDMS 1246780](#))
