Irradiation at CHARM of a HL-LHC prototype board for the CMS Muon DT On detector electronics based on the PolarFire FPGA

2 OBDT-v1 boards

C.F. Bedoya, I. Redondo, A. Navarro, J. Sastre, D. Redondo, C. de Lara, J. León, J.M. Cella, C. Carrillo
(CIEMAT)

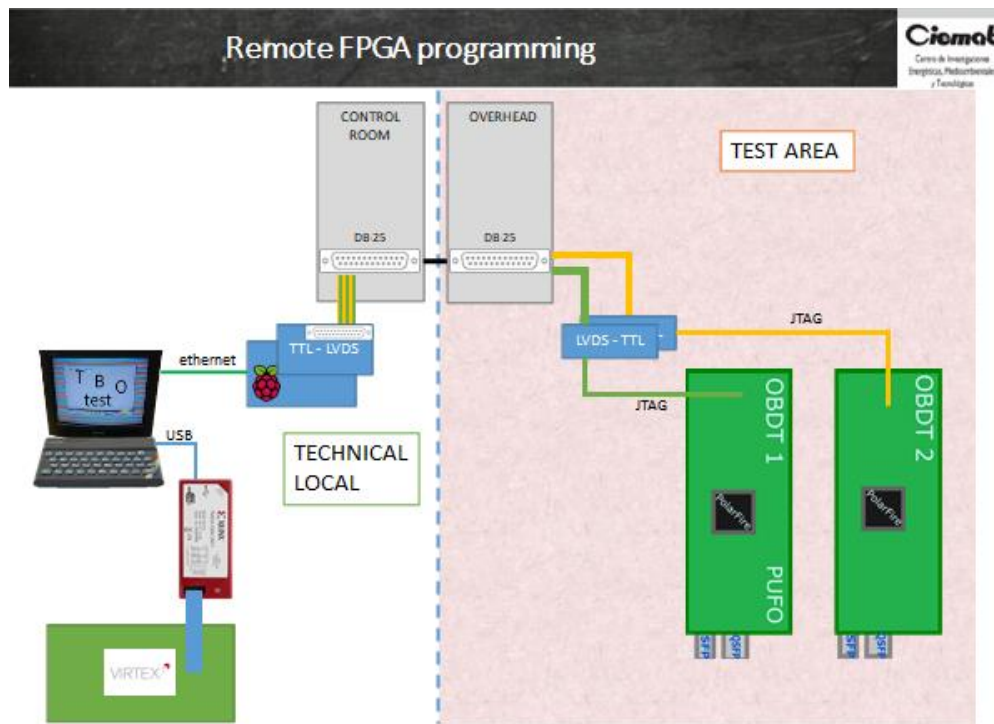
- We built a system to program and verify remotely the Polarfire's FPGAs firmware (that could cope with the 35 meters which prevented Flashpro/USB cables or expanders)
- Remote FPGA verify worked fine before the radiation test (bunker zone)
- First time we tried a verify during radiation was on Friday Nov. 5th at 13:00, **after 15.55 Gy, and firmware verification was NOT working.**
- IDCODEs were being read properly but the verification was failing at 66% and 45% of the process on each FPGA respectively. Same issue happened a couple more times we tried (some times not at 66% but at other values)
- However at the end of the irradiation period we were capable of loading the **firmware remotely so the programming system seemed to work fine after 109,8 Gy** (though still the verify was incorrect)

Remote FPGA verify worked fine before the radiation test (bunker zone)
First time it was tried was on Friday Nov. 5th at 13:00, after 15.55 Gy, and it was not working.
IDCODEs were being read properly but the verification was failing at 66% and 45% of the process on each FPGA respectively each time we performed it during the irradiation
However at the end of the irradiation period we were capable of loading the firmware remotely...

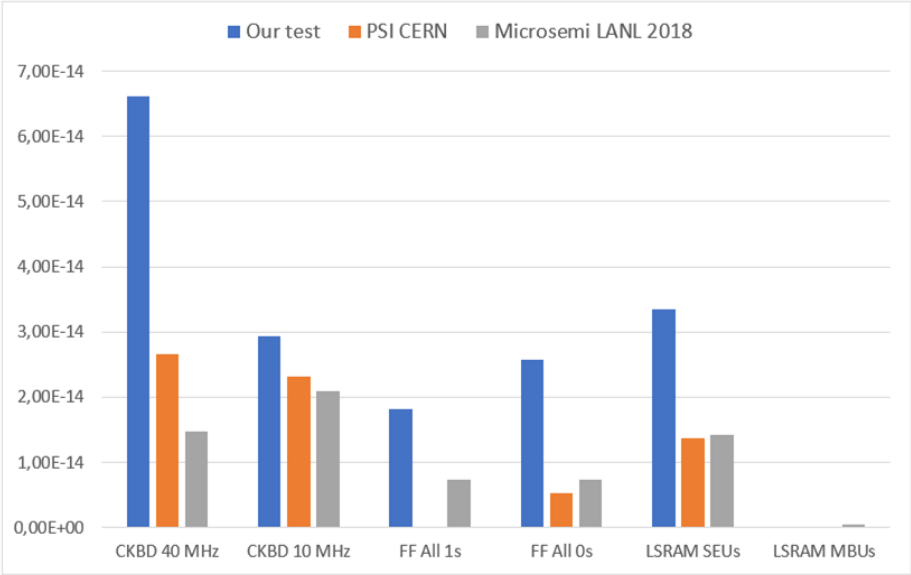
Qualitative comparison with other irradiation tests on Polarfire devices with same or very similar reference logic:

Our test	PSI CERN	Microsemi LANL 2018
	Cross-section (cm2/bit)	Cross-section (cm2/bit)	Cross-section (cm2/bit)
CKBD 40 MHz	6,61E-14	2,66E-14	1,47E-14
CKBD 10 MHz	2,93E-14	2,31E-14	2,09E-14
FF All 1s	1,82E-14		7,39E-15
FF All 0s	2,57E-14	5,31E-15	7,39E-15
LSRAM SEUs	3,35E-14	1,37E-14	1,42E-14
LSRAM MBUs	2,78E-18	< 9,5e-18	5,58E-16

Caveats: different particles, energies, different clock frequencies, different firmware implementations...

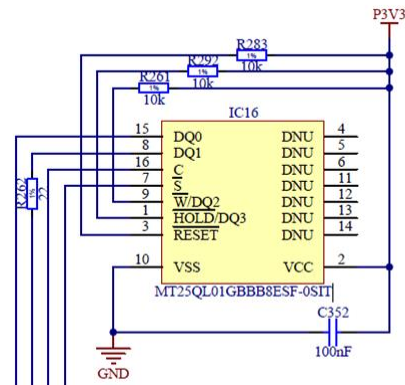
FLASH MT25QL01GBBB8ESF-0SIT

Tried to load the Polarfire from the Flash:

- it did not work during radiation time
- it did not work once radiation was over

Polarfire is loaded in Master mode. It could be the Polarfire logic that was not working or it could be the flash being dead.

Summary, the mechanism did not work after the full irradiation (109.8 Gy). Further radiation tests devoted specifically to the FLASH will be required.

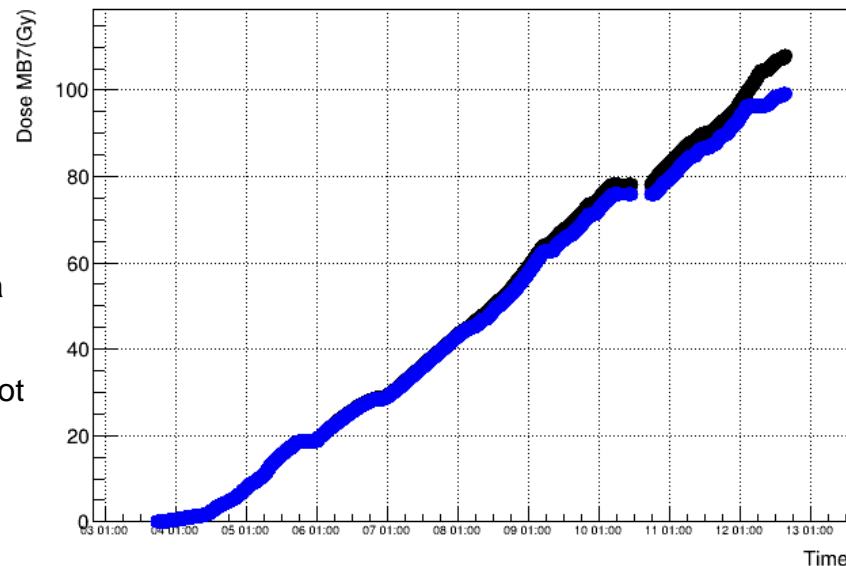
During this period (10 days 24h shift) there are times in which the data is not reliable and has been removed.

Basically there are the following causes in which the monitoring was not operational (efficiency 85%):

Black: Total integrated dose
Blue: Dose with good monitoring

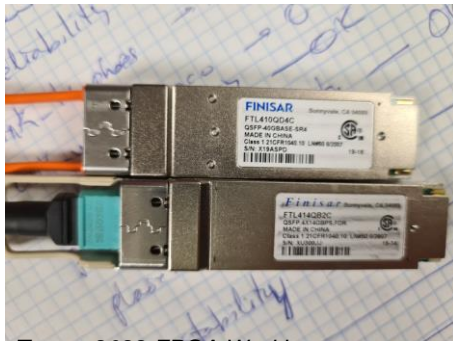
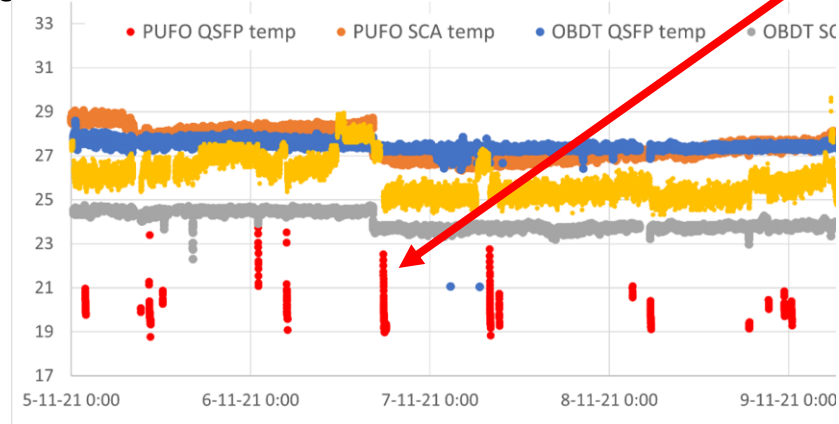
QSFP PUFO: FTL410QD4C (Finisar)

- SFP+ OBDT: AA13323A3ME (Avago)
- SFP+ PUFO: FTLX8574D3BCL (Finisar)
- QSFP OBDT: FTL414QB2C (Finisar), beige handle
- QSFP PUFO: FTL410QD4C (Finisar), orange handle. Internal I2C temperature reading failed since the beginning of the test

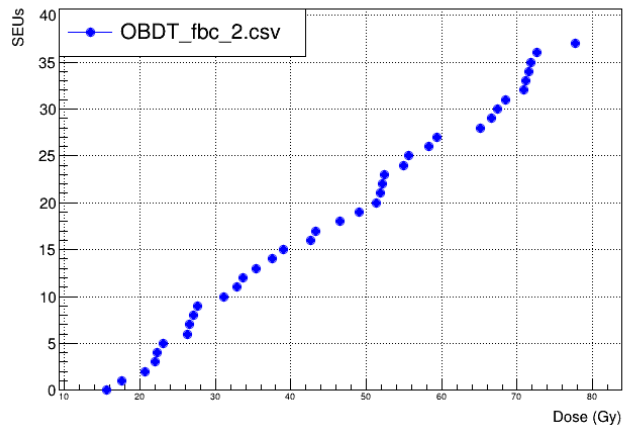
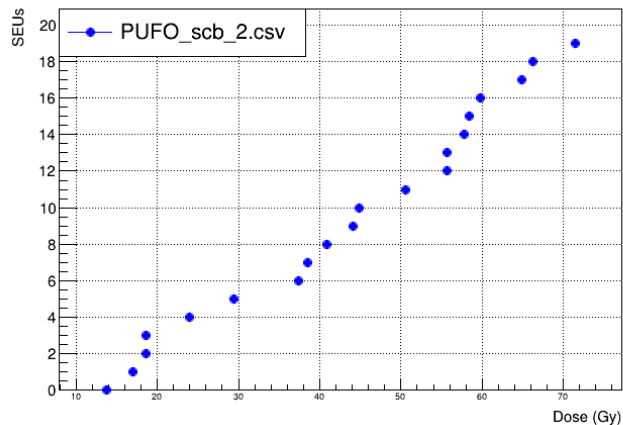
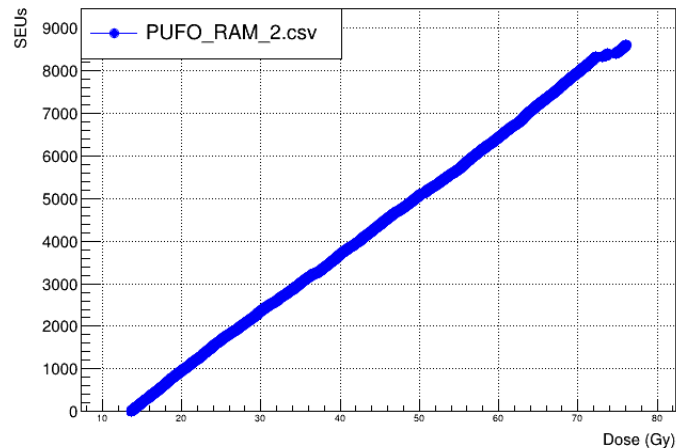
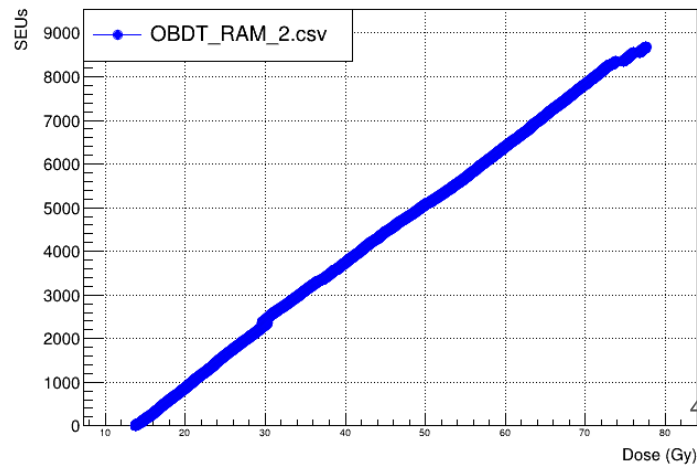
A few examples of how the number of SEUs in this reference test where increasing versus the integrated dose
