# RFD Prototype: Assembly lessons learned

12th HL-LHC Collaboration Meeting

21/09/2022

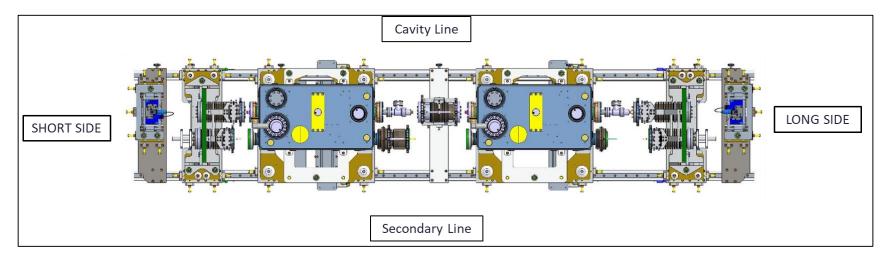
RFD Short CW Transition LHCVBMCC0033 Dent | LHC-ACFVW-QN-0001

- Error during assembly led to a dent on the secondary line CWT,
- Highlighted the need to follow assembly procedures carefully,
- Non-conformance is to be closed once secondary line vacuum

integrity has been demonstrated, (coming weeks)
