MQXFA magnet assembly: lessons learnt from MQXFA07/08

P. Ferracin

12th HL-LHC Collaboration Meeting
Uppsala, Sweden
September 19-22. 2022

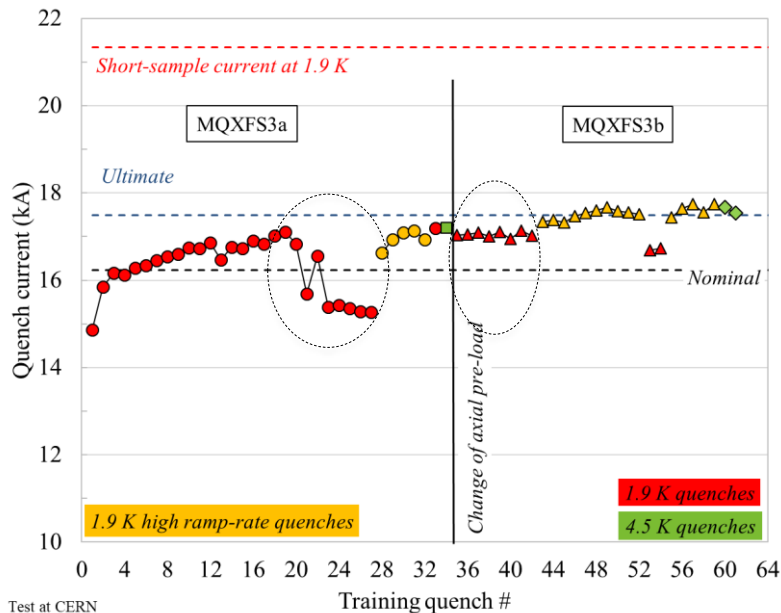
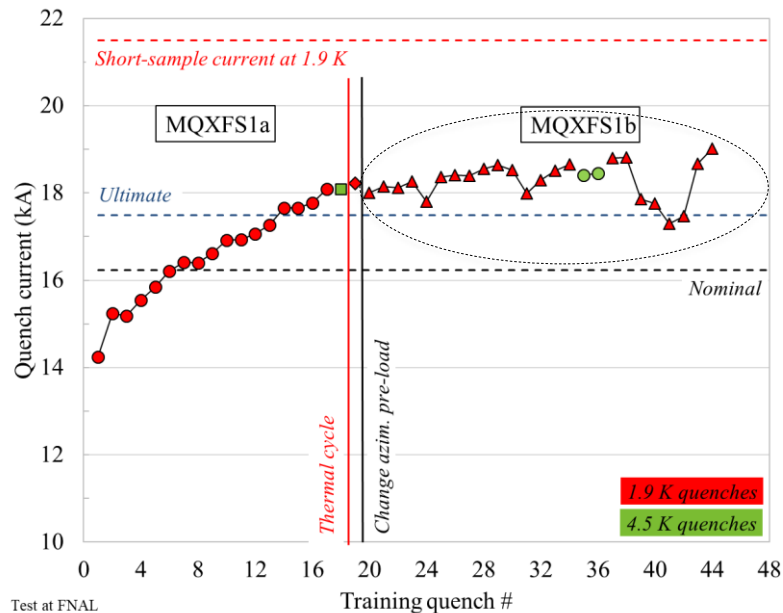
- Also in MQXFS3 (Oct 2016)
 - Detraining...a3a4...increase with ramp-rate, 4.5 K....and with axial loading
- MQXFS1b (Oct 2016)
 - a3a4 appeared after increase of azimuthal, with low axial
 - No clear detraining, but more erratic....

- Interpretation of behavior: self-field instability triggered by a local issue, likely affecting only some strands, that pushes more current in adjacent strand(s)

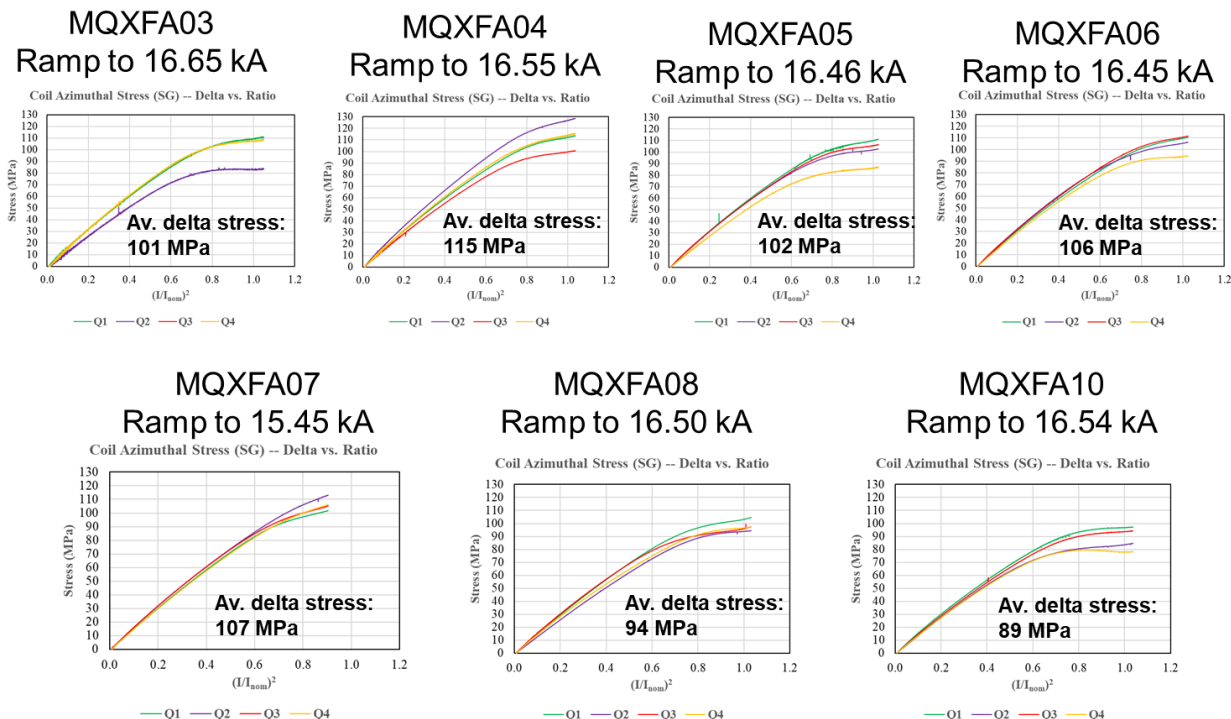
- No major anomaly in azimuthal pre-stress of shell and coil
 - Nothing unusual in the coil unloading
 - However, measurements only on the RE (4 m from quenching)

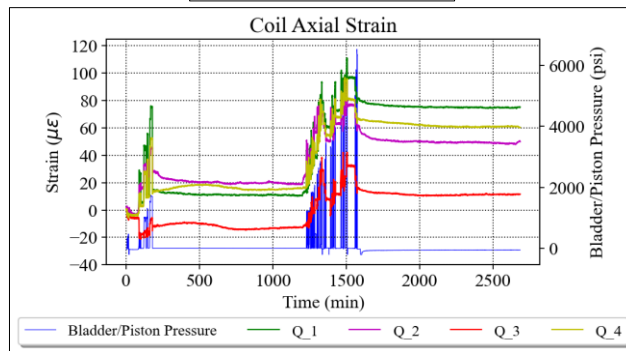
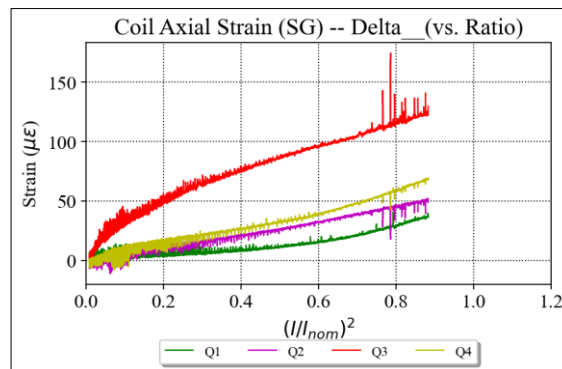
MQXFA07

- “Suspicious” coil z behavior during loading/excitation, however
 - Visible also in some previous magnets
 - Not reproduced by any of the FE models
 - Again measured far from the quenching zone

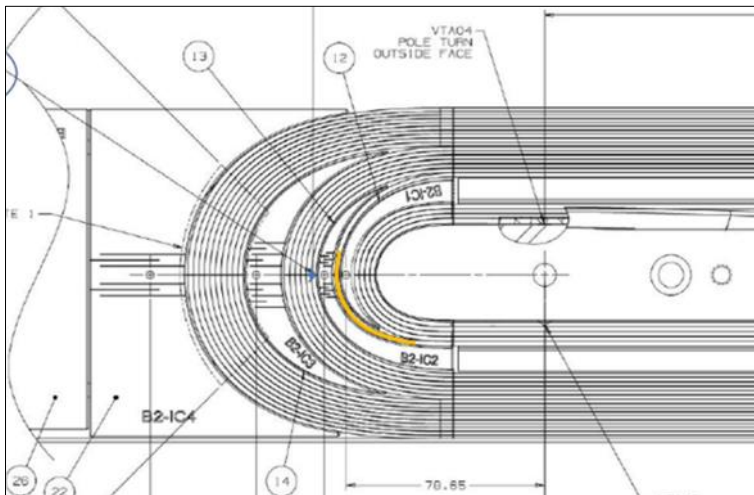
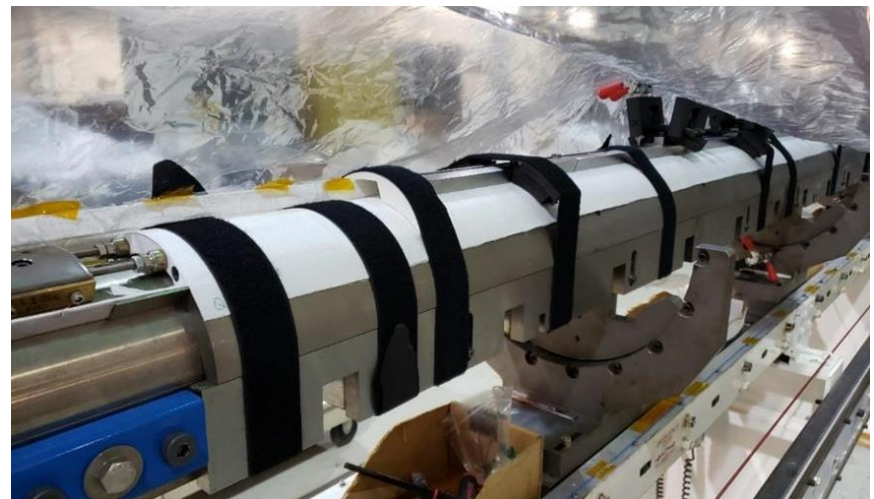
- In MQXFA08, **splice** between the magnet negative lead, connected to inner layer LE Q3, and the test facility had resistance equal to $42 \text{ n}\Omega$
 - Thermal analysis from CERN did not show any significant impact on quench zone
- A07 coil 214:
 - Some **strands popped out** during winding, then fixed, popped out overnight, fixed a second time
 - Occurred in previous coils
 - Affected by **COVID lockdown**: 14 weeks stop after winding & curing of inner layer
- A08 coil 213
 - Affected by **COVID lockdown**: 14 weeks stop in the reaction fixture, in the oven.

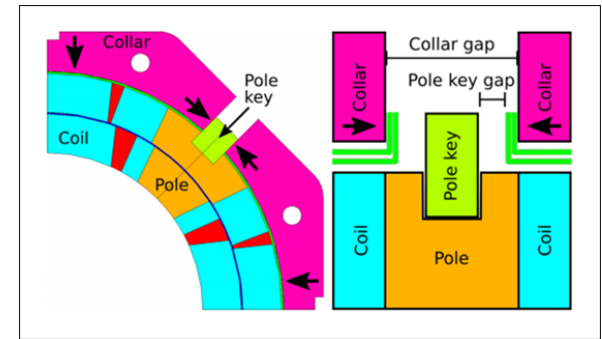
MQXFA07

- Spec. pole key gap (local ave. on cross-section)
 - 0.200 ± 0.050 mm
- Before to after the test
 - Q3 with an **very low** gap both before and after the test
 - Average decreased by about 0.100 mm
 - **Same profiles** after pre-load and test

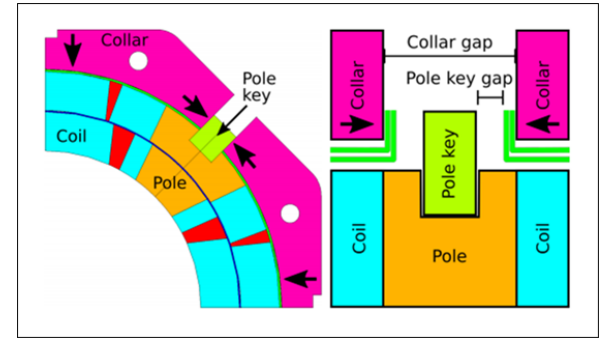
- Similar results on MQXFA08
 - But not as dramatic as in A07-p

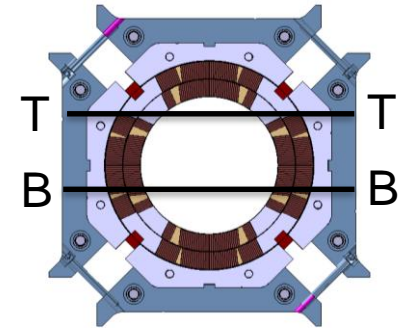
MQXFA07 vs A07-p

- The same conclusion could be drawn looking at the coil pack dimensions
 - Significant trapezoidal shape
 - No change from before to after test

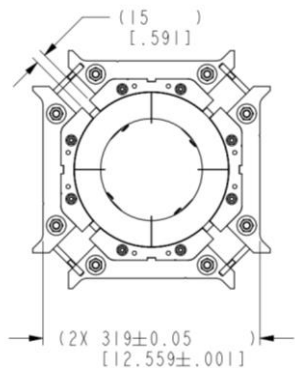
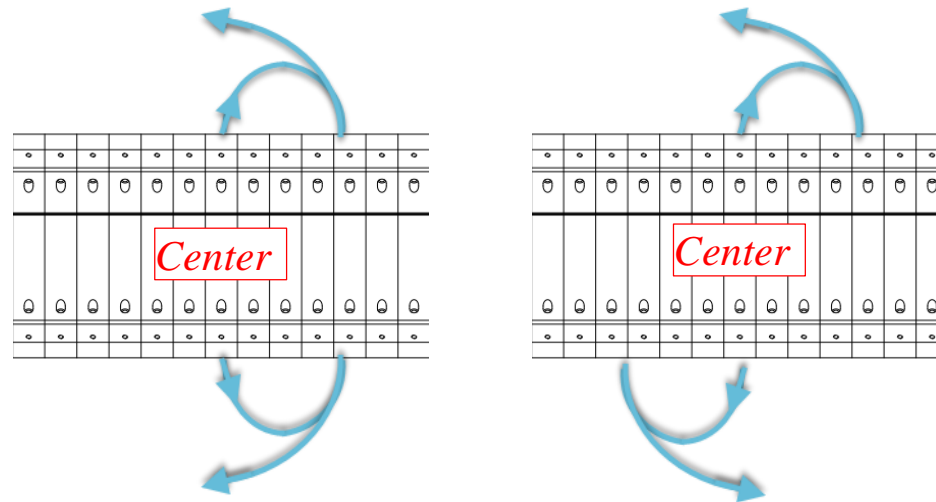
- Changes to magnet assembly procedures due to Covid requirements:
 - #1: change in bolting procedure for increasing tech distance

- #2: the technician who had been leading the coil-pack assembly operations up to magnet MQXFA05 was **removed from that task** (starting from MQXFA06) because not vaccinated.
- Also, end-plate mis-aligned, so magnet **unloaded axially** and re-loaded

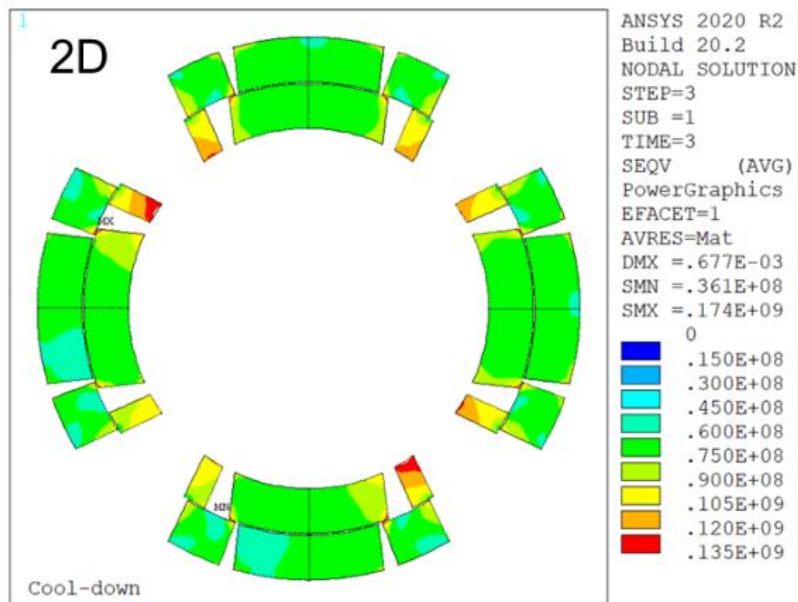
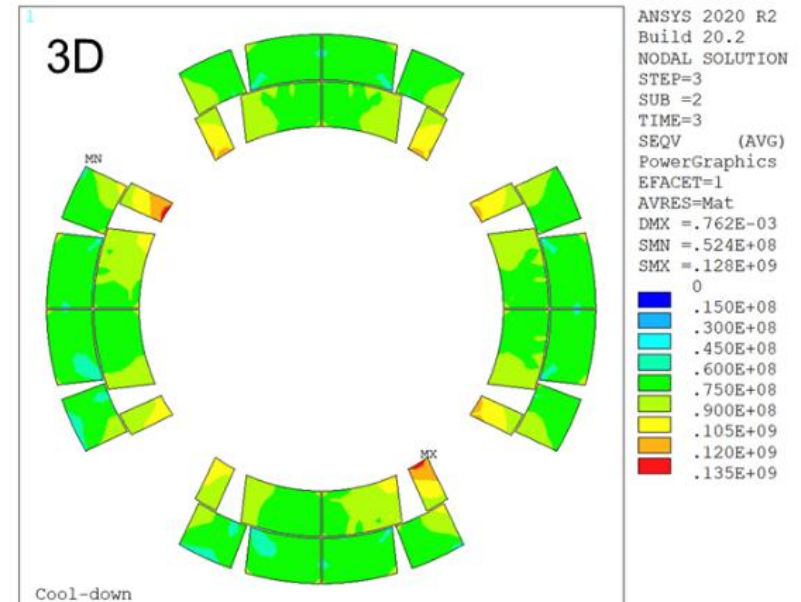
- Lower pre-stress in Q3 confirmed by 3D model

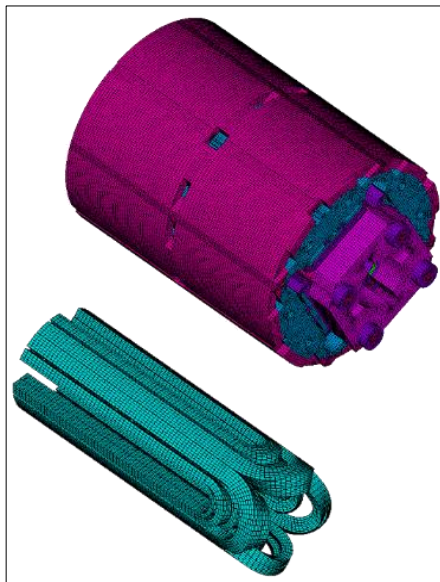
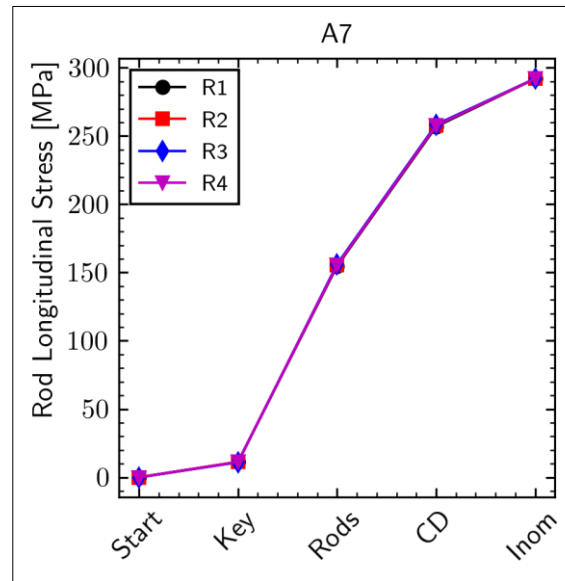
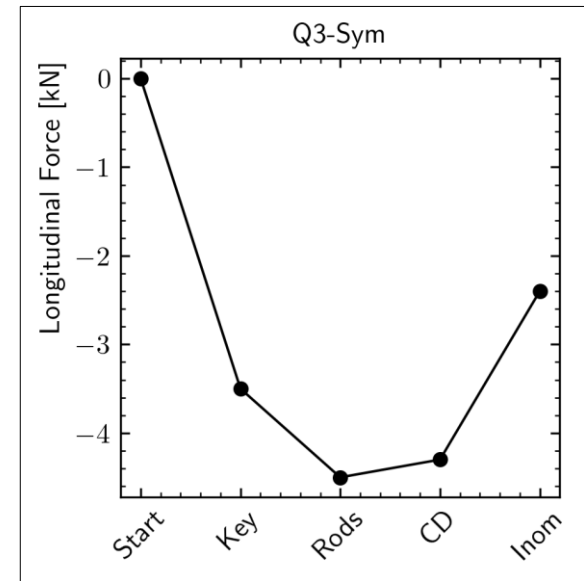
- Axial behavior
 - No difference in the rods stress, but less force axial pre-load on the Q3 coil
 - Lower azimuthal pre-stress results in less friction coil-structure → “axially softer coil”

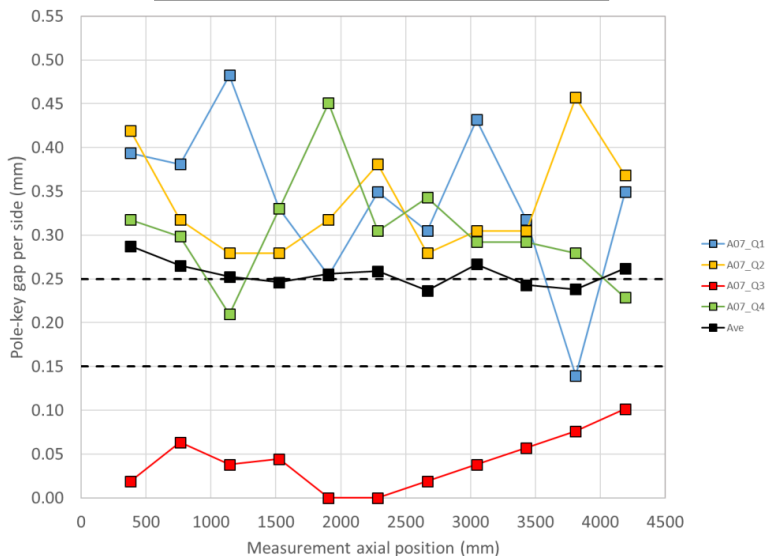
MQXFA07

- First we set a local minimum of pole key gap
 - Min. > 0.100 mm
 - Implemented in A10, which met the test requirements
