Identification and Recovery of ATLAS18 Strip Sensors with High Surface Static Charge

2023-12-06

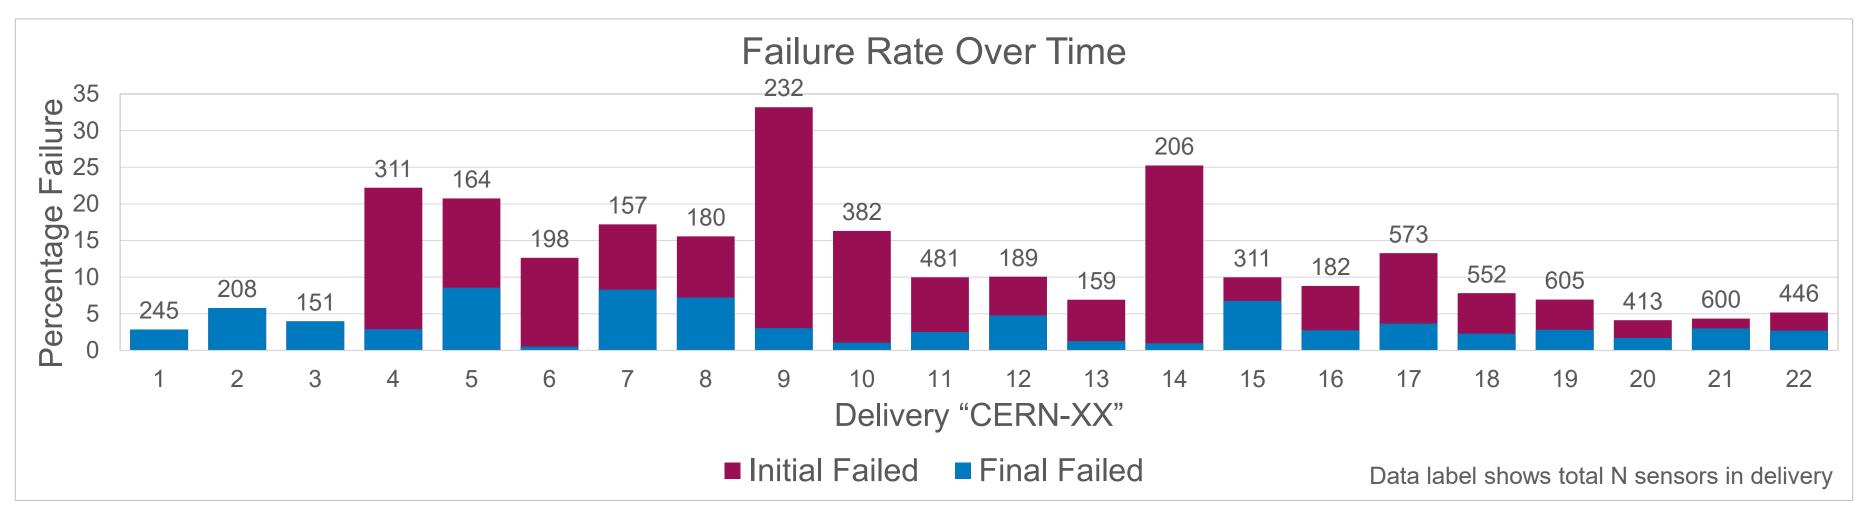
- At the start of production, failures were low (modulo a rejected batch from second delivery due to bad p-stop doping)
- Need for recovery became apparent around CERN-04 delivery
 - Initially a significant fraction, gradually reduced over time; especially last few deliveries
- Final fraction of failures has been quite consistently low, thanks to recovery efforts
- Decreasing fraction of sensors requiring recovery is still essential:
 - less sensor handling at QC sites,
 - less effort/manpower required for recoveries,
 - higher testing throughput without recoveries

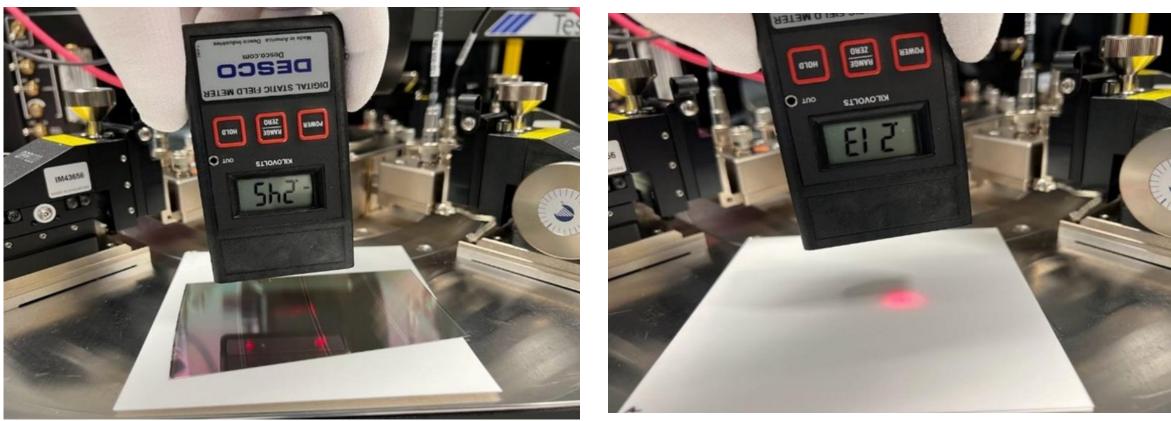
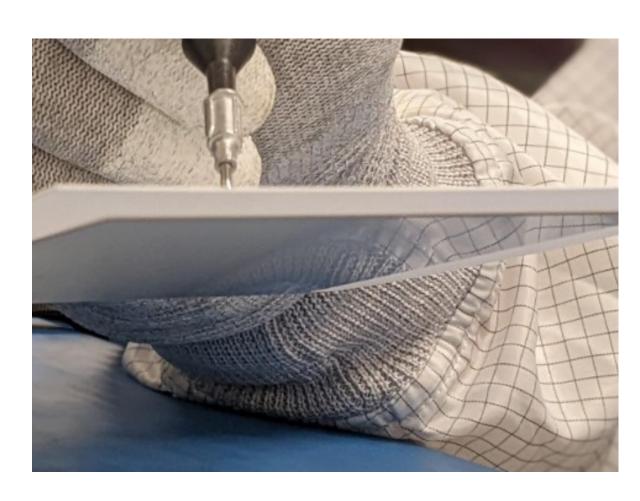
- Almost all QC sites observed a static charge on sensors/sheets
 - Measurement performed with electrostatic field meter upon reception (before) any QC)
- Static charge can cause ESD issues (eg. poor strip isolation in strip test and/or lower BD voltage)
- In extreme cases, the static charge built up between the sensors/sheets is enough to "stick" the surfaces together (not seen in pre-production)

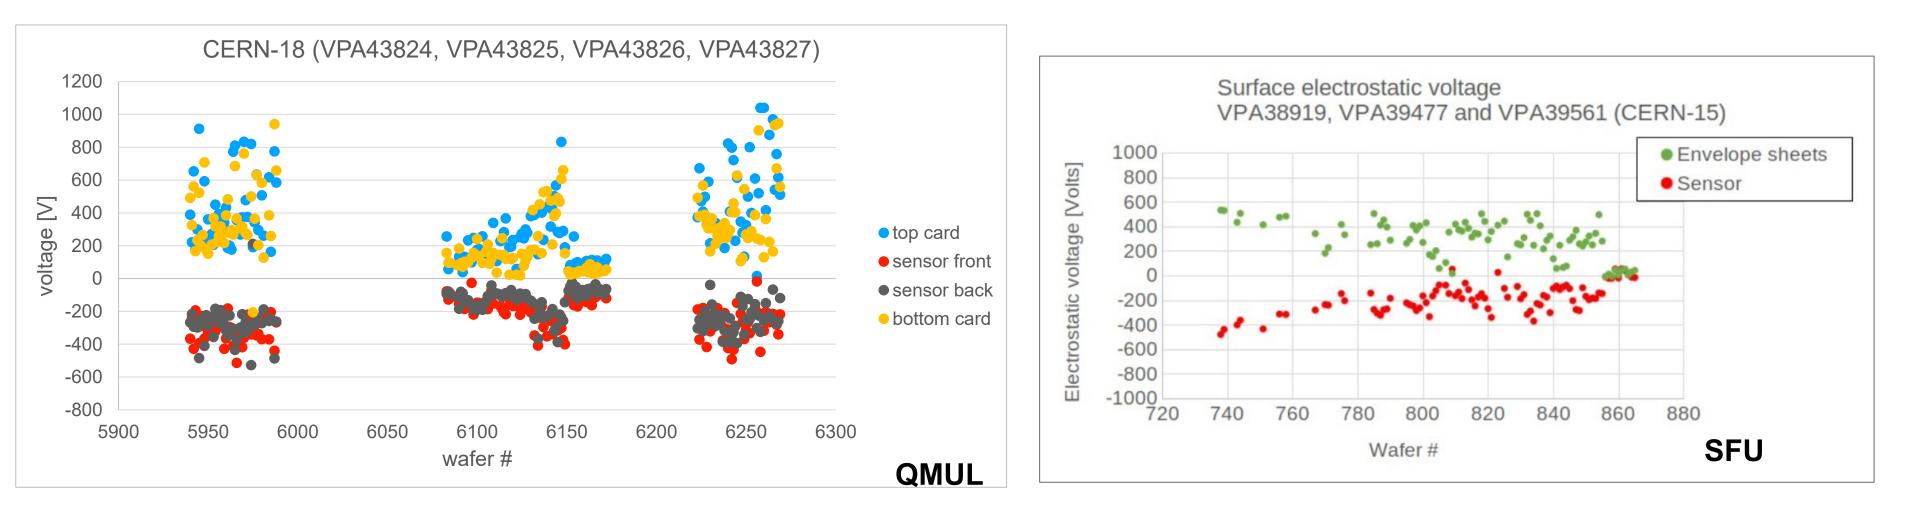
- Usually, the packaging sheets are measured to have positive charge, sensor surface has negative charge
- Packaging sheets were noted to have two distinct finishes on either side: "shiny" or "matte"
- Orienting the two cards so the same side faces the sensor (shiny-shiny or matte-matte) reduced the stickiness and partially resolved high static charge

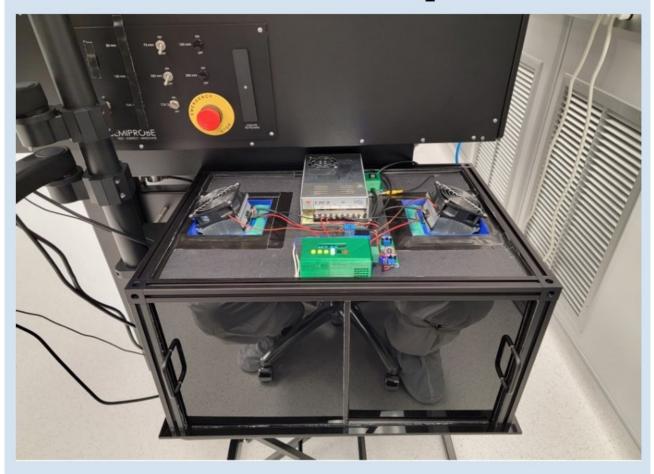
SFU UV-A setup

- Long term exposure to UV-A light (370-410nm) has proven to be effective at restoring some sensors' IV and ST performance
- Exposure time varies, but is typically 4-8 hours
- UV-C (~250nm) was also explored (see backup) but has an undesirable side effect of greatly increased (3-50x) leakage current
 - Optionally used in extreme/difficult-to-recover cases
- Exposing the sensor surface to a constant stream of ionized air is also effective for recovering sensor IV and ST performance
- Exposure time is much less than for UV-A treatment; about 10 min is sufficient Some sites now pre-emptively treat all incoming sensors with ion blower

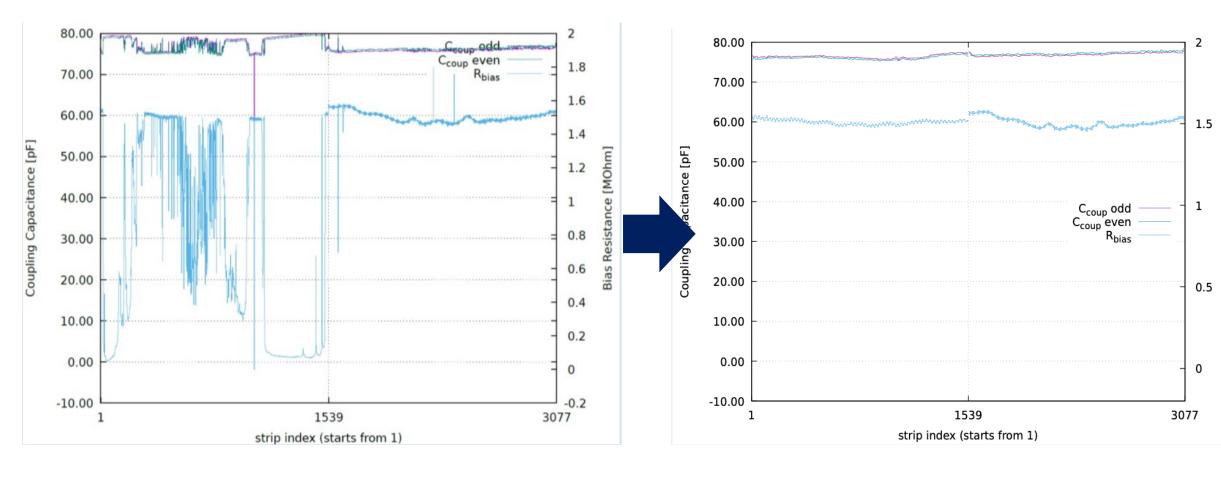
Varying levels of success at each site – At CU and QMUL great success using ionized air; At SFU and FZU, more success with UV-A
