# POPS Operational Issues during October 2022

Joint Accelerator Performance Workshop December 2022

Aramis Schwanka Trevisan and Fulvio Boattini (SY-EPC/HPC)

Date: December 7<sup>th</sup> , 2022

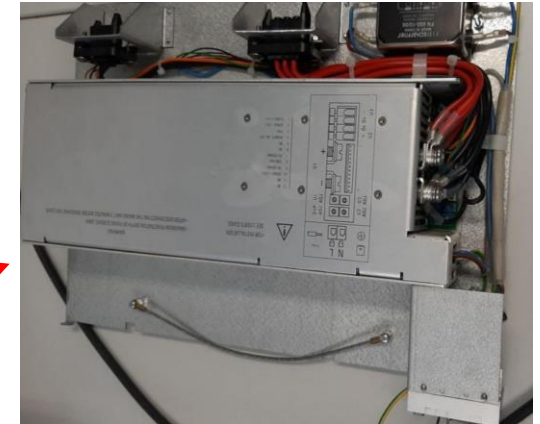
VME (20 slots) - Schroff BGTR 10HE

- **Built-in to the Schroff chassis**
  - +5V (100A), +12V (8A), -12V (6A)
  - The 24V for the fans is taken from the  $\pm 12V \rightarrow$  **Very bad idea!**
  - Specification: max. ripple of 50mVpp
- **POPS measurements:**
  - 5V  $\rightarrow$  ~300mVpp ripple (!)

- Can it be caused by its AC Power Supply?

- Spare 1 (never used, ~10 years old): did not solve the problem!
- Spare 2 (~10 years in use in the spare chassis): did not solve the problem!
- New power supply (should replace the “old” ones): non compatible!
  - Oscillations persisted in all cases...  
... were the oscillations there from the beginning? ...

- 1) **Replacement of the Frankenstein with more robust solution**
  - i. Alternative power supply for +5V and  $\pm 12V$  that fits into the chassis plus an external 24V for the fans
  - i. Two units ordered

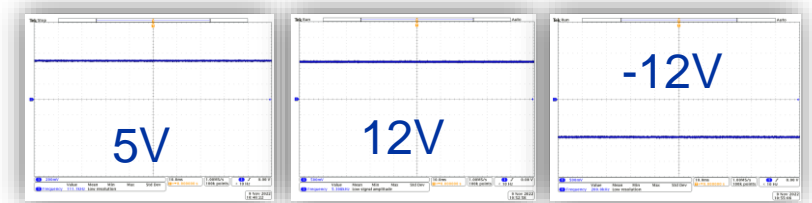
Ripple-free voltage levels in Frankenstein ps

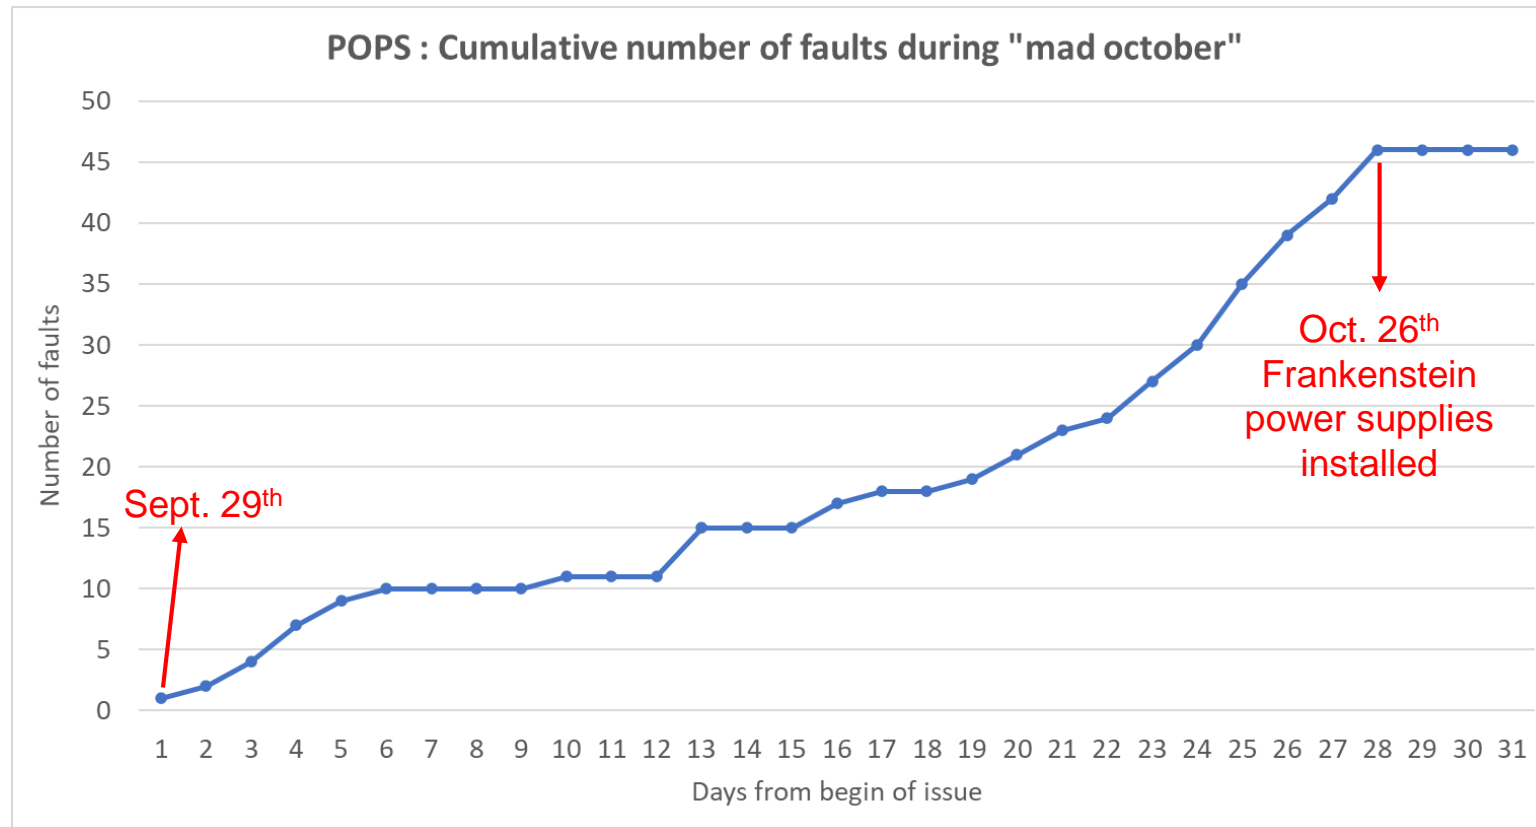
- Number of trips during “Mad October”

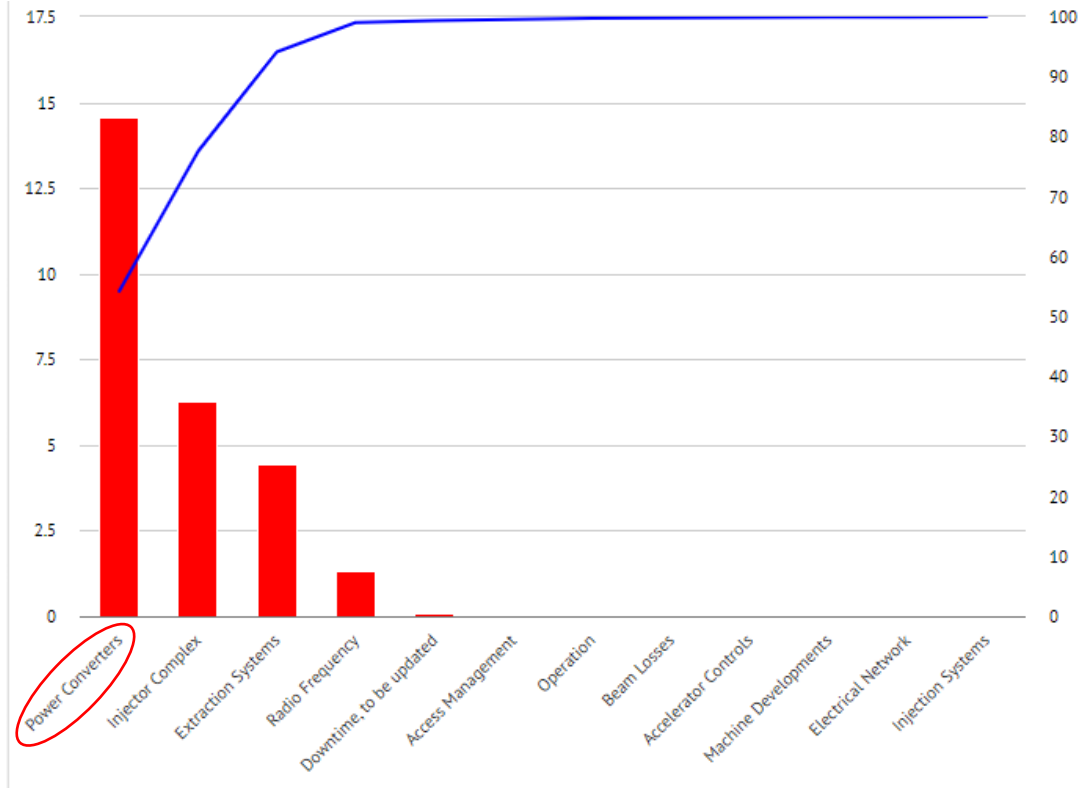
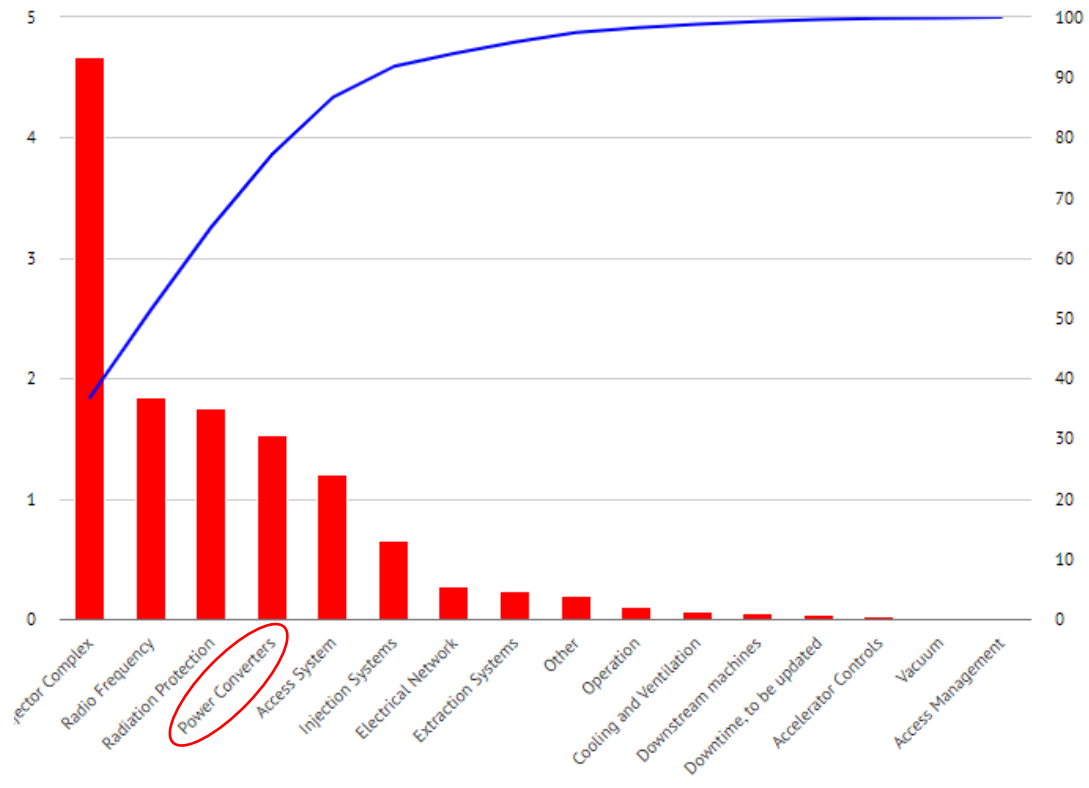
- Overview of PS Accelerator unavailability

- “Mad October” (Sept. 29<sup>th</sup> to Oct. 29<sup>th</sup>)

- “Rest of the year” (May 1<sup>st</sup> to Aug. 31<sup>st</sup>)

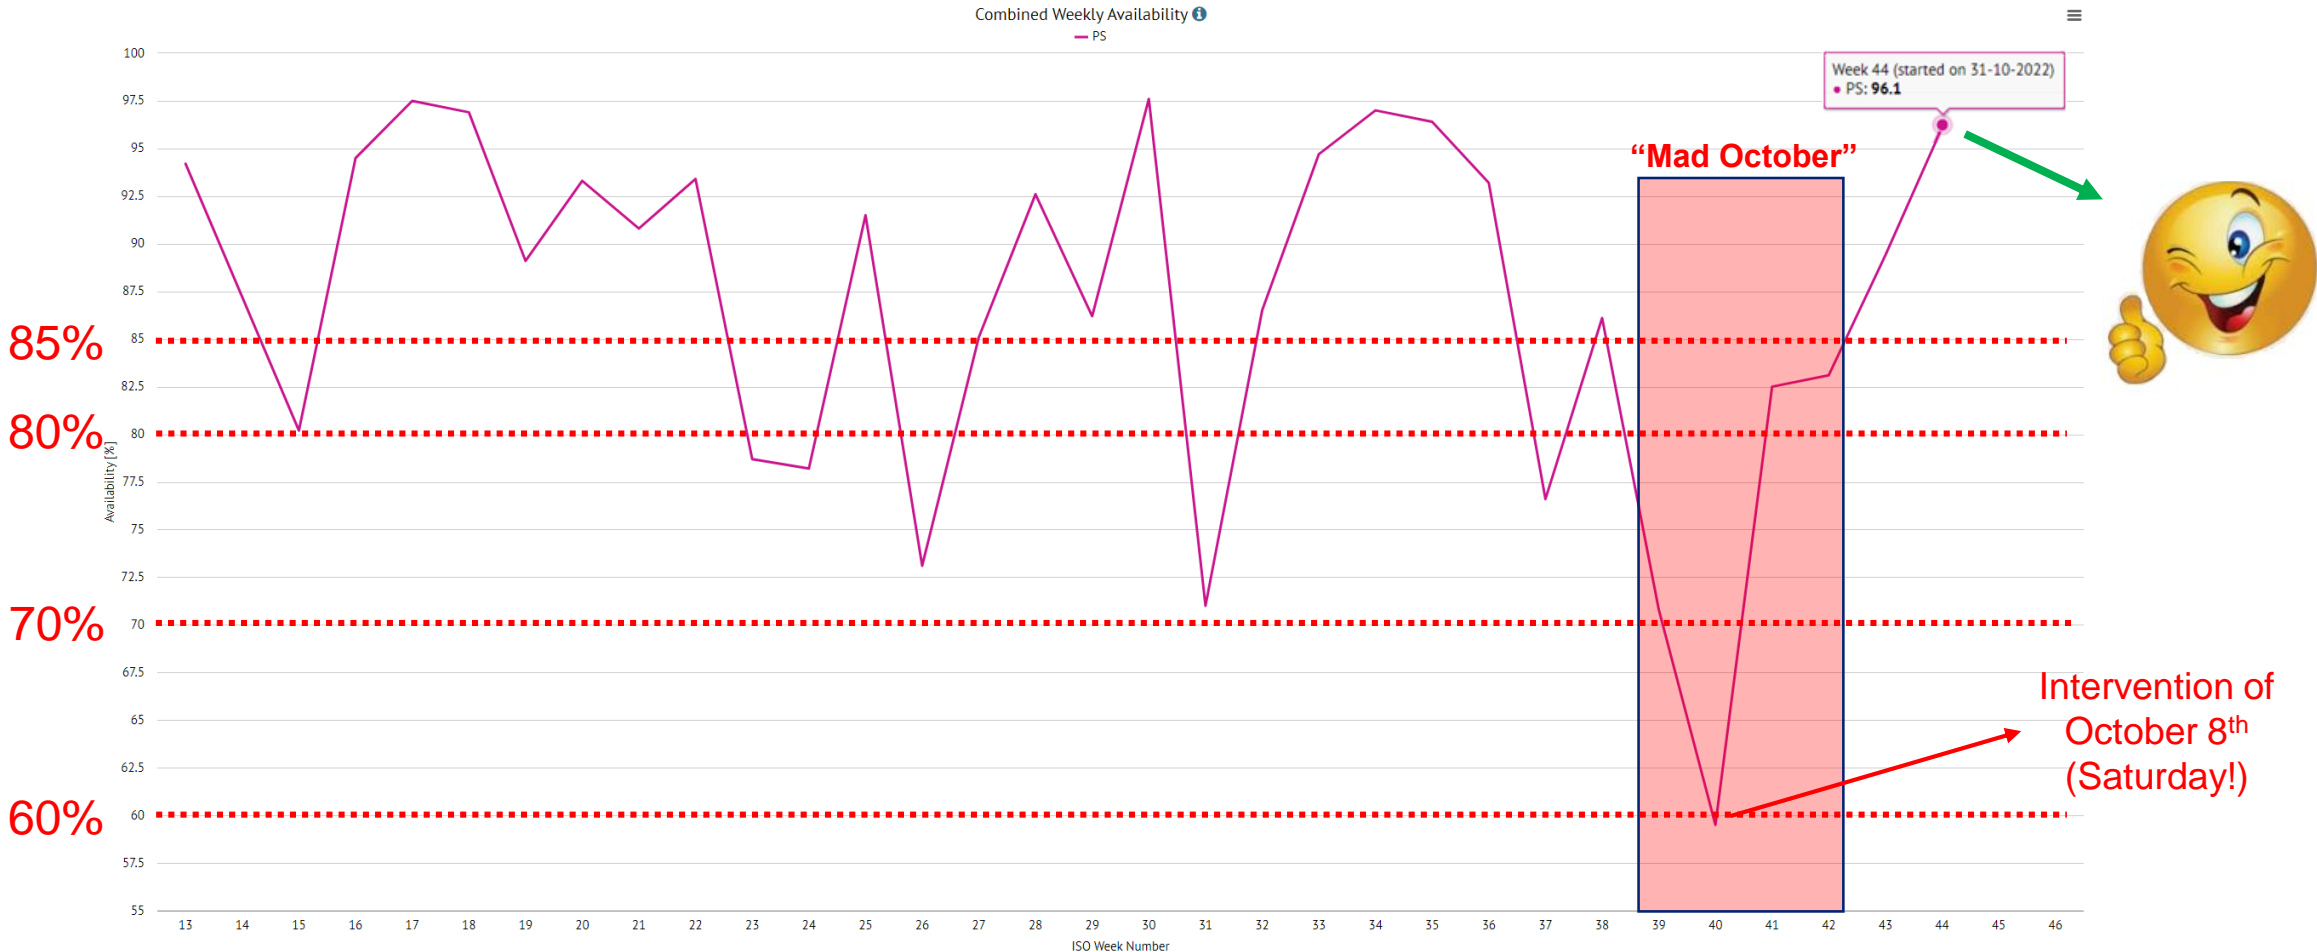
- **Combined Weekly Availability from “Accelerator Fault Tracking”:**

**Only possible thanks to “Procedures (including “reset”) + EPC piquet team”!**
