Challenges and Lessons Learned from fabrication, test and analysis of ~10 MQXFA Low Beta Quadrupoles for HL-LHC

Giorgio Ambrosio and the MQXFA team

ASC
22

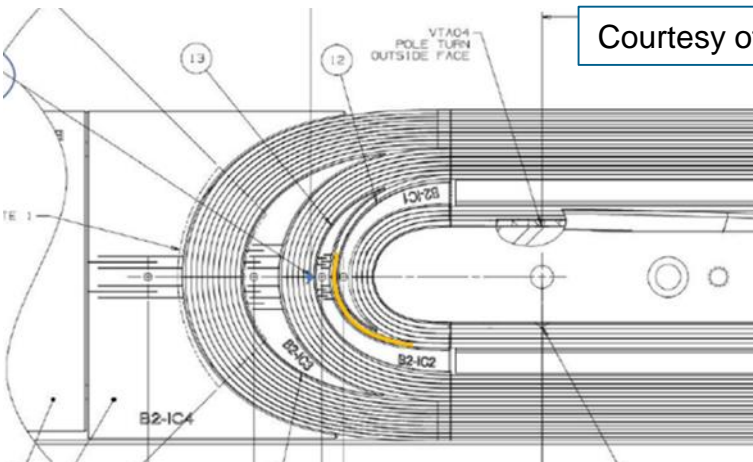
Courtesy of J. Schmalzle

- A few discrepancies during fabrication:
 - Some strands popped out during winding, were fixed, popped out overnight and were fixed a second time (BNL DR AM-164)
 - Limiting coil was affected by COVID lockdown
 - 14 weeks stop after winding & curing of inner layer
 - No other NCR nor traveler data anomaly

Inner layer coil showing in yellow the position of coil-214 cable affected by DRAM-164

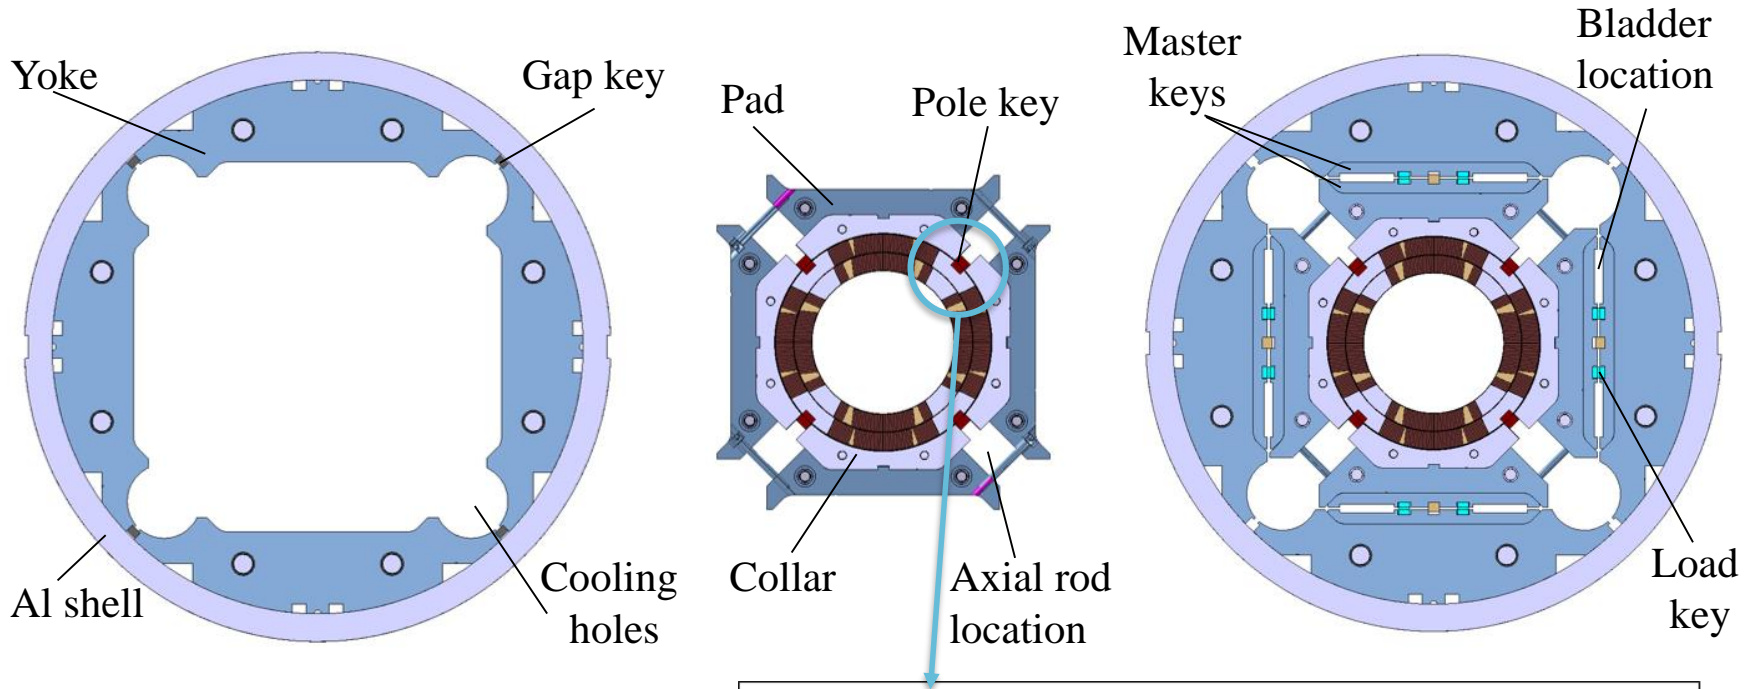
A pole-key gap asymmetry was found during MQXFA07 and MQXFA08 disassembly:

- Gaps closed in quadrant 3
- Gaps open in other quadrants

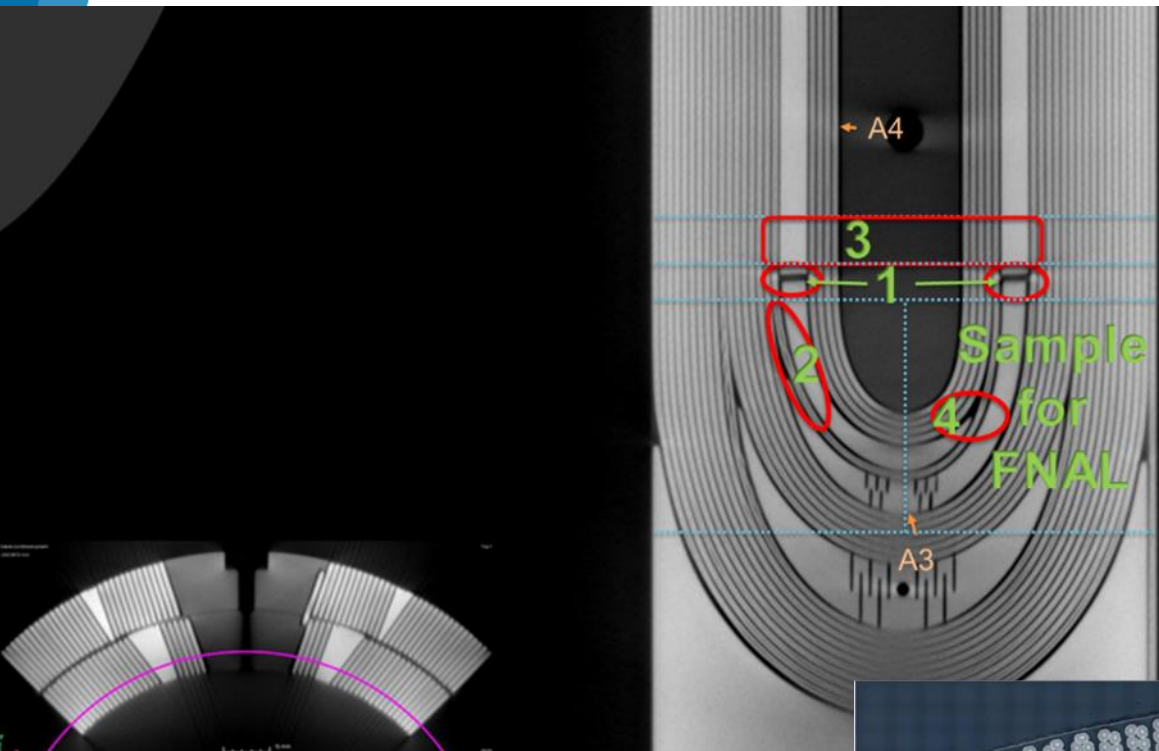
By B. Bulat, CERN

Analysis started with sample #1: wedge-spacer interface

No anomalies found in cross-section #1. Therefore, we did **longitudinal sections**

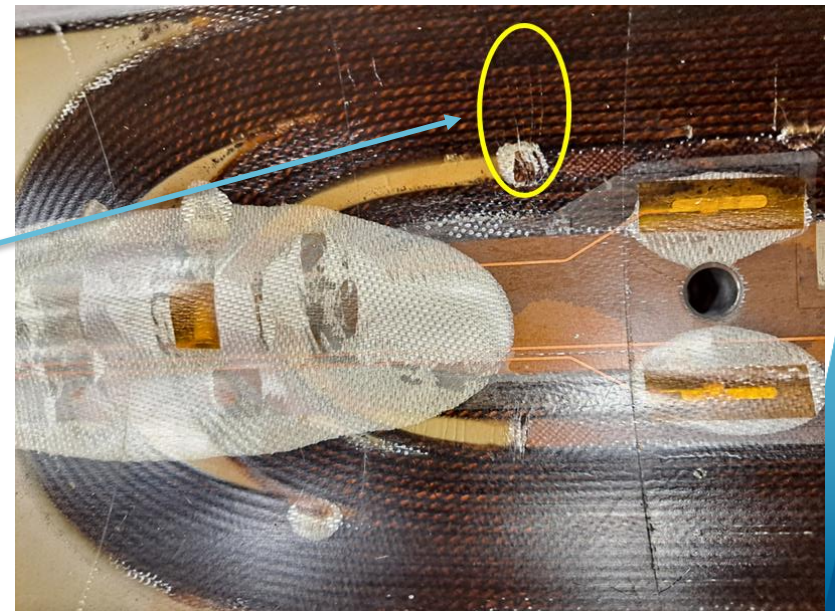
- Pressure imprint in Q3 pole-key gaps
- Unusual marks at wedge-spacer interface in lead end

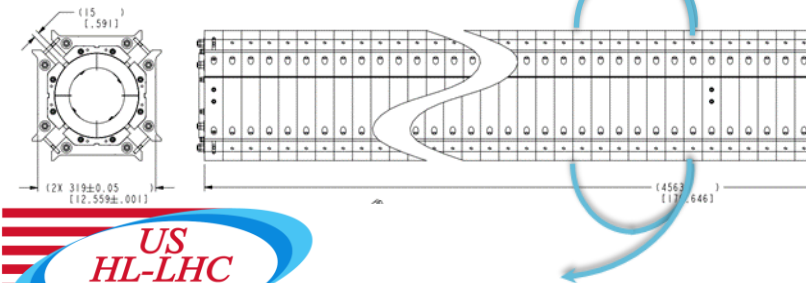
Before change #1

- Changes to magnet assembly procedures due to Covid requirements:
- #1: change in bolting procedure for increasing tech distance
- #2: the technician who had been leading the coil-pack assembly operations up to magnet MQXFA05 was removed from that task (starting from MQXFA06) because not vaccinated.
