# **SOLEIL Power Supply Reliability**

### POCPA Workshop 2023 François Bouvet

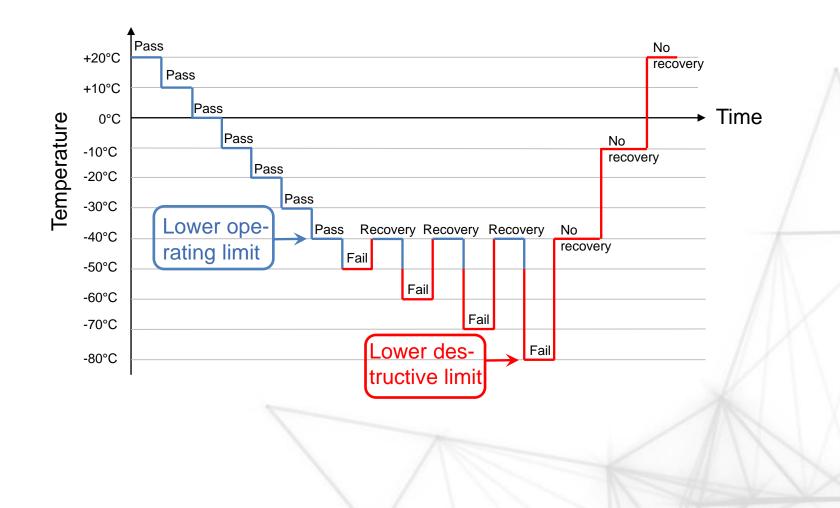
- Focus on the HALT methodology:
  - Example: Step by step temperature decrease

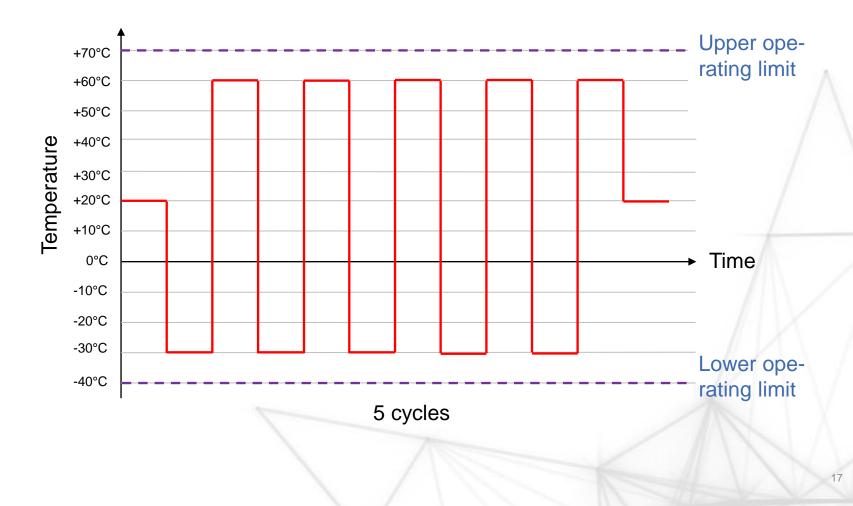
- Focus on the HALT methodology:
  - Example: Rapid temperature variations (min. 45°C/min, up to 60°C/min)

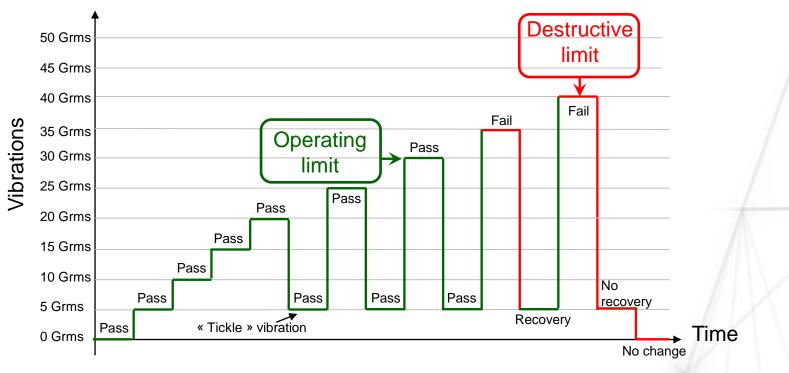
- Focus on the HALT methodology:
  - Example: Step by step "Grms" vibration level increase

Pseudo-random vibrations 0 to 10 kHz on the 3 axes
