LINAC2 PERFORMANCE AND HARDWARE REVIEW

Giulia Bellodi - BE/ABP-HSL

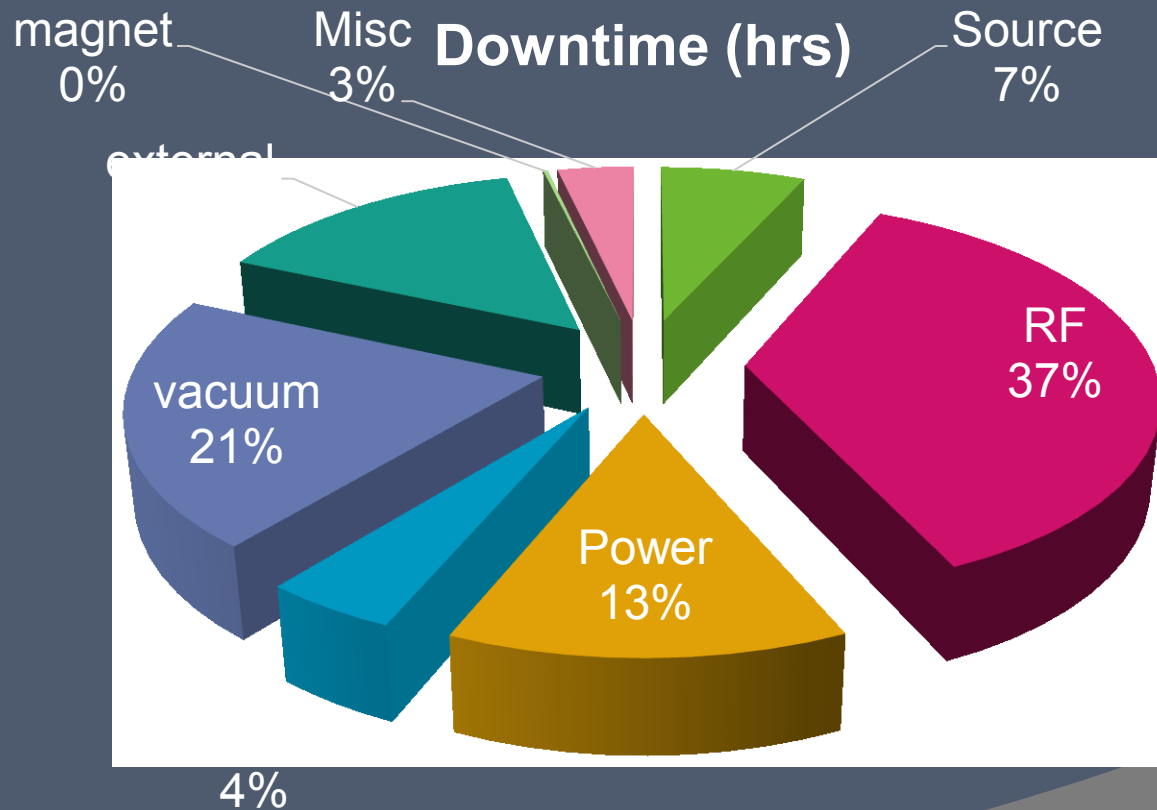
Linac2 ran from 3 February to 23 November, for a total of 6880 hours, with 53 hours in fault → 99.2% uptime

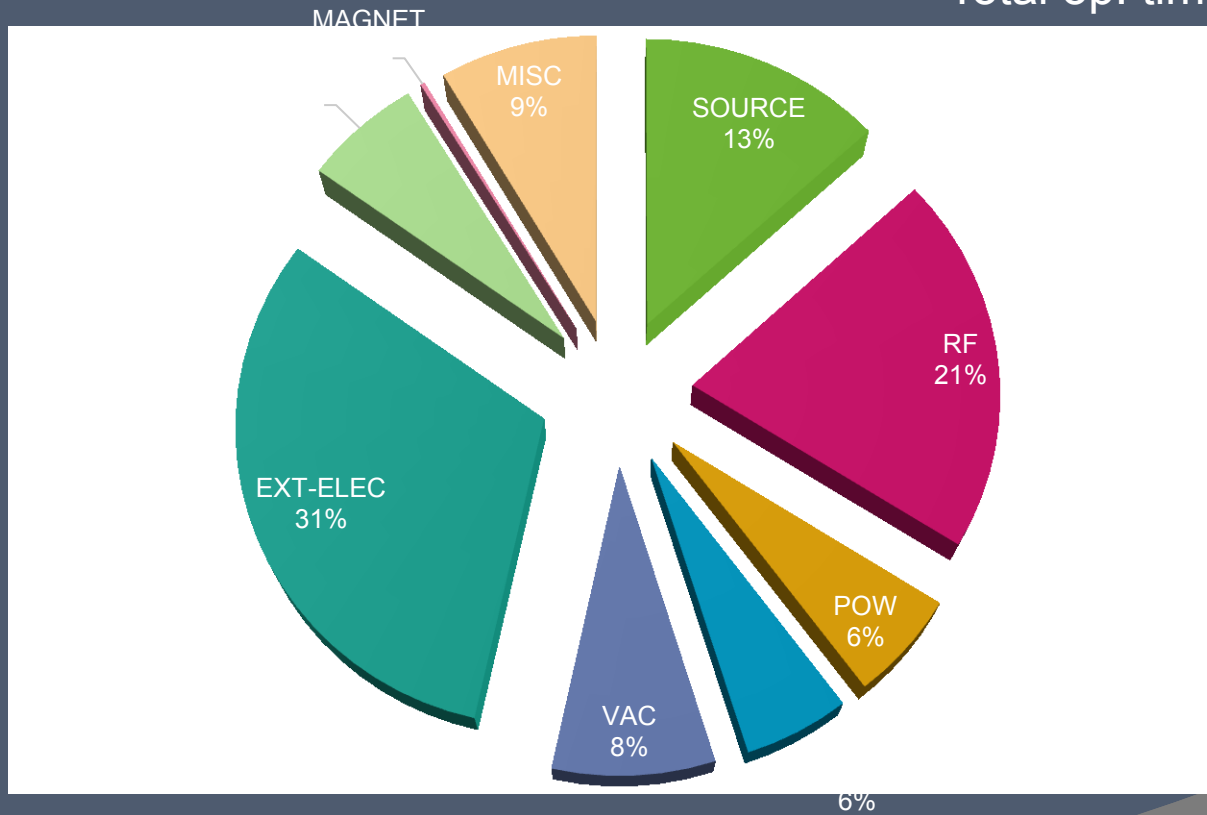
2000-2010 faults – integrated

Total downtime= ~964 hrs
Total op. time = 59994 hrs
Availability = 98.4%

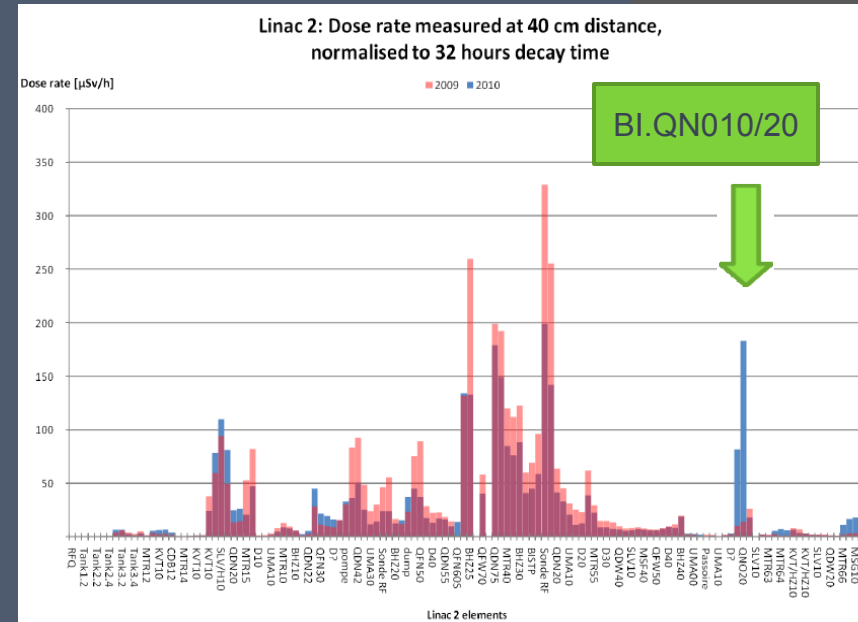
Dec 2010 survey, M Wadorski

20% increase from Aug-Sept 2010 & regular level 1 alarms

Increase not understood (higher intensity delivered?). Levels temporarily reduced with optics changes, however the problem was just shifted downstream, as new RP measurements revealed (new hot spots in BI line, 15→172 $\mu\text{Sv/hr}$ from 2009 to 2010). New BLMs installed in the shutdown and further optics changes implemented (end of February 2011).

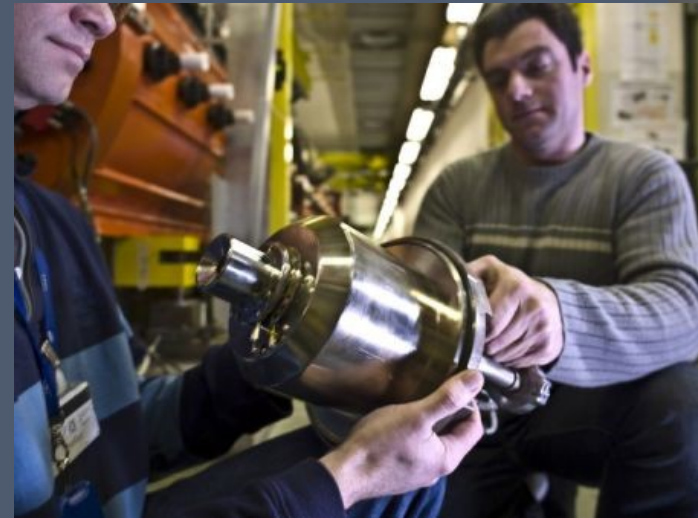
Source

Duoplasmastron in service since 1992: 5000-7000 hrs operation/yr

Year	Down time (hrs)	comments
2005	39.3	2 cathode/electrode changes
2006	31.1	One cathode change
2007	7.2	
2008	6.1	
2009	2.75	
2010	3.6

Annual maintenance (dismounting and cleaning, polishing, electronics testing).

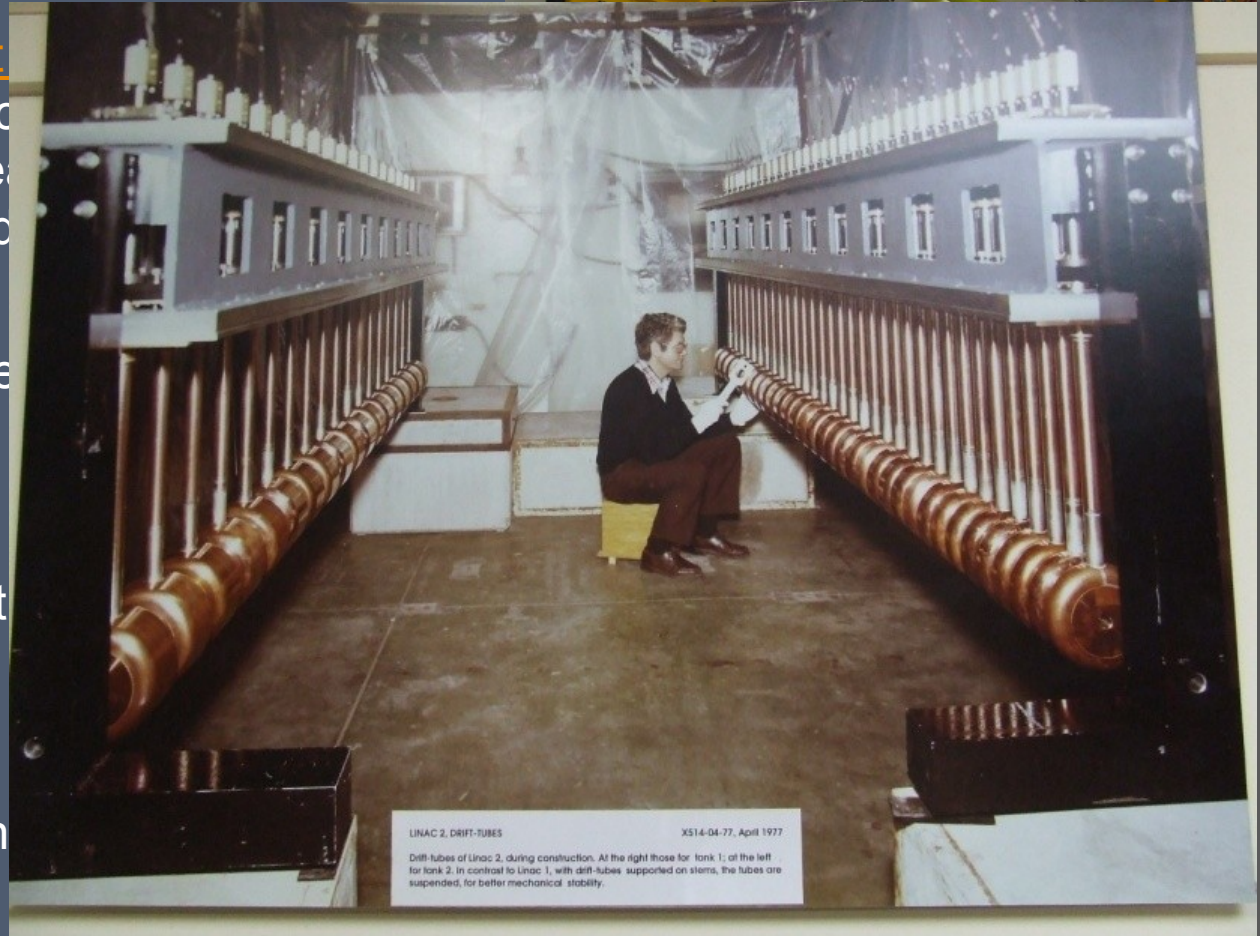
Nightmare 1: DTL quad failure

- 131 quadrupoles, (powered in series of 1, 2 or 3) inside the drift tubes pulsed with $>300\text{A} \sim 700\text{V}$ every pulse. $\sim 500\text{ M}$ pulses to date.
- The drift tubes are suspended to a girder; they are aligned externally and successively introduced into the tanks. A mechanical positioning system on the outside of the girder together with a bellow on the inside allows positioning of the drift tubes with the required precision.
- No maintenance of these circuits (inside the drift tubes) has ever been made.
- 2 vacuum leaks differentially pumped
- MTR in case of fault? \rightarrow R. Scrivens, ATOP days 2009

Short-term operation w/o quadrupoles might be possible with **degraded** emittance growth and transmission to PSB.

For longer term solution, a **repair plan** has been put together:

- Study of how to remove girder. Design of tooling.
- Study of repair.
- Study of tooling for drift
- Study of tooling to leak to girder seal.
- Installation and re-align
