# TGC's ageing experience

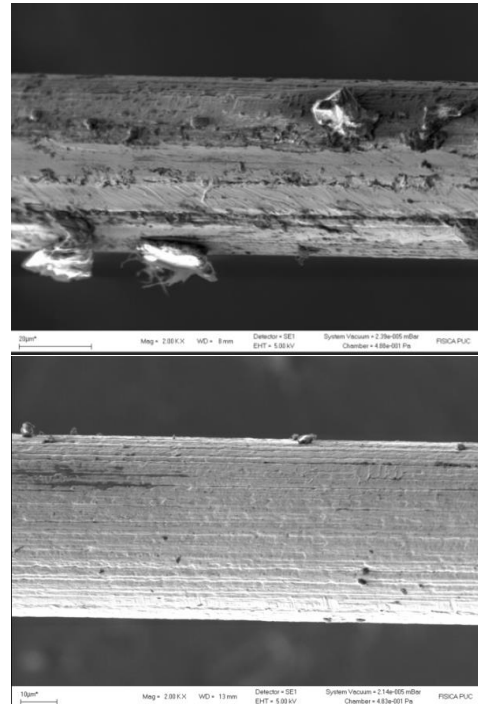
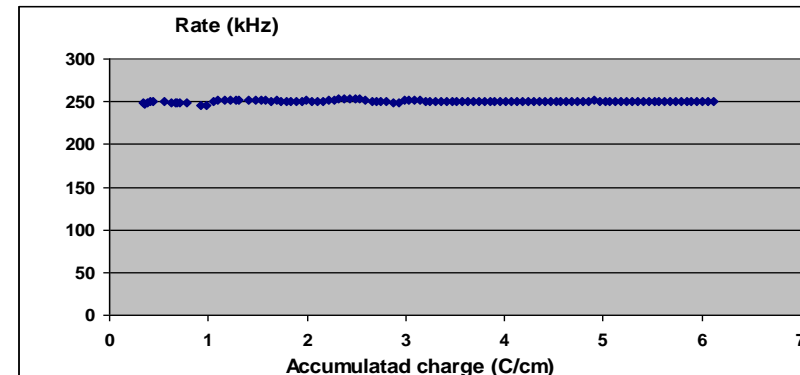
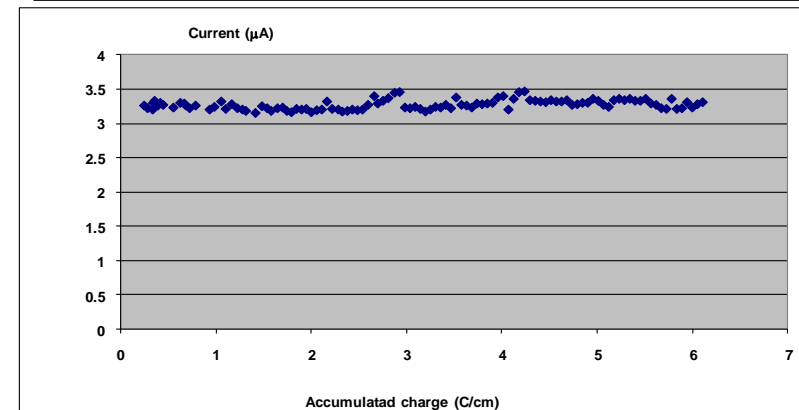
Deposits due mainly to Carbon and Oxygen

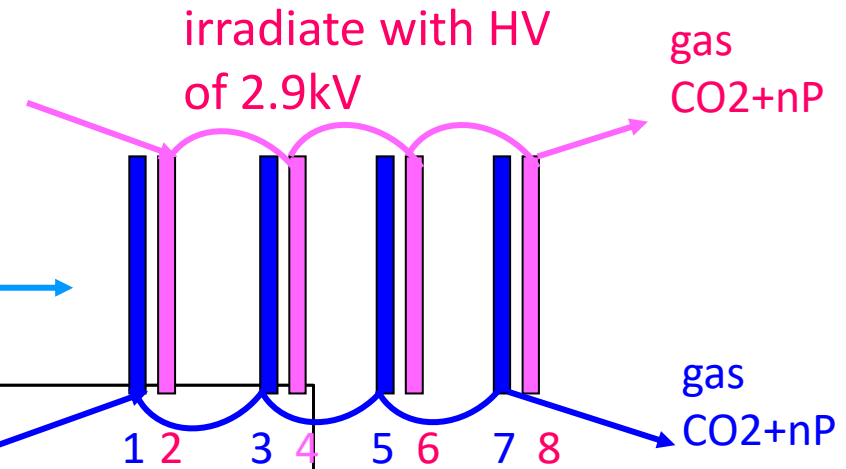
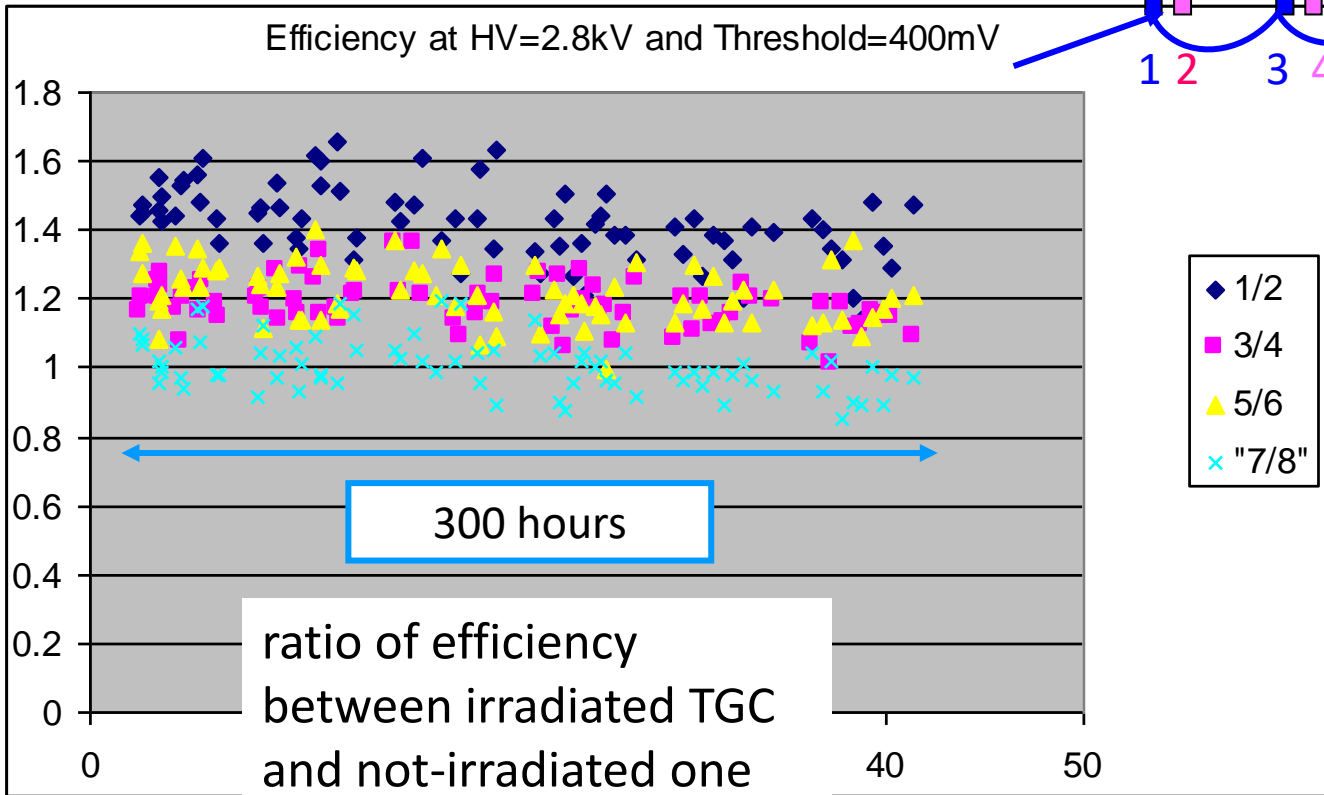
irradiate gamma-ray from Co60  
(300 hours, 3000Hz/cm<sup>2</sup>).  
accumulated charge  
corresponds to 3 yrs of  
operation in ATLAS

- irradiate with HV off
- no degradation of efficiency
  - no effect of gas decomposition even in the last chamber

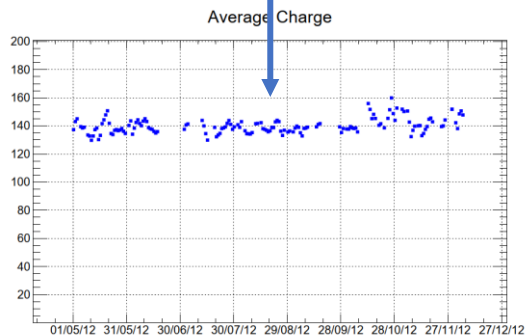
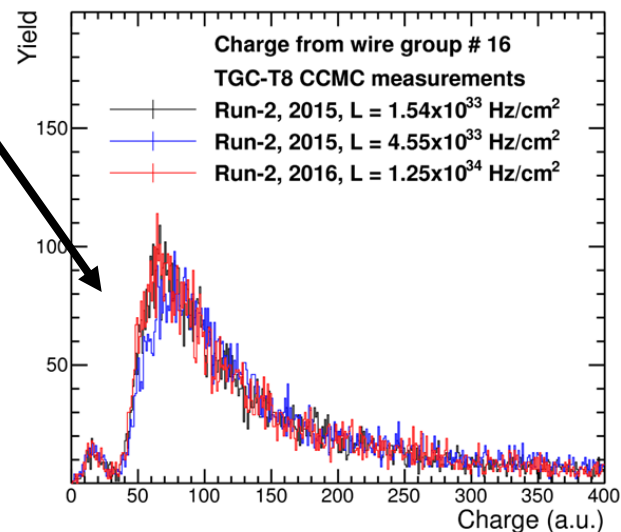
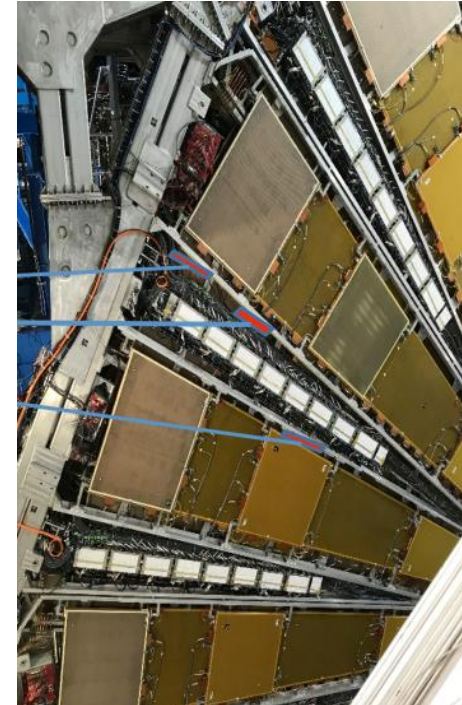
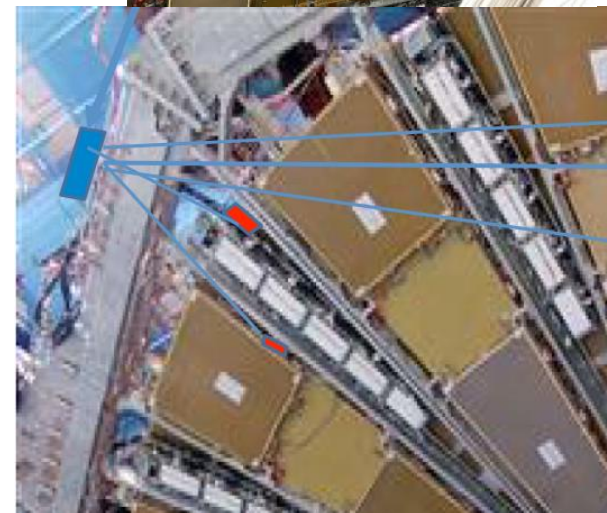
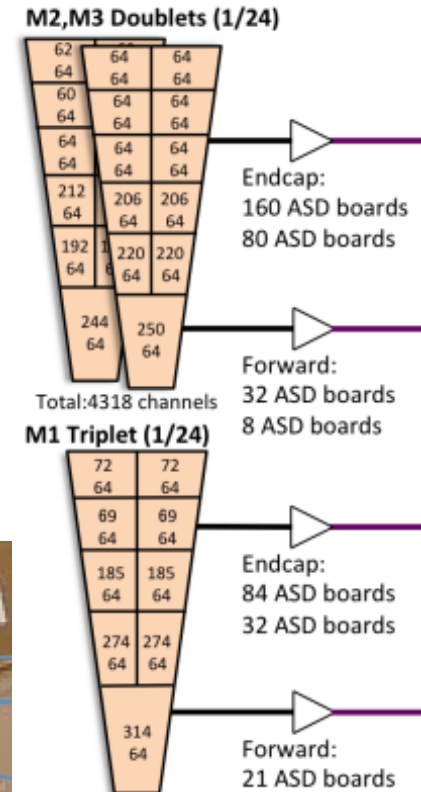
Typical charge spectra for one channel as a function of the instantaneous Luminosity And its average variations

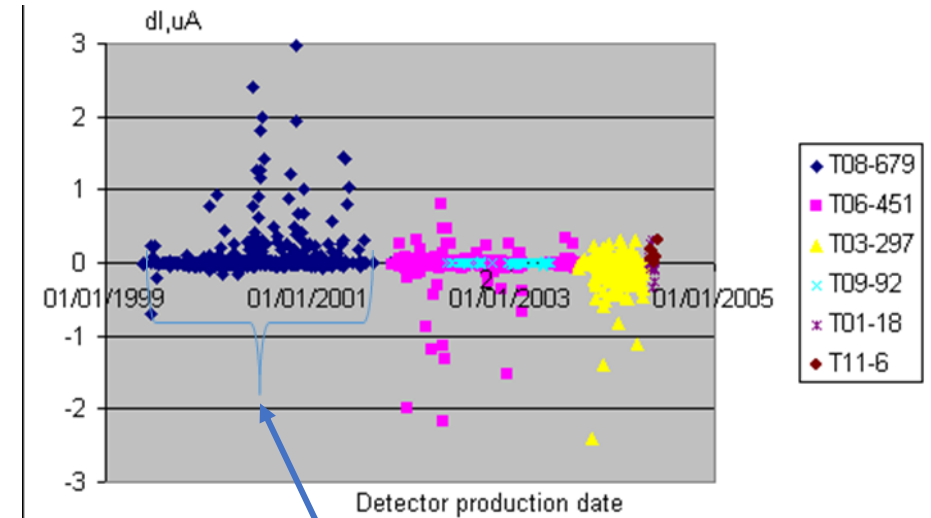
- All Israeli produced triplet detectors were fully irradiated with a strong Co(60) for 1/2hr at a rate of 100Hz/cm<sup>2</sup> and then the current was compared to the initial current imposing a cut on the difference of 1μA (graphite and glue related problems were found in the rejected detectors).
- A high level technician (Boris) was put in charge of the clean room, where detectors are closed, to ensure that any defect is either properly cured or cathode is replaced.
- Following this changed, all detectors were irradiated with a rate of 200-3000Hz/cm<sup>2</sup>, with requirement cut at 0.5μA.

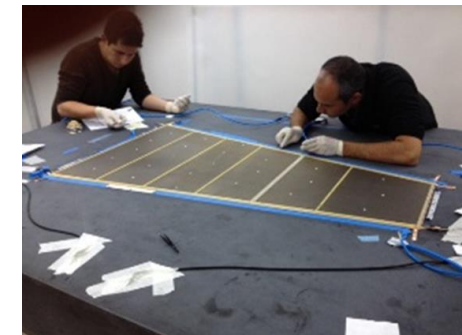
TGC tests: first set of chambers tested at 1/3 of the rate=>change person in charge of clean room to ensure good quality detectors.

The issues for the detectors to be replaced clearly not related to irradiation but to quality in the construction

Crucial to have competent people to check every step in the detector construction
