Irradiation effects on GEM detectors operated at RUN1 and RUN2 at the LHCb experiment

M. Poli Lener

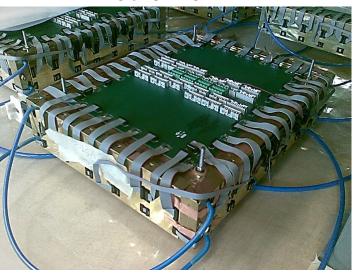
Station A15A1 (two GEM detectors called RIGHT & LEFT) has recently analysed after RUN1&RUN2

439 days colliding beams @ $<\Phi>\sim$ 250 kHz/cm² @ G \sim 4*10³ \rightarrow Q_{int} \sim 300 mC/cm²

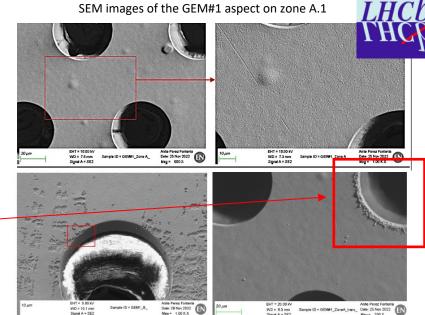
Chemical analysis by EDS on the hole's surrounding areas pointed out **no residue** when approaching the hole's edge Holes and Cu surface are homogenous

Some Cu edges exhibit a molten aspect —

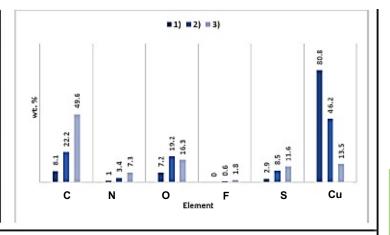
OM and SEM images of the GEM#3 A.2 zone

- sulphur residual deposit mainly on the third GEM, probably due to the outgassing of the ARALDITE 2012;
- no effect of F-etching on GEM;
 - → No major performance loss observed during LHCb operation
 - → < 100 nA dark current recorded on GEM#3

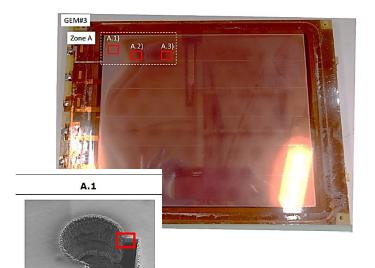
Zoom of A.1 hole inside the stained area of GEM#3

FIB-SEM inspection confirmed that **the residue** observed on the hole's edges **is also deposited into the hole internal surface** covering the Kapton and modifying the hole's geometry:
