Machine Protection Panel Meeting

Analysis of the LHCb VELO RF Foils Incident and First Actions

Rodrigo Ferreira | rodrigo.ferreira@cern.ch

On behalf of the **TE-VSC** Group

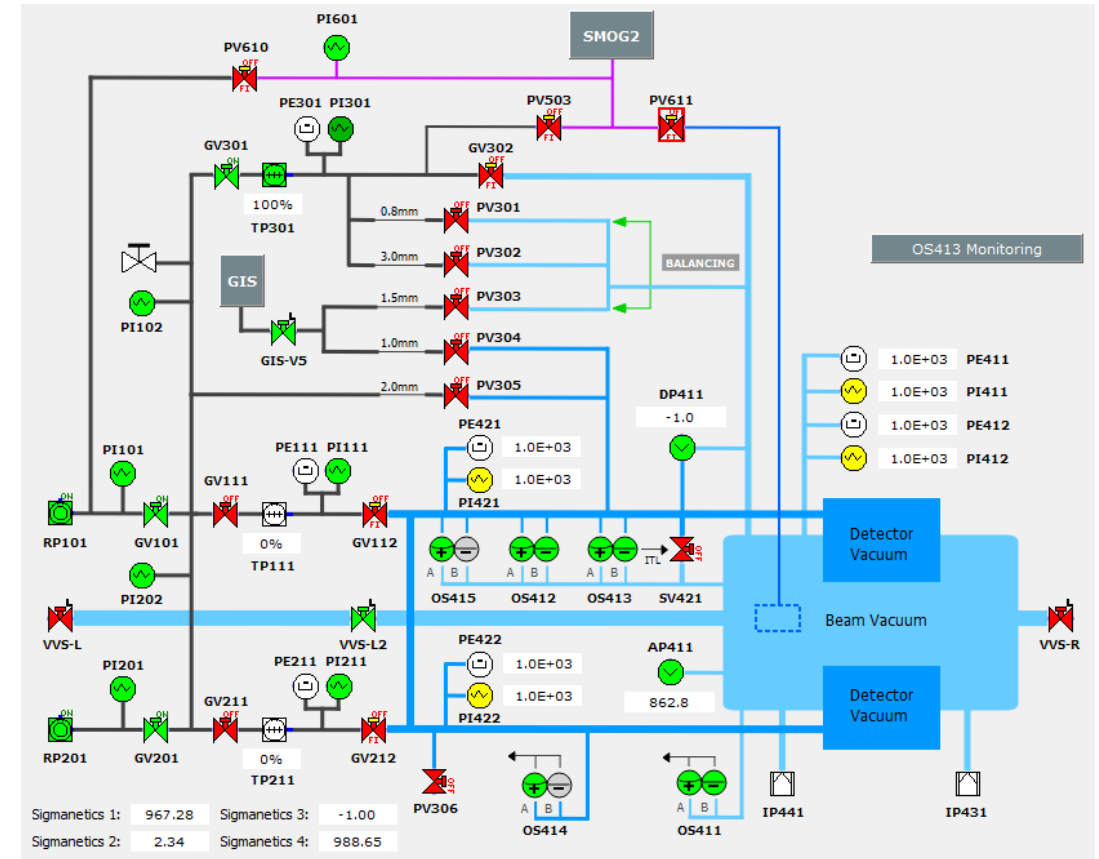
Balancing Mode and Safety System

In order to protect the integrity of the RF foil, the Control System is designed to keep the pressure differential between Beam and Detector volumes within strict limits (± 5 mbar) at all times.

While vented, VELO is set to **Balancing Mode**

- If Beam **Overpressure** > 2 mbar is detected, Beam Volume is **pumped** through PV301.
- If Beam **Underpressure** < 5 mbar is detected, ultrapure neon is **injected** in Beam Volume through PV303.

If the Balancing System fails or cannot cope, an independent **Overpressure Safety System** protects the foil:

- Electrical hardwired safety system, does not rely on PLC
- In case pressure differential reaches ± 10 mbar SV421 is open, putting the volumes in contact and equalizing pressure
- This protects the integrity of the foil but can introduce gas contaminants in the Beam pipe.
