Status and plans for the LHCb VeLo motion system re-validation

Victor Coco (CERN) for the VELO Group

Analysis of the LHCb VELO RF Foils Incident and First Actions

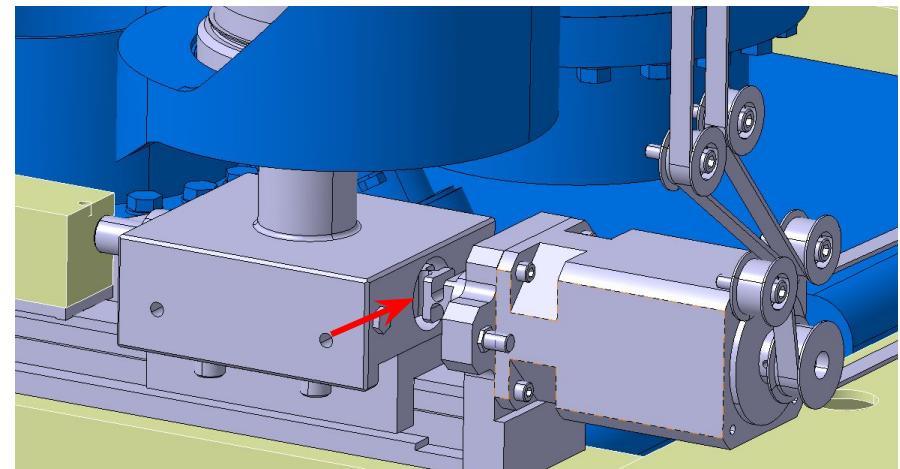
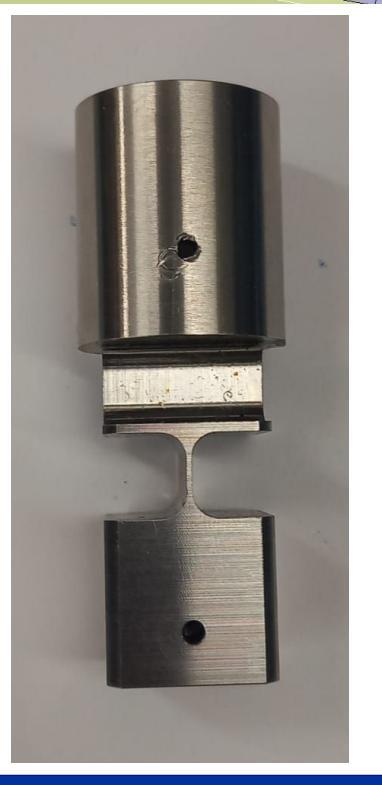
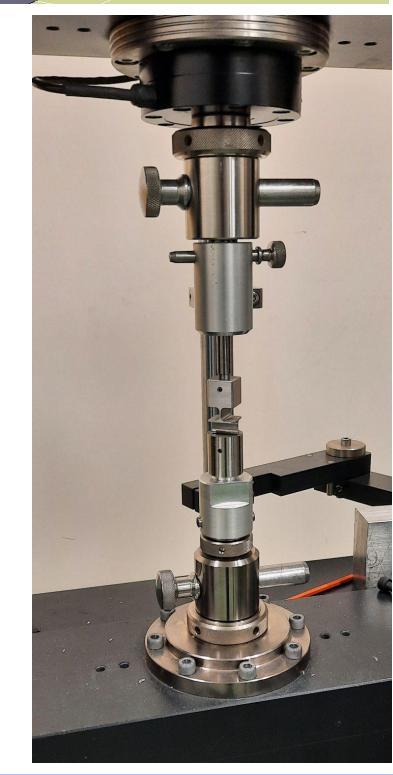
Test and investigation

• Good response of the system during test

- small movement between -26/28mm and -29.8/29.8mm
- \circ residual displacement of the top support by 1.25(0.9)mm on C(A)-side

• Hypothesis is deformation of the coupling piece

stress test on-going, significant elastic deformation and deformation by more than 1mm seen, data to be further analysed and quantified

• Re-qualification procedure to be defined

- inspection of coupling pieces need to be done with half closed
- only possible after tomography: with one foil open and one closed closest approach ~1-2mm ie risk of collision

⇒ HW and SW limits on the motion system for now

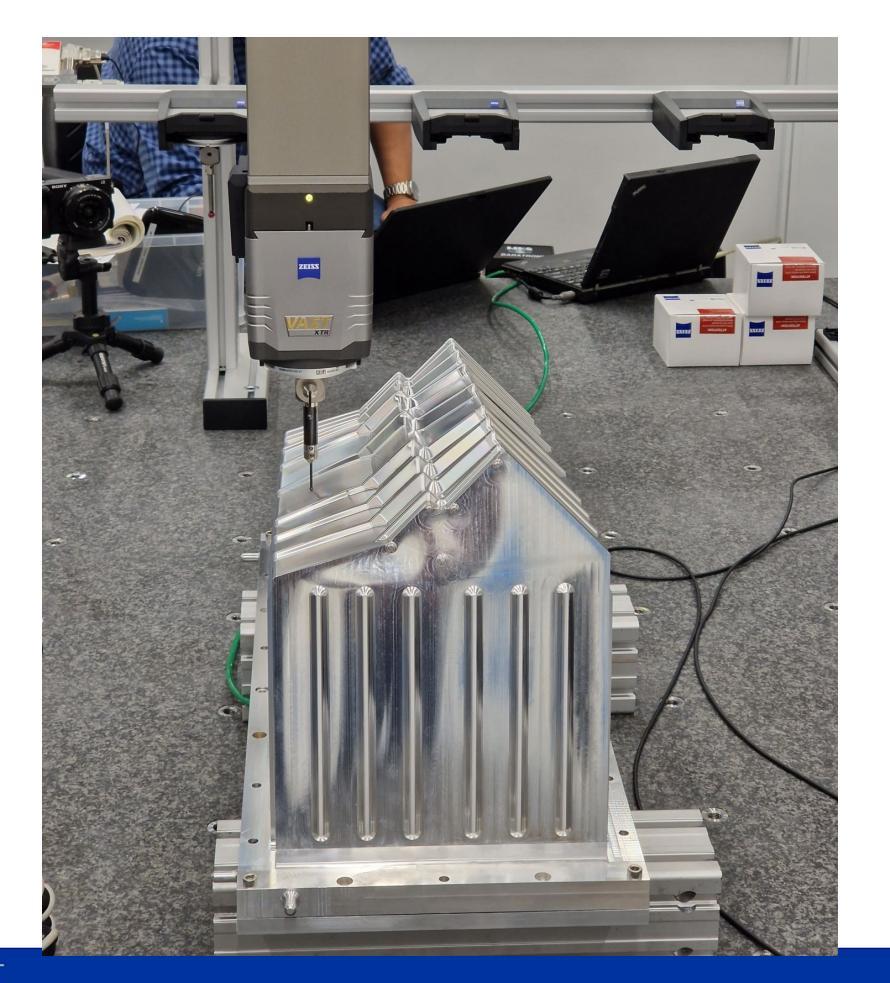
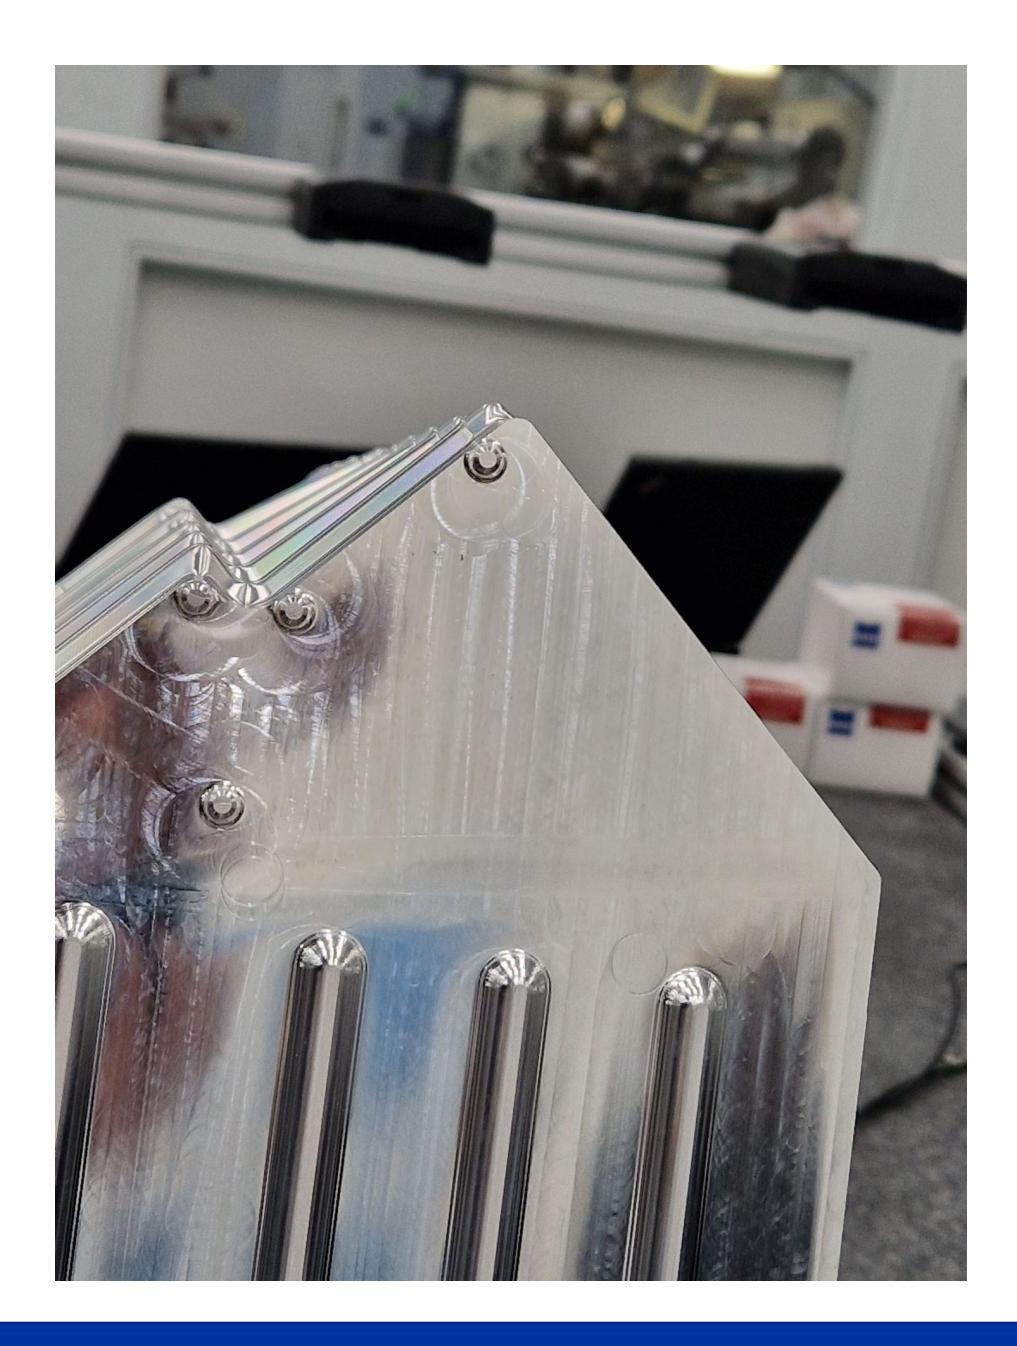
Measurements at Nikhef

- Half box, 500 μm thick with central thinned/etched part to 250 μm, torlon coated
- Pressure cycle: $0 \rightarrow 200$ mbar $\rightarrow 0 \rightarrow -11$ mbar $\rightarrow -25$ mbar
- Used to validate simulations

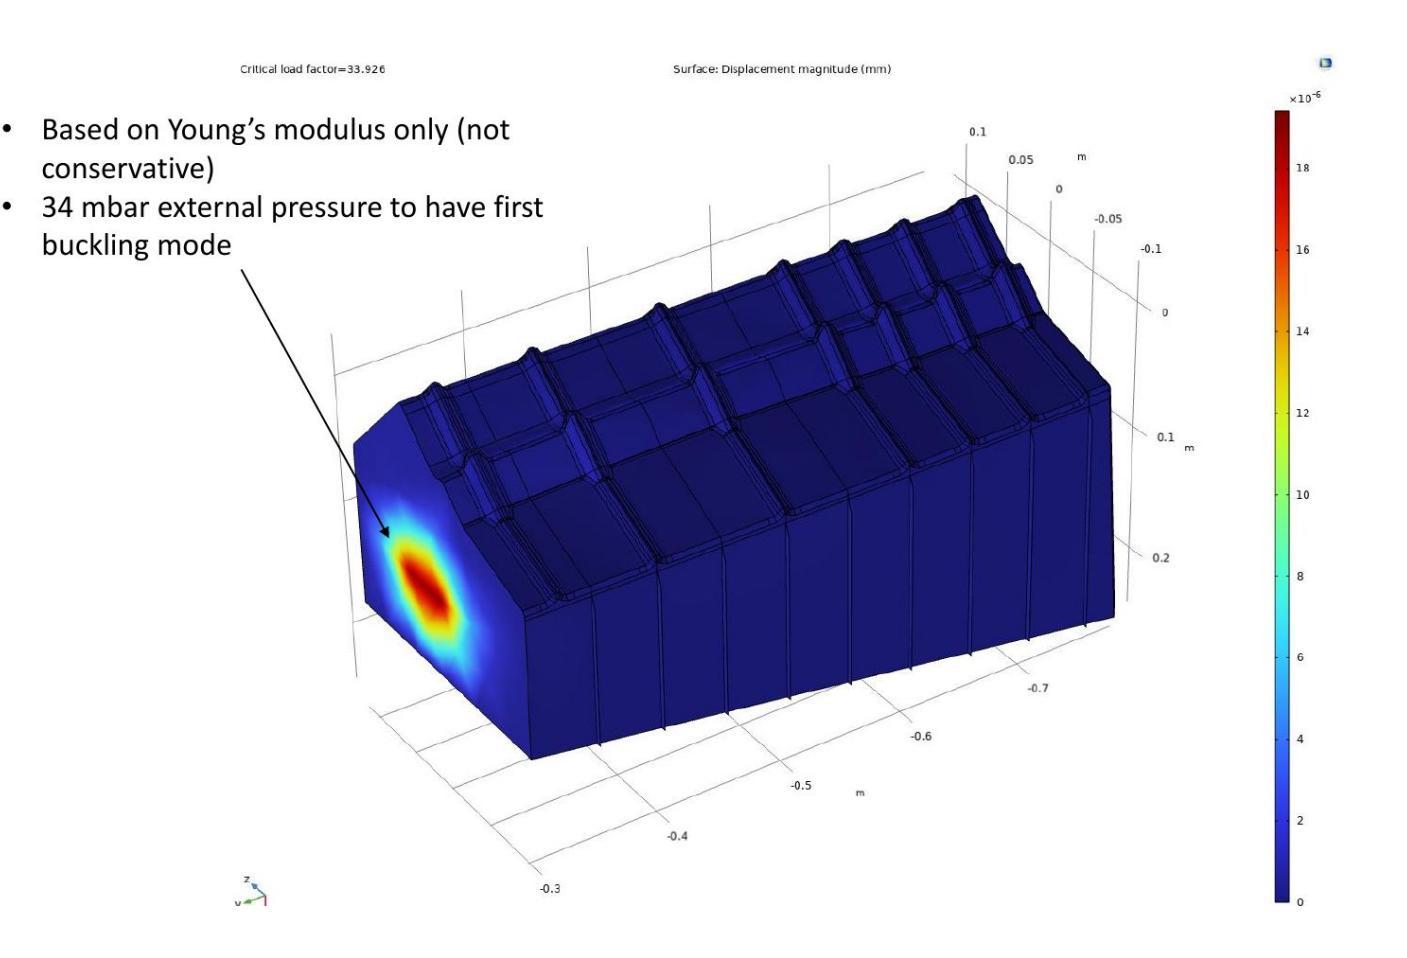
Half box buckling simulation linear buckling analysis

- Linear buckling analysis to see if sudden movement could happen when going in underpressure
- No buckling mode on the top side
- Bucking seen on the large flat side after 34mbar
 Linear buckling analysis thought to underestimate the effect
- At Nikhef went down to +25mbar, no "brutal" buckling, can feel with finger that pushing there deforms, but in an "elastic" way

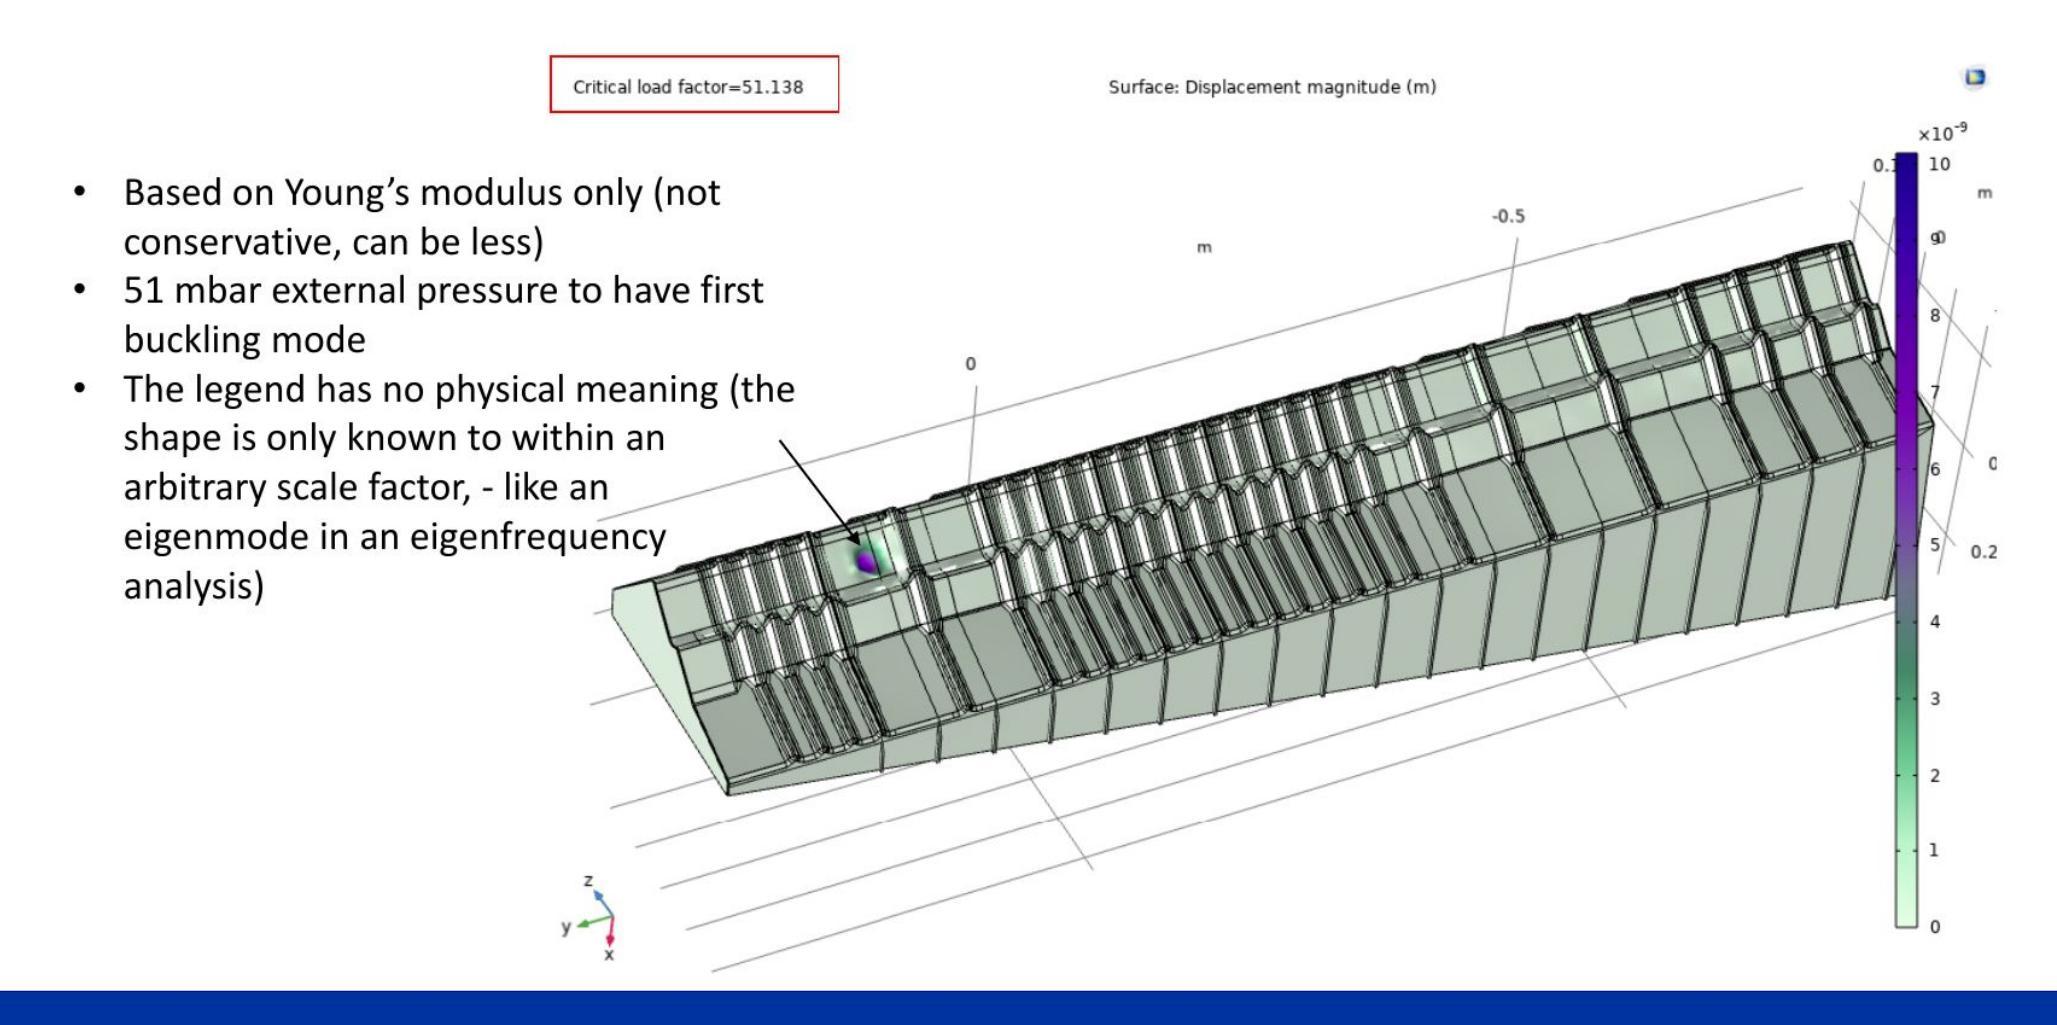
Full box simulation Linear buckling analysis

• Same linear buckling analysis show deformation possible on the flat part of the foil ie far from the modules

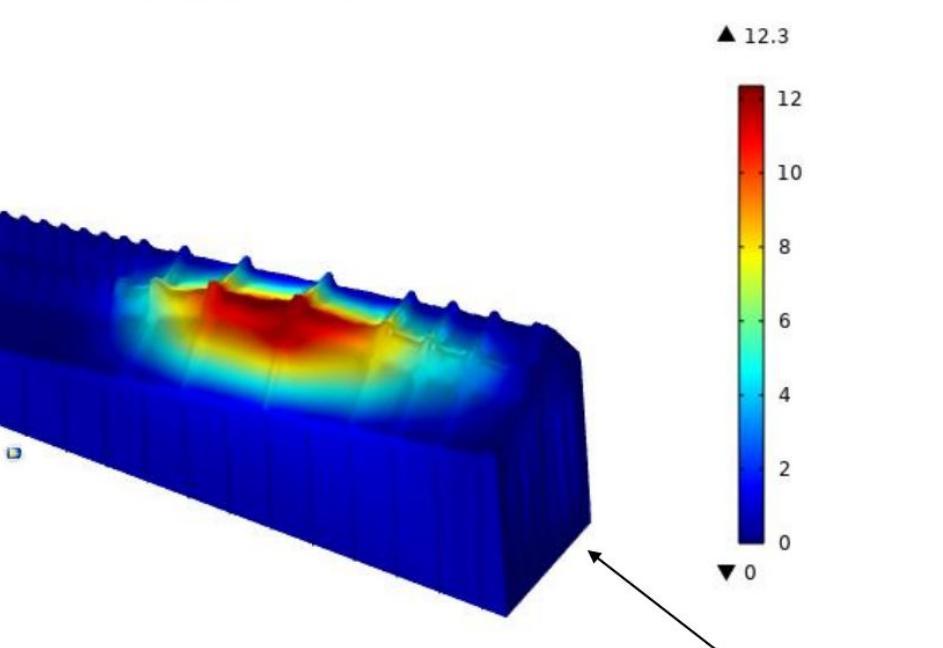
Non-linear buckling analysis

- Non-linear buckling analysis;
- Geometry updated every DP=10 mbar;
- Pressure from DP= -2 to -62 mbar;
- Elastic limit= 134 MPa;
- Young's modulus = 70 GPa;
- Isotropic tangent modulus = 1.5 GPa;
- No kinematic hardening considered;
- Dimensions: main body 0.5 mm, lateral ribs 2mm, beam envelope 0.18 mm
- Computational time ~ 17 h

global buckling

- Everything indicates it should be safe to go to +10mbar with the detector in BUT if there is a safe way to avoid it, until we either replace the foil or remove the detector it should be considered

- 3 possibilities:
 - go to +2mbar, remove the detector, finalise with +10mbar, put back the detector (not recommended unless we change the foil)
 - go to +2mbar, keep the detector in, operate without risking +10mbar until we change the foil

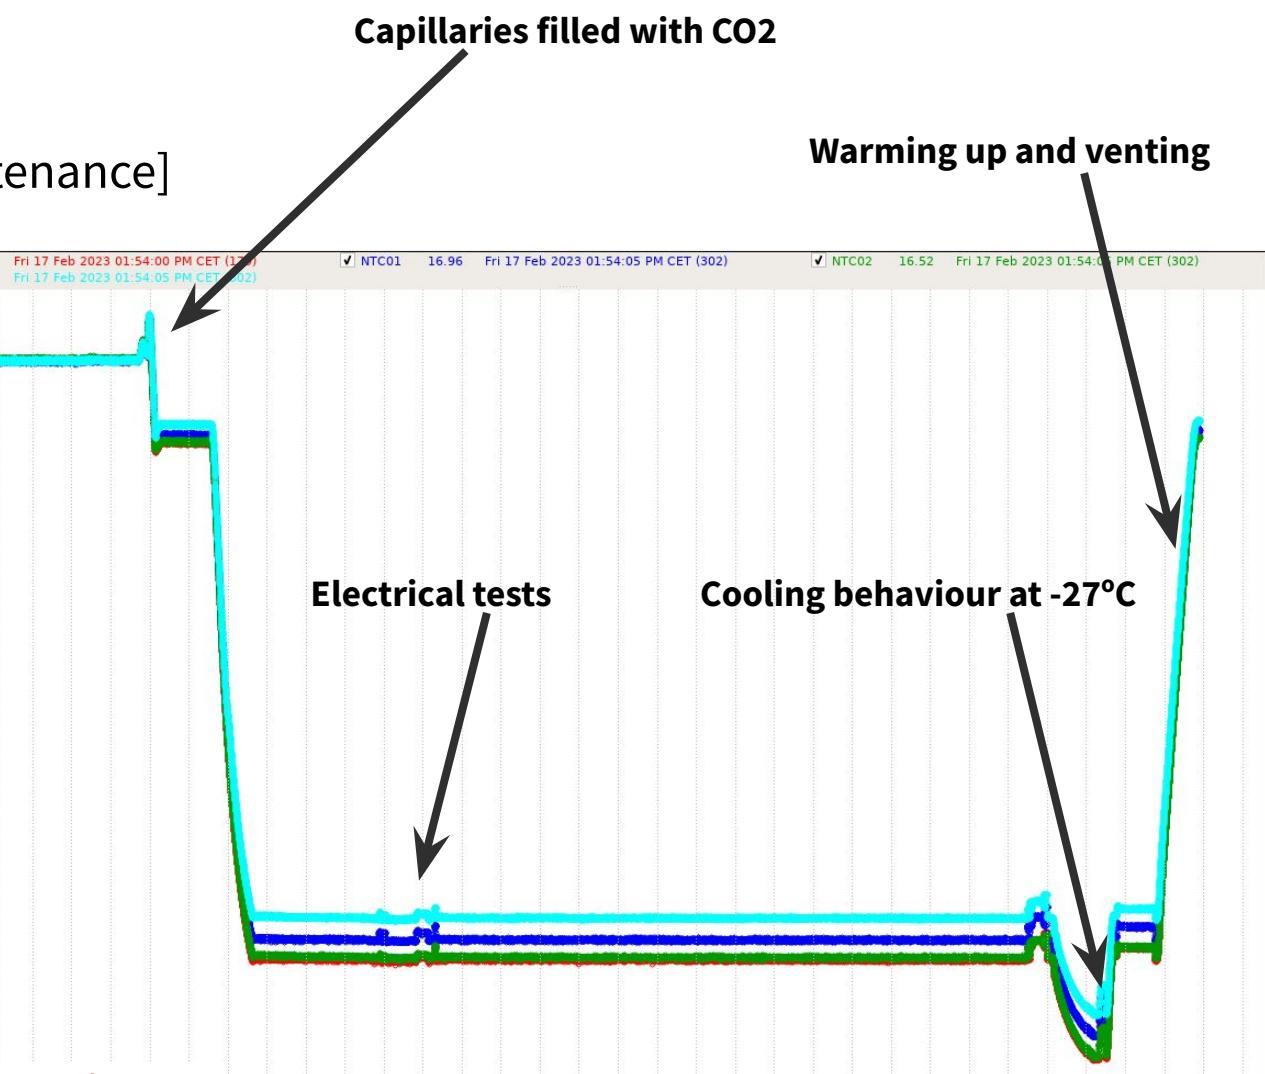
Phase 2 recovery 13/02-17/02 [VELO side]

- Module 35 tested down to -27°C
 - module was left OFF in 2022 as cooling performances were sub-optimal
 - restriction gasket changed on 10/02
 - \circ tested with full load \Rightarrow OK
- VELO electronics response tested:
 - configured the detector, ie tested LV, and slow control path as well as basic VELOpix functionalities
 - PRBS generation to test DAQ links
 - Detector OK [full analysis to come]
- High voltage:
 - More voltage points taken [20,50,140-200V]
 - No misbehaving sensors, full annealing analysis to follow

⇒ Cooling, sensors and electronics (ECS/DAQ) operational
