PSB Quadrupole

A. Newborough, M. Karppinen

PSB Main Quadrupole Magnets

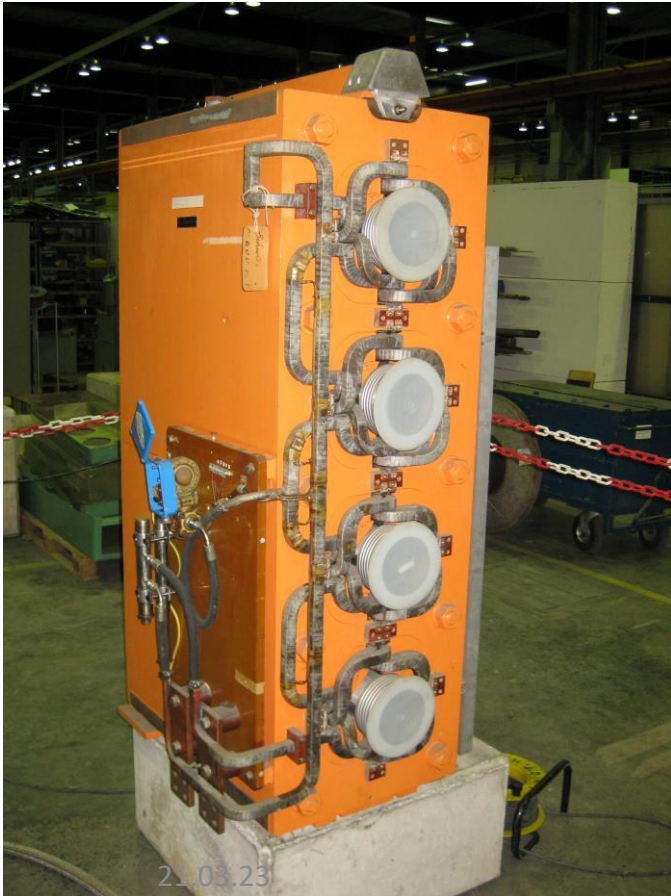
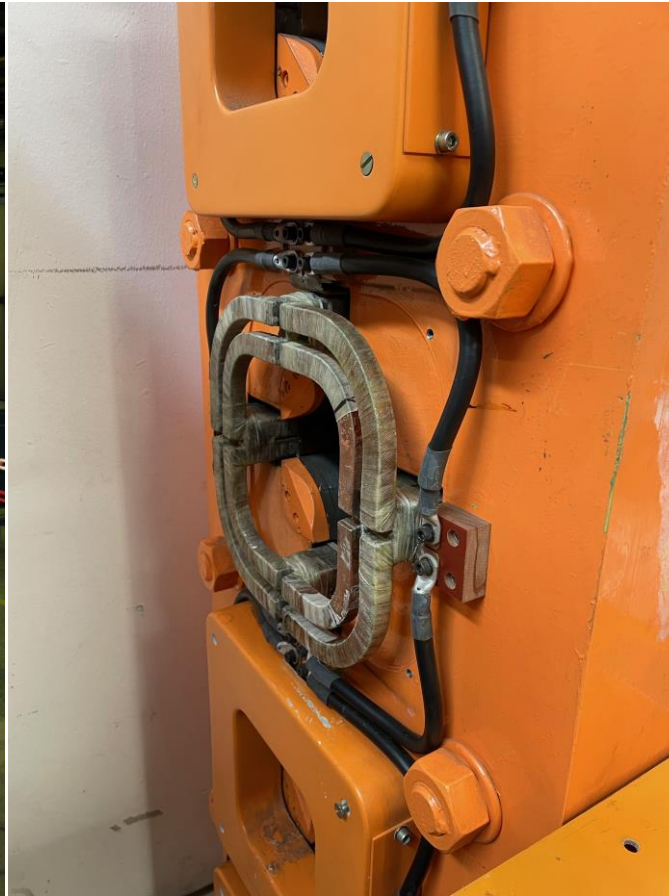
A Unique Construction!

- Single lamination (no split planes)
- Coil built-up turn by turn (~80 brazed joints/magnet)
- Mica/glass fiber insulation tape with the whole magnet resin impregnated (true VPI method based on autoclave, not available at CERN)
- Reliable operation over nearly 50 years

NO LEAKS UNTIL 2021, FIVE OCCURRED SINCE THEN!

Preliminary inspections indicate corrosion near brazed connections, presumably accelerated by the presence of Sulphur.

Corrective actions and renovation/new production under investigation by the mandated Task Force.
