PS Booster magnets Task Force

Today's understanding of the failure modes

Meeting 1 – 21.03.2023 – Subtask-2: Analysis and understanding of the failure modes

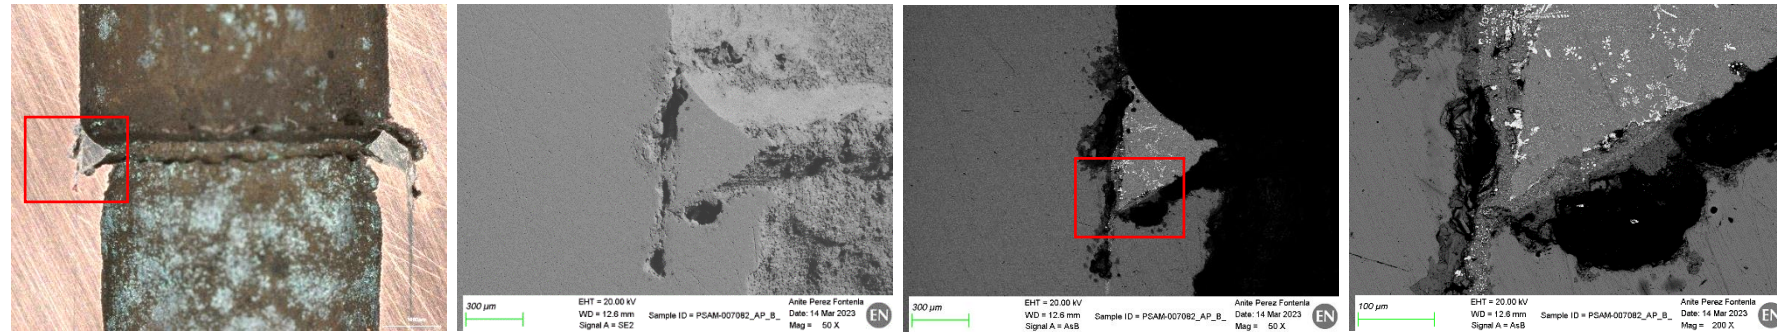
- The state of various non-leaking brazed joints from the PSB cooling circuit were investigated via NDT and microscopic means;

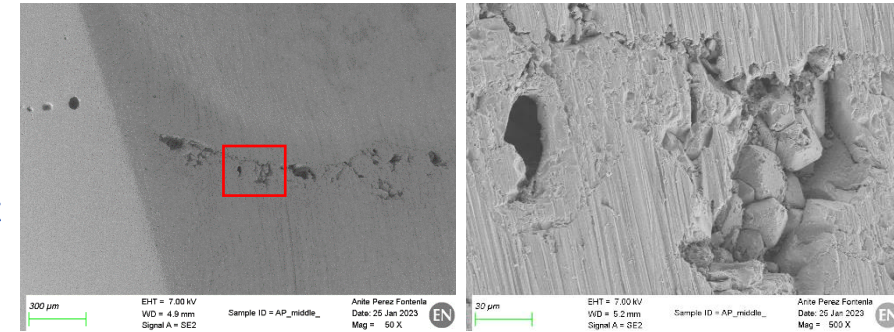
- Corrosion selectively attacks Cu at the interface with the braze and the Cu within the braze metal;
- As corrosion progresses, the Cu grain structure is revealed and in some sites a large gap is formed;
- Phenomena practically not visible associated to Cu-Ag braze alloy used to join the Cu with StSt;
- Evidence of “S” within the corrosion products is confirmed in higher or lower (traces) amount depending on service time. The origin of the “S” contamination is unclear for the moment;

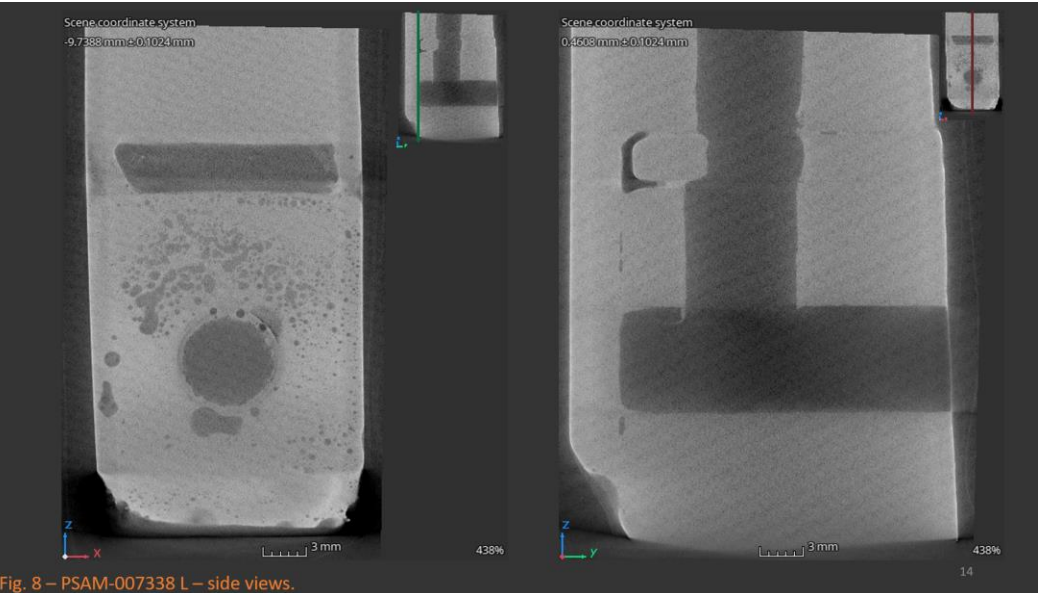
Additional samples (tests ongoing)

- Three additional non-leaking samples from main quadrupole already inspected by CT;
- Cutting and microscopic inspection will follow with identical procedure to gain understanding of the corrosion mechanism and have more statistics about the joints state

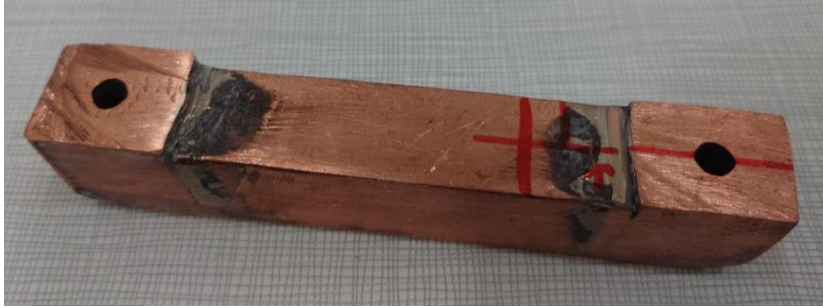
Sample #1

1. NDT (voxel size= 21 μm)
 - Brazing interfaces present numerous cavities and discontinuities
 - Radially aligned features are clearly visible
2. Chemical analysis:
 - Cu-Ag-P braze metal is confirmed and Cd traces (?) were detected punctually
 - S is univocally present locally on the corrosion products (up to 5.5 wt. %)
3. Microscopic examination:
 - The bulk Cu is attacked and large gaps are visible at the vicinity of the brazing alloy
 - The oxidation of the Cu phase within the braze material varies depending on the area
 - It is likely that the Cu has been selectively corroded due to galvanic corrosion phenomena

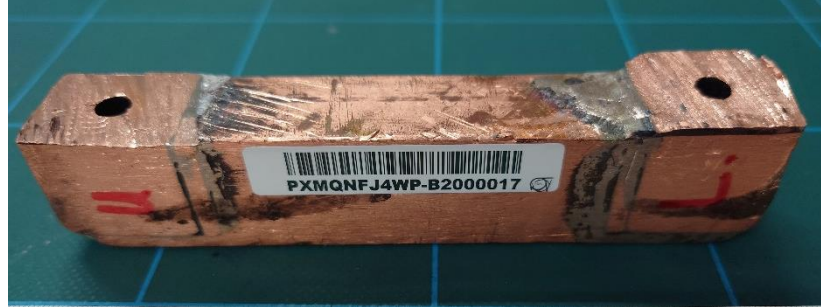
Sample #2

1. NDT (voxel size= 21 μm):
 - Brazing interfaces present numerous cavities and discontinuities
 - Radially aligned features are slightly visible
2. Chemical analysis:
 - Traces of “S” well below 1 wt. % \rightarrow much lower than samples that have been in service for longer periods
3. Microscopic examination:
 - Same type of corrosion phenomena
 - Lower progression

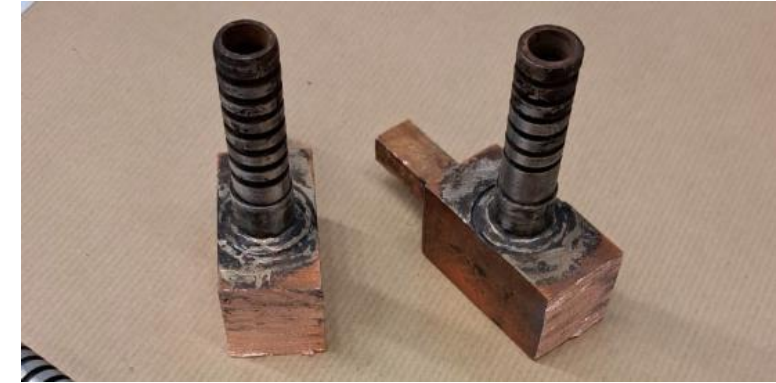
Sample #3

1. NDT (voxel size= 40 μm):
 - Brazing interfaces present numerous cavities and discontinuities
2. Chemical analysis:
 - "S" (up to 5.5 wt. %)
3. Microscopic examination:
 - Same corrosion phenomena
 - Cu-Cu joints (Cu-Ag-P brazing) highly affected
 - Cu-StSt joint (Cu-Ag brazing) less affected
