SPS WS wire
breakage

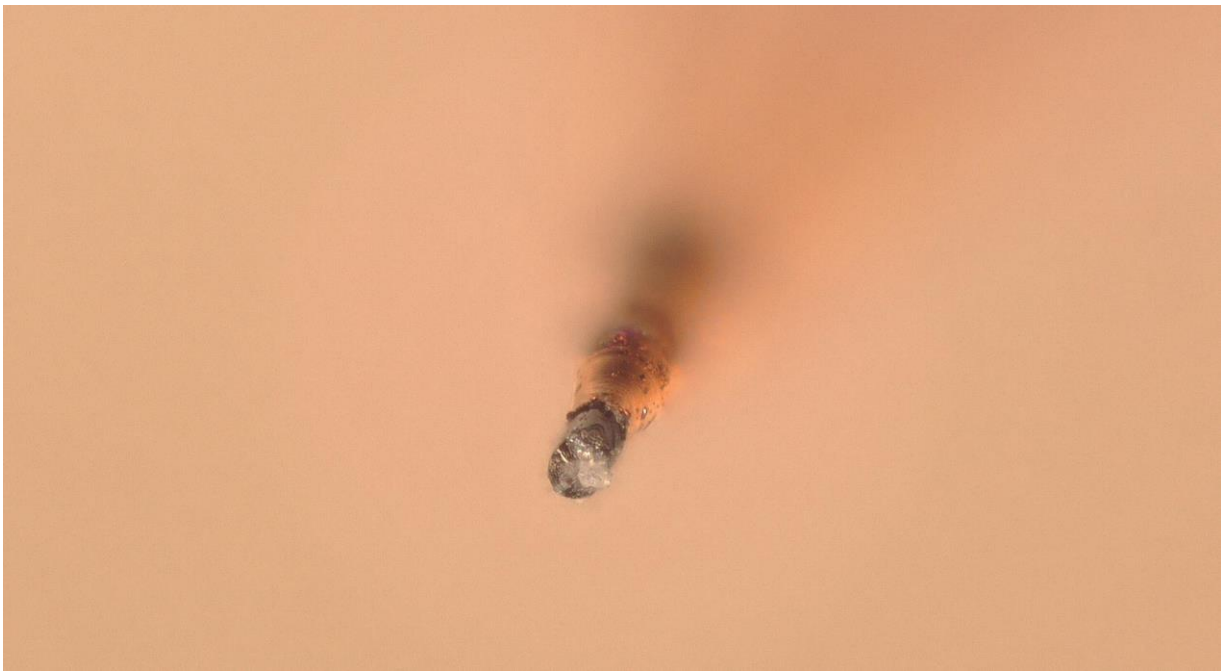
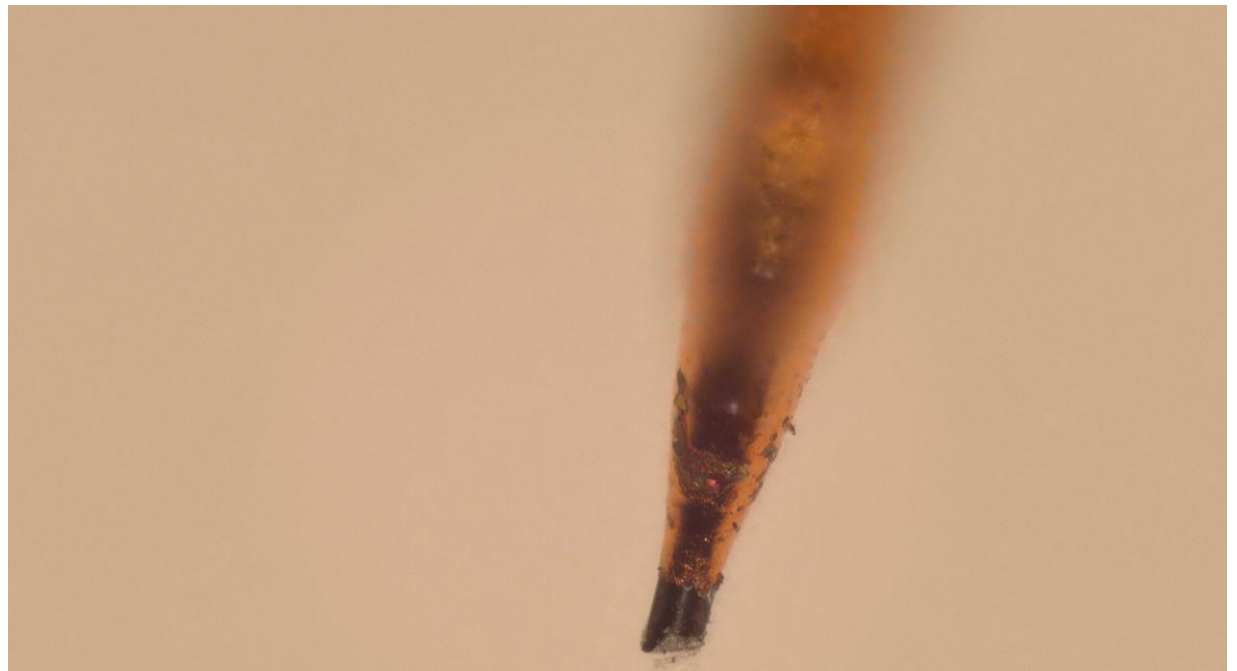
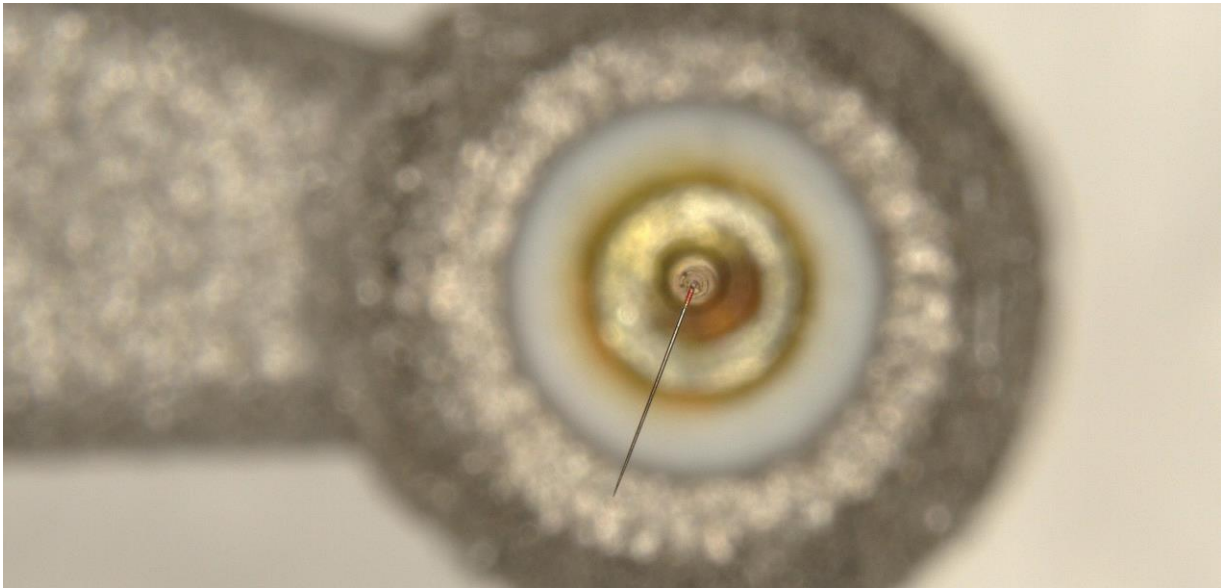
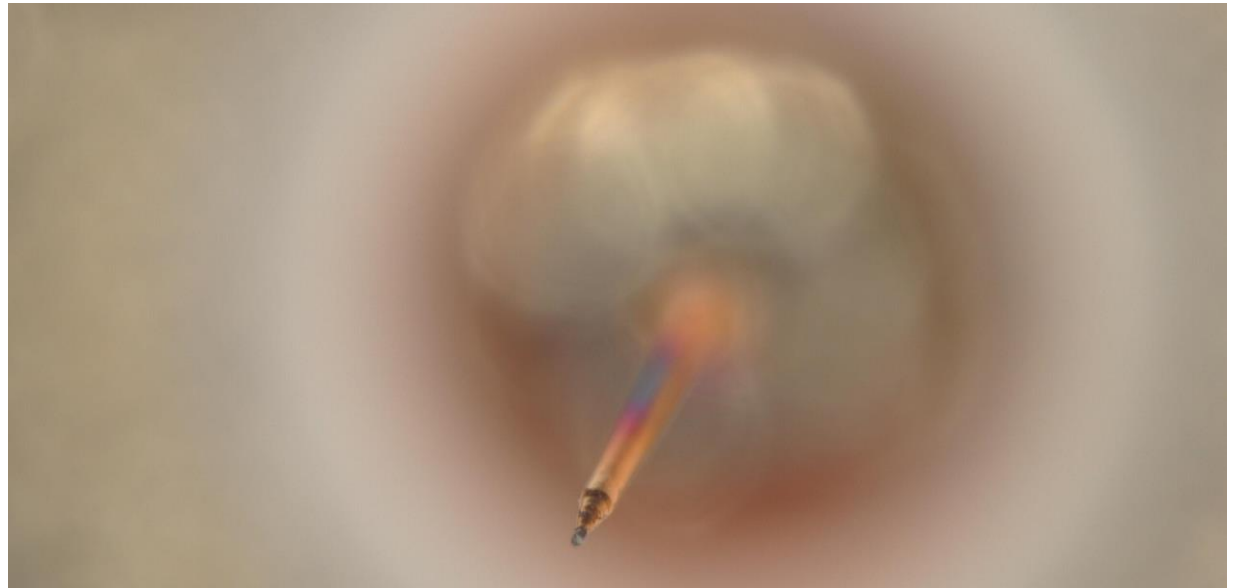
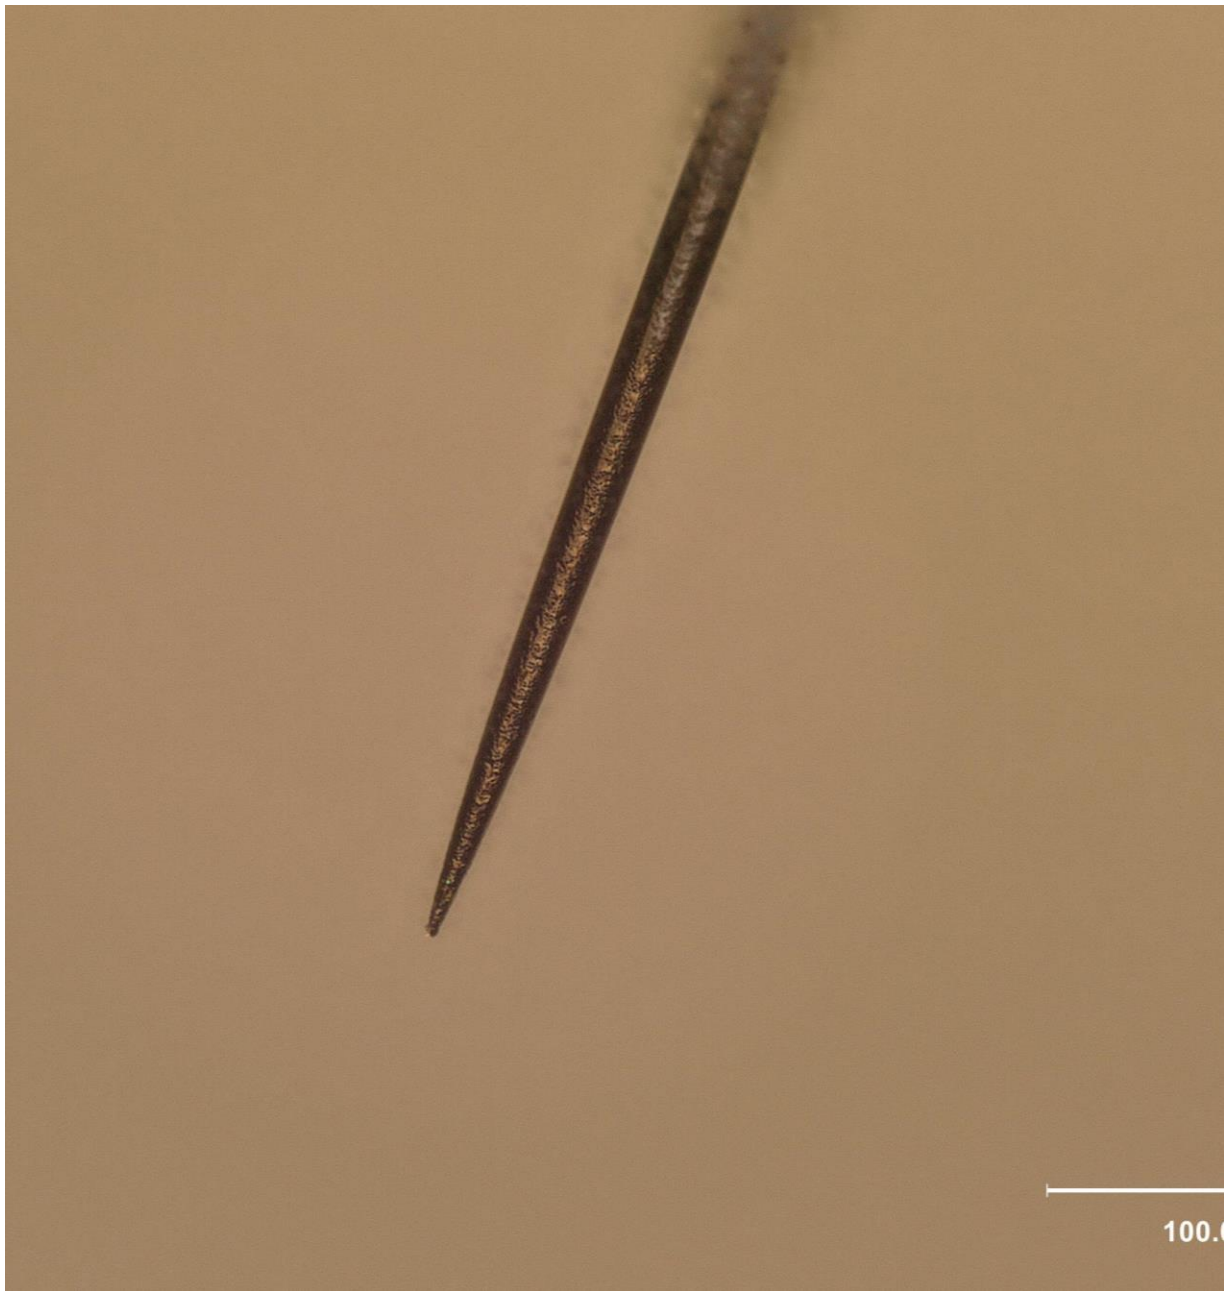
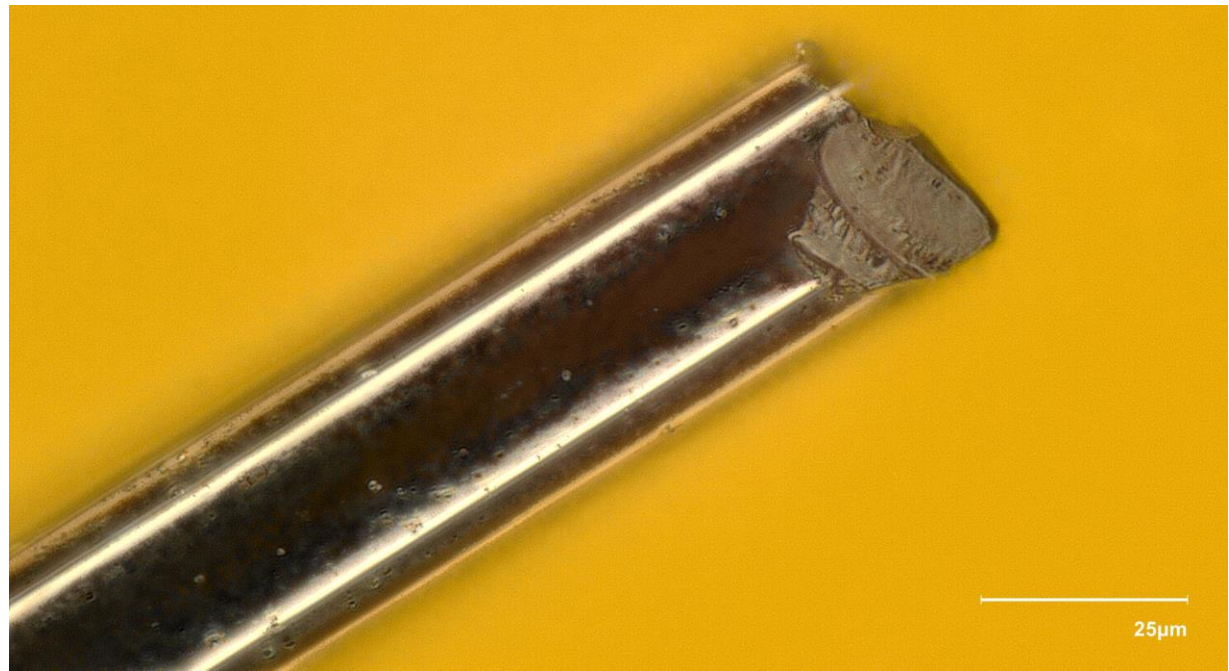
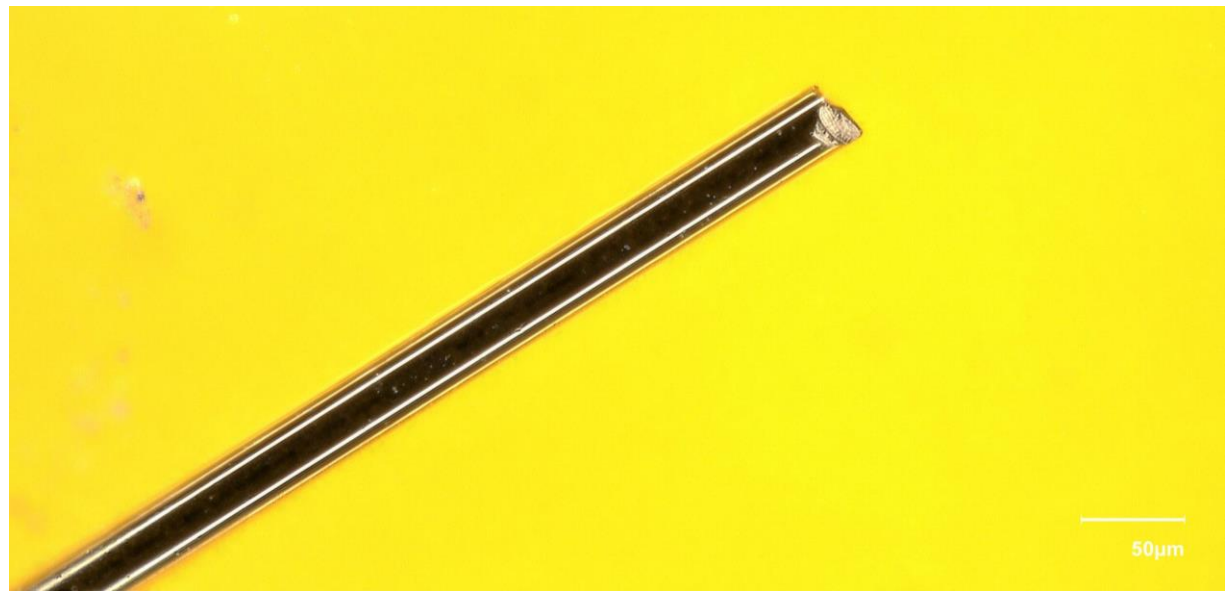
- First results from C wire imagery
- The C wire is present on all four forks
- Sharp fracture breakage presents in most of the sample, in one case a necking is visible
- More results in the coming days
