How to upgrade a pixel detector

lessons from Phase-1 being applied to Phase-2 CMS Pixel Upgrade

Rachel Bartek

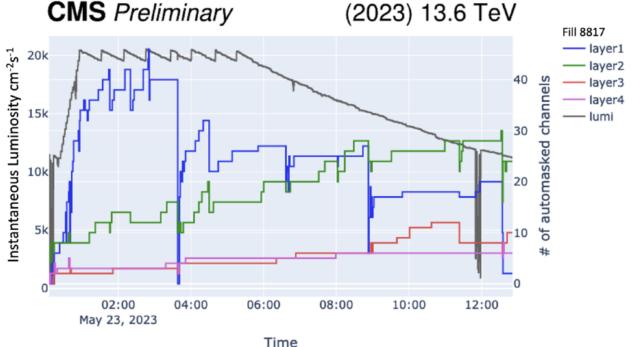
Stability is hard to come by

Soft Error Recovery refreshes configuration

Recoverys port cards and front end chips

Experiences Soft Error Recovery "storms" PU > 60

Adjust 400 MHz and 160 MHz TBM phases

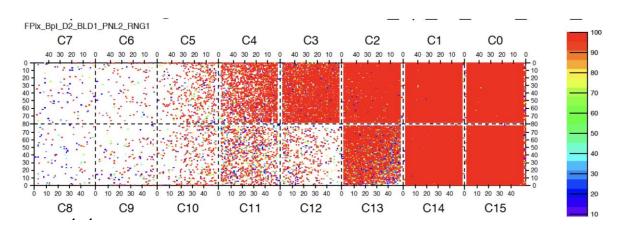
DC-DC converter saga (4 of 4)

- All DC-DC converters replaced during LS2 with new chip
- Some modules permanently damaged
 - HV on LV off was not a considered running configuration
- Fixed the TBM problem. The new layer 1 installed during LS2 does not have the stuck TBM problem
- No TBM for phase 2
