MQXFA Mechanical Assembly and Preload

Daniel Cheng, For the MQXFA team 28-Sep-23

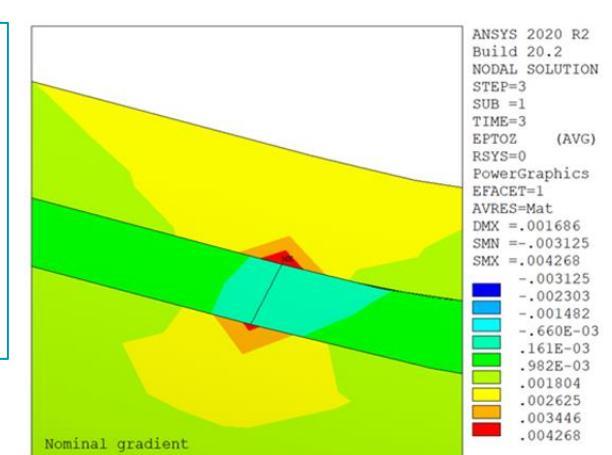
Closed pole key gap in a coil may lead to poor longitudinal preload in the ends of that coil at edge to end-spacer transition

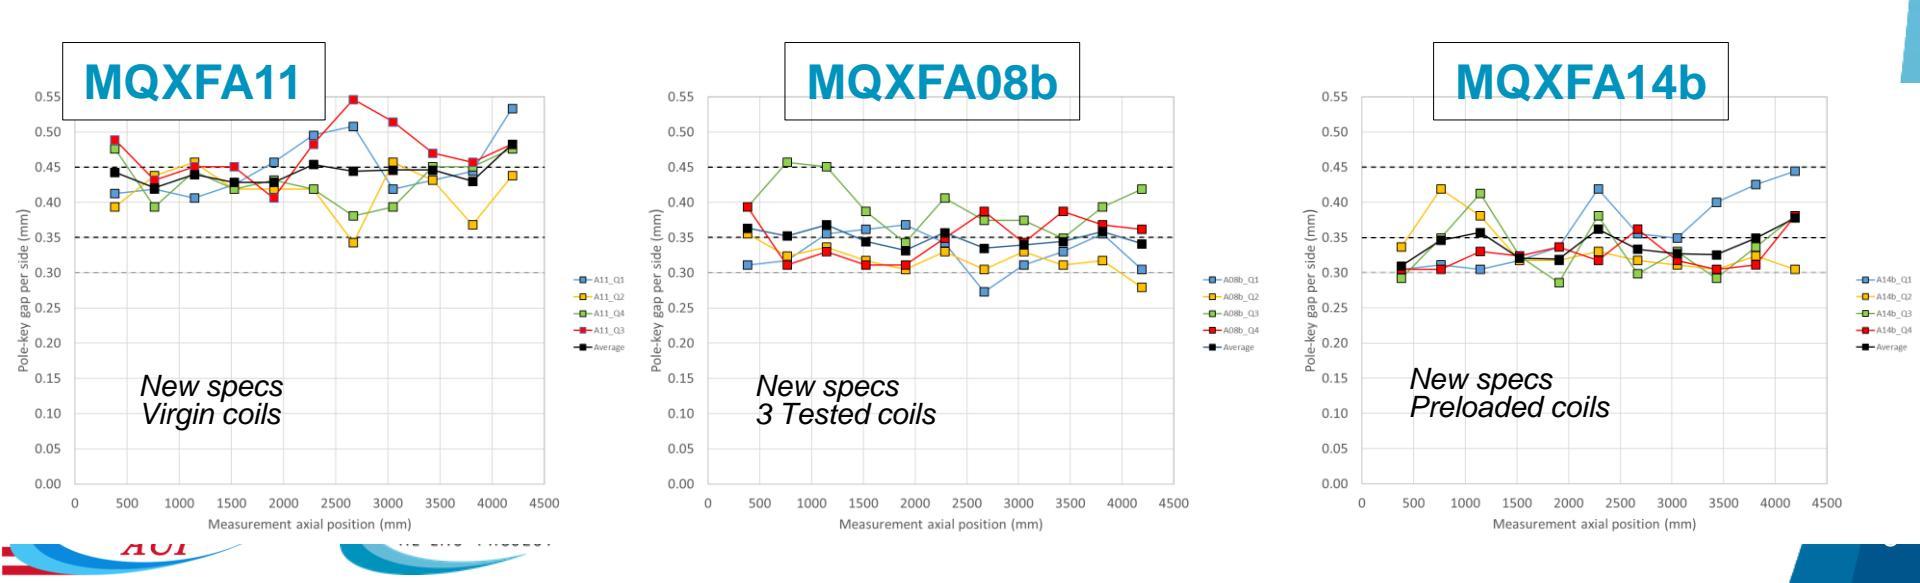
Updated Specification wording in Doc DB 4009 for the pole key gap:

- The average pole key gap (per side) among the four coils on each longitudinal location shall be +0.400 ±0.050 mm.
- The minimum pole key gap (per side) in any quadrant and in any longitudinal location shall be > +0.300 mm.

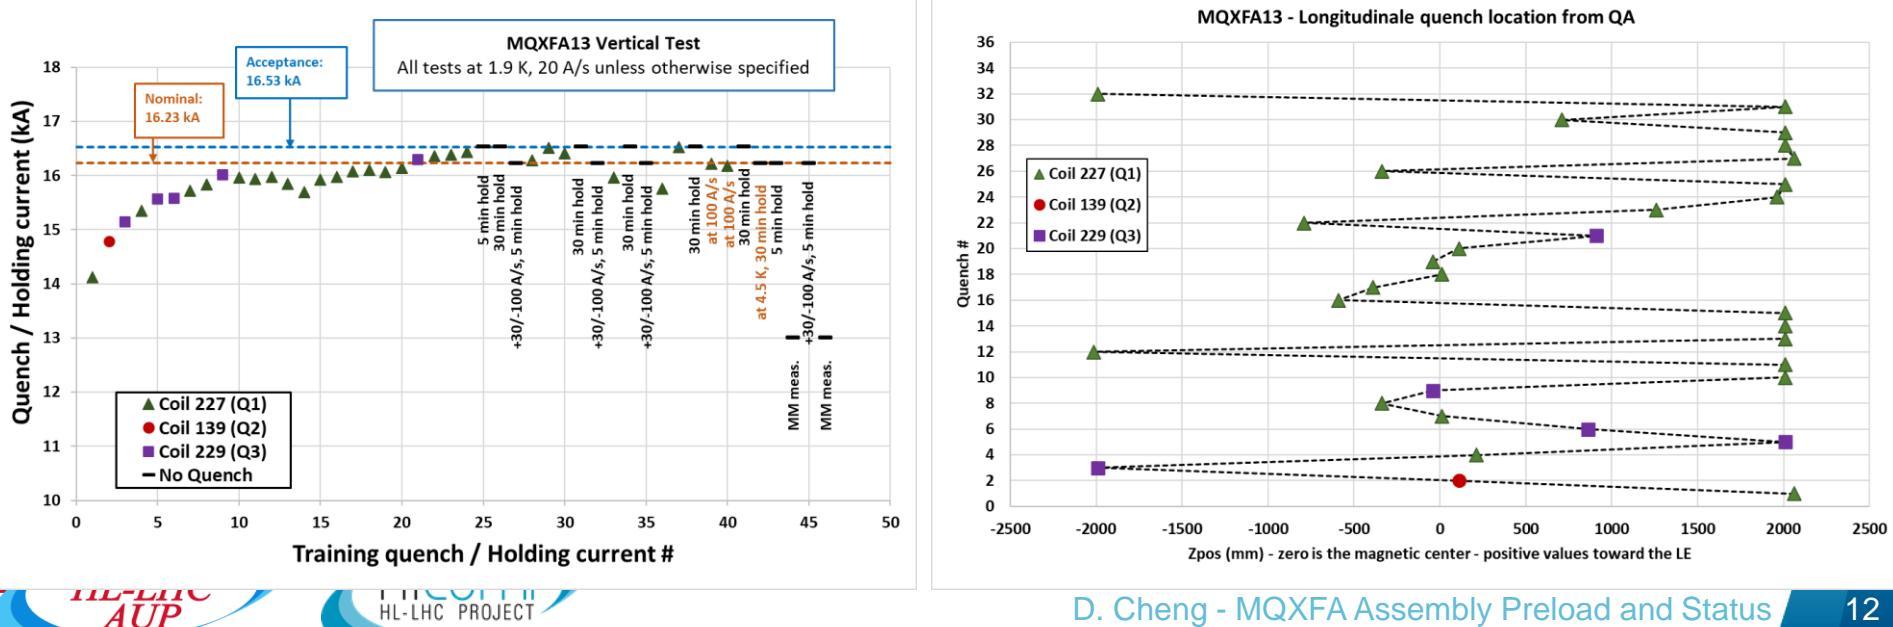
- **MQXFA13** investigation
 - Quenches occurred at same location as in MQXFA07/08
- Main suspect: Small arc-length in the ends of all coils caused low pre-load and high strain in the ends.
 - Limiting coil had smallest arc-length of all tested coils
- Preventive actions:
 - Increased the maximum allowable stress during preload: from 110 to 120 MPa
 - Target for minimum loading key size based on coil dimensions

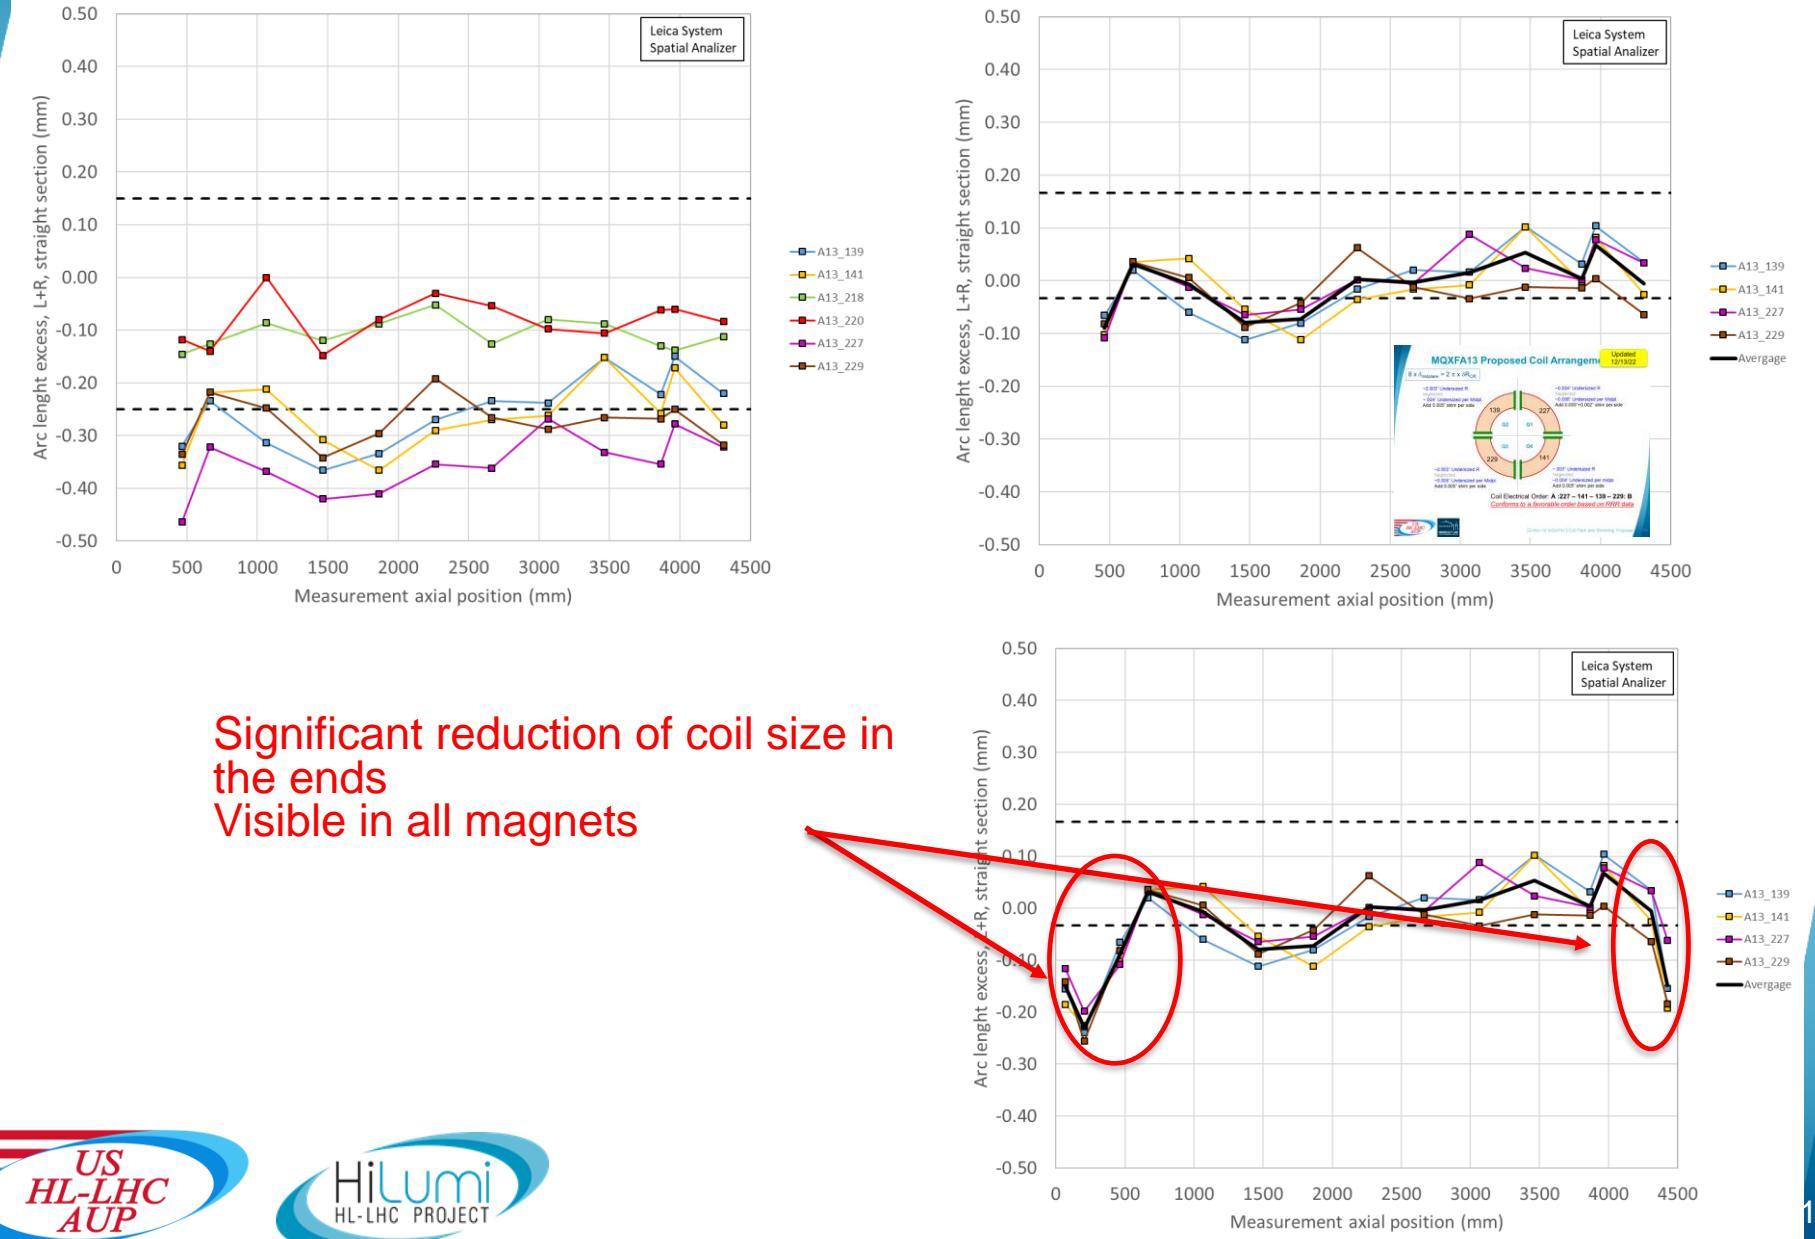
A13 coil size (unshimmed and shimmed)

In A13, small coils and small loading shim

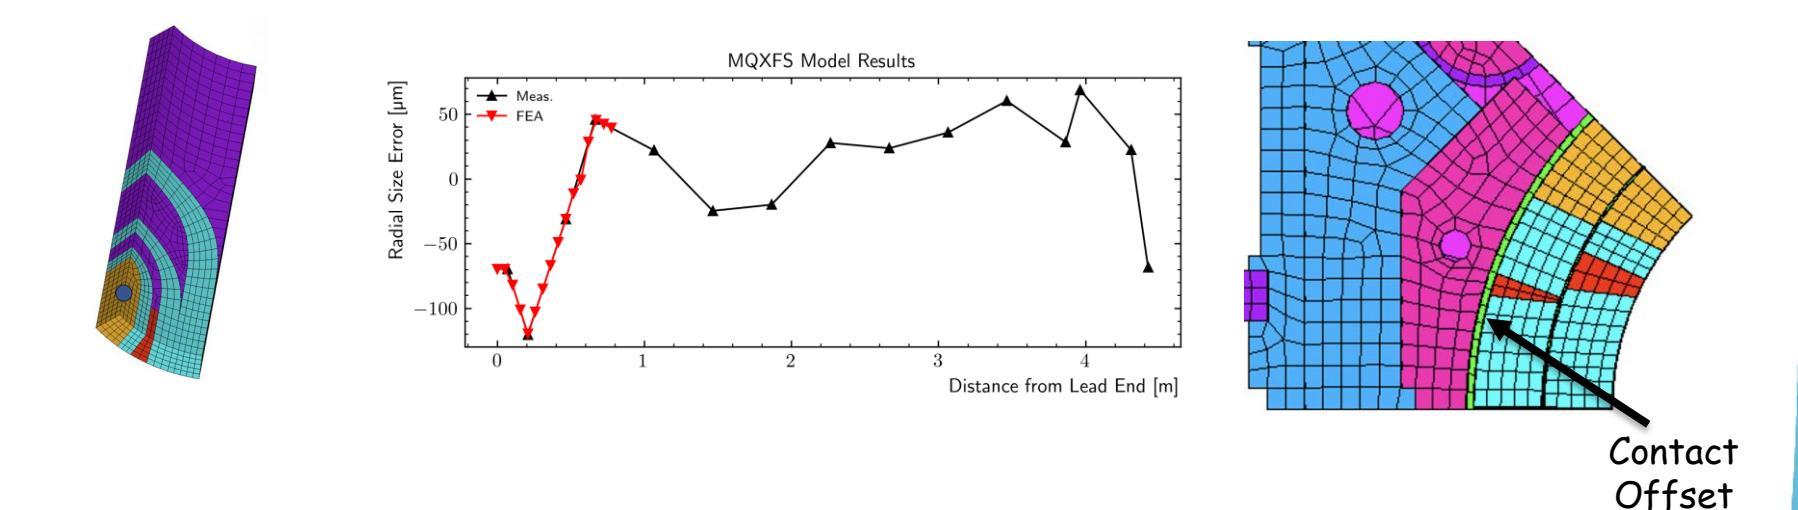
Finite element model assumption

- Study of the impact of the coil pack size on the coil strain
 - in particular in the 'wedge/end-spacer transition' region

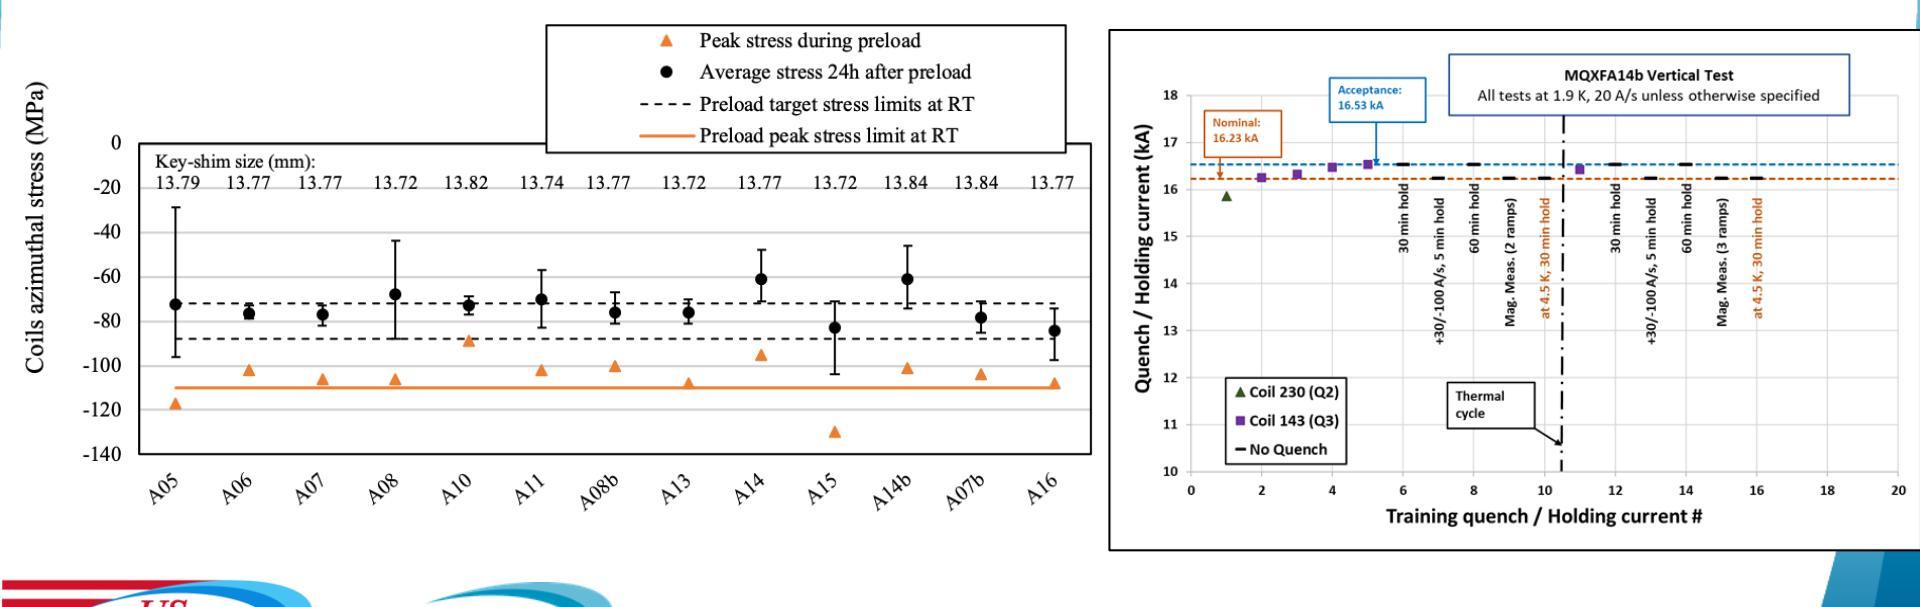
- Magnets MQXFA14b and MQXFA16 have been preloaded with this criteria
- MQXFA15 will actually have its preload increased before testing
 - Will be shipped back from BNL in October 2023

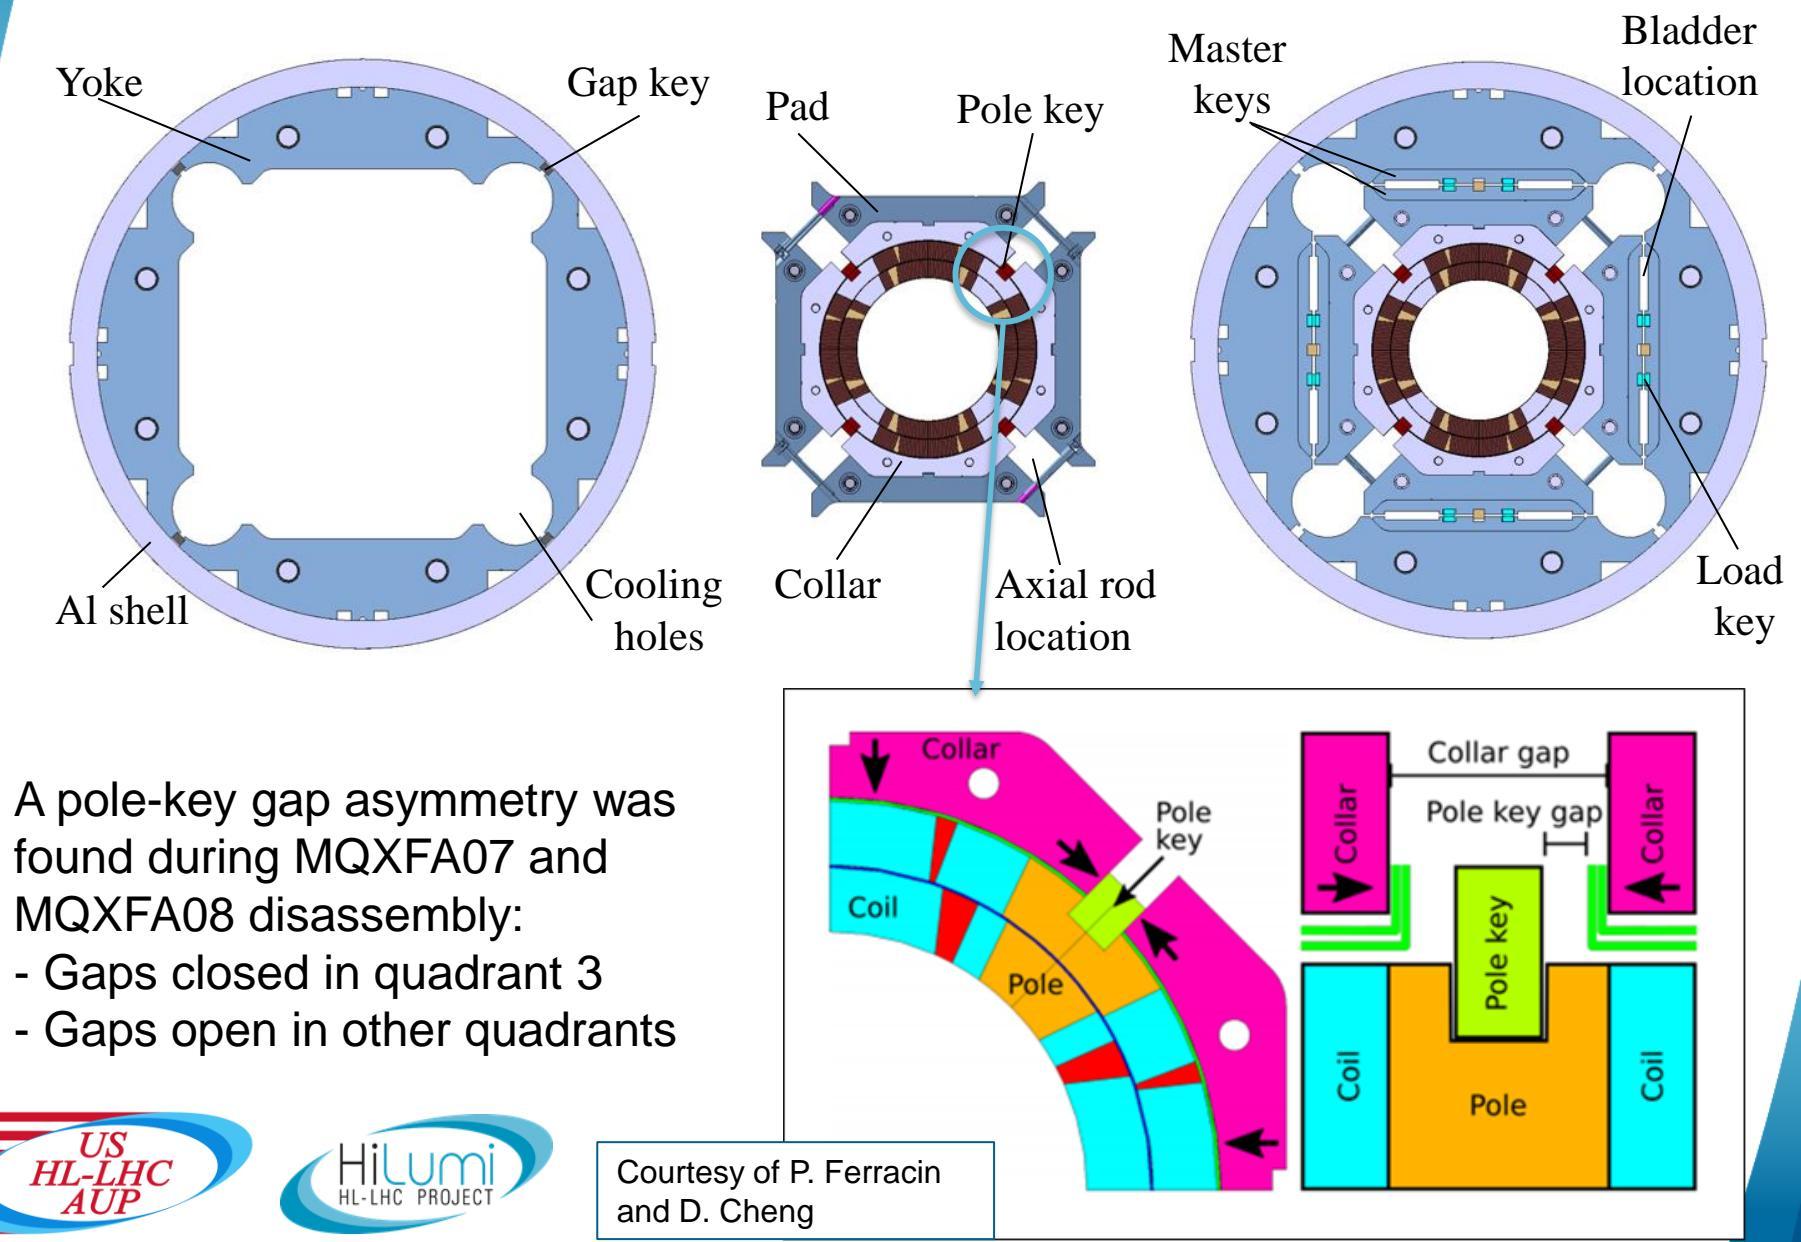
Structure Analysis & MQXFA07 Disassembly

- The measured pole-key gaps were not as uniform in MQXFA07 and MQXFA08 as in past magnets; this is particularly apparent on the limiting coils (Q3 for both magnets)
- Only the total average (on the 4 keys) was targeted in the specification. The underlying assumption was that the gaps would be redistributed across coils during loading.
- Investigation of the effect of this non-uniformity on the mechanical performances with 2D and 3D FE models
 - 2D effect: preload variation within acceptable range

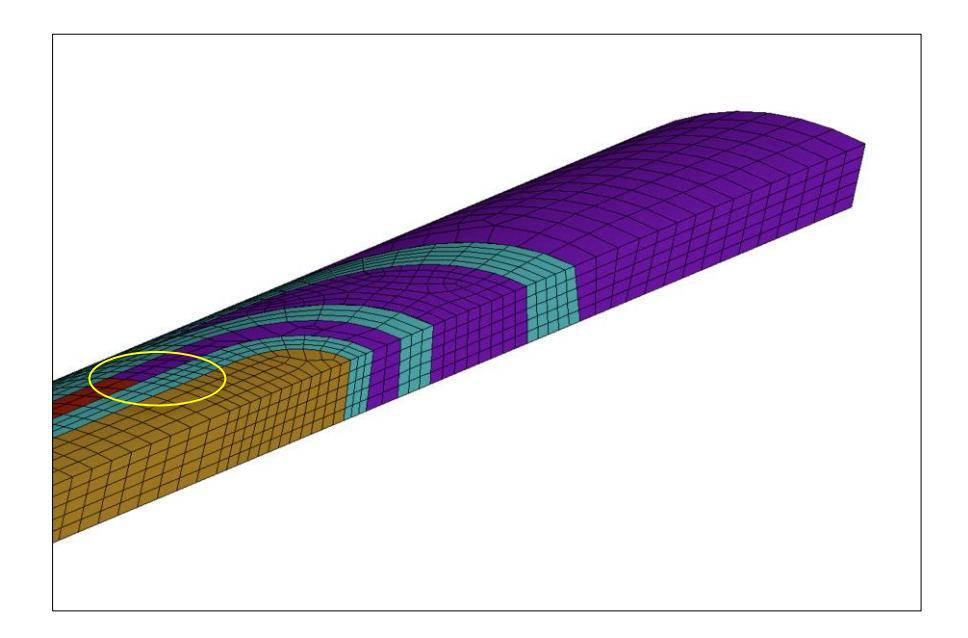
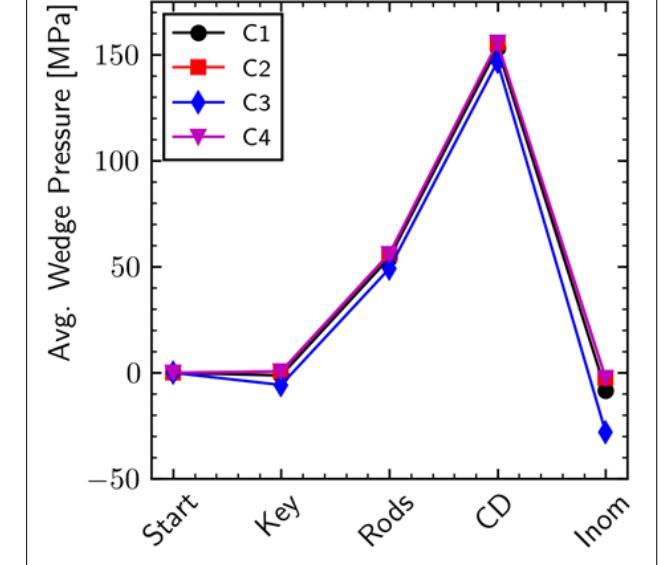
- "a3a4 LE area"
 - Contact between wedge and end spacer in L1
 - Considering bonded conditions
 - Tension occurs in Q3 during excitation
