J.Zhang^{*,1}, P.Arnold¹, J. Fydrych¹, P.Nilsson¹, M. Chorowski², J. Polinski²¹ European Spallation Source (ESS) ERIC, Partikelgatan 2, Lund, Sweden² Wroclaw University of Science and Technology, Wybrzeze, Wyspianskiego 27, 50-370 Wroclaw, Poland

Abstract: The European Spallation Source (ESS) is a neutron-scattering facility which will use a pulsed 2.0 GeV proton beam generated in the linear accelerator (LINAC) for releasing high-energy neutrons in the ESS target station. The 2K superconducting linac comprises 13 spoke and 30 elliptical cryomodules. The cryogenic distribution system (CDS) connects the cryogenic plant with the 43 cryomodules through a 400 meters long cryogenic multi-transfer, 43 valve boxes and an endbox.

The CDS consists of 373 control valves in total. There are 8 and 10 control valves in each elliptical and spoke valve boxes, respectively, and 3 valves in the end box. The control valves are used for regulating or blocking the process helium flows. The seat tightness of the CDS valves is crucial especially for warming up individual cryomodules, which is required for potential short-term maintenance or repair activities in the cryomodule while keeping the others i

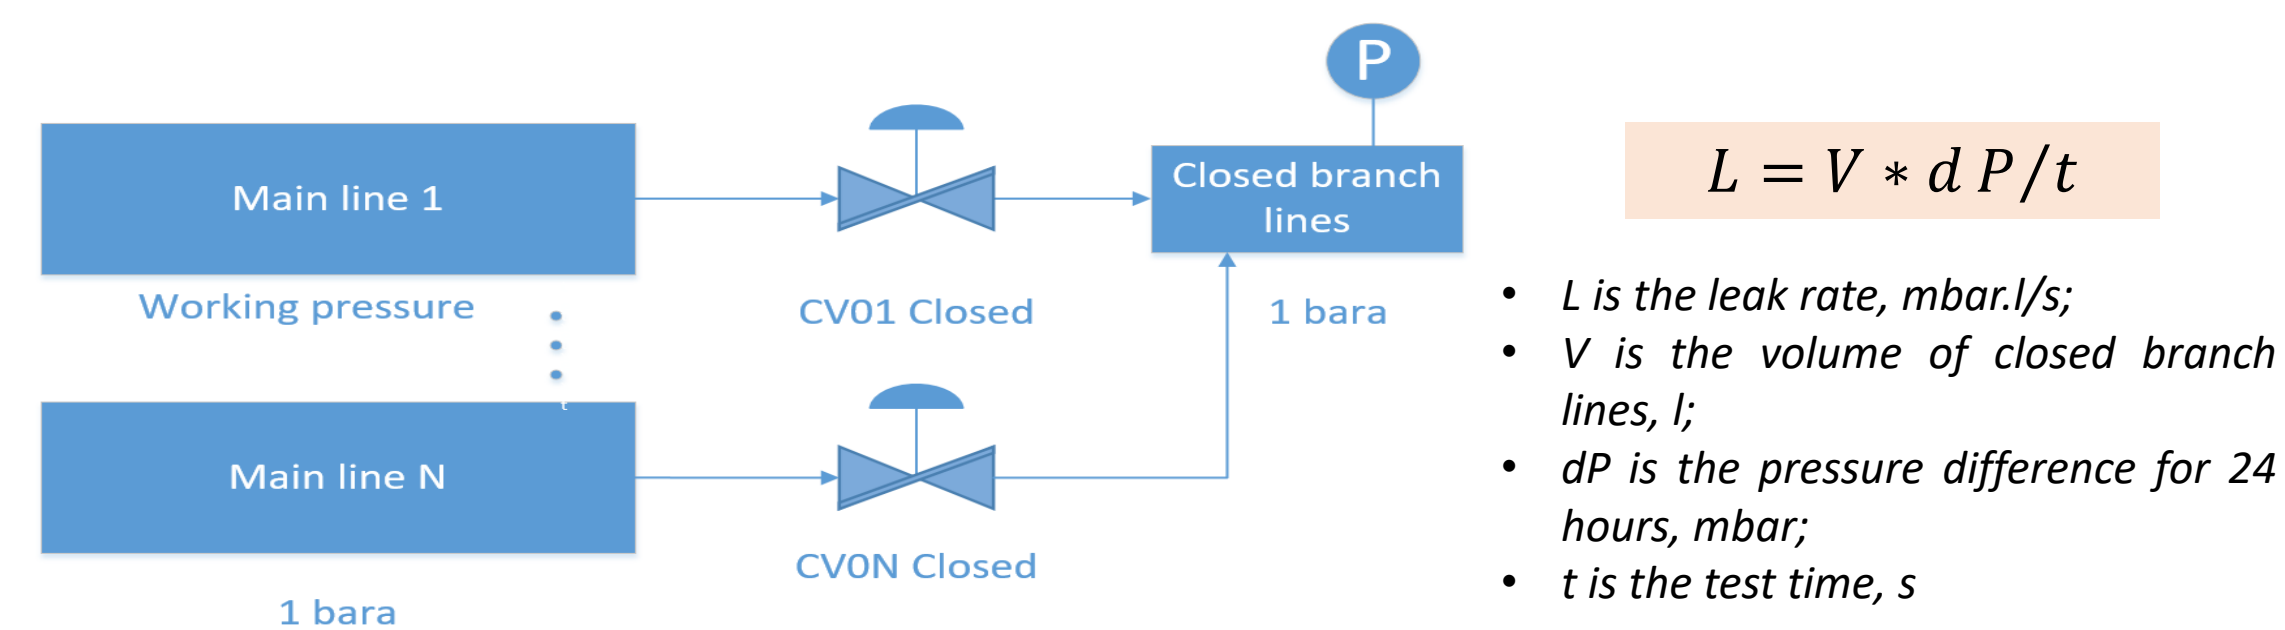
Test method

- One of the main lines is pressurized to the working pressure while the other lines are 1 bara and all valves keep closed.
- Monitor the pressure different of the closed branch line to calculate the leak rate of the tested valves.
- The chosen acceptable leak rate for valve seat leak tightness is $\leq 10^{-2}$ mbar.l/s.
