LHC BLM

Firmware Update during TS1-23

238th Machine Protection Panel Meeting

14/06/2023

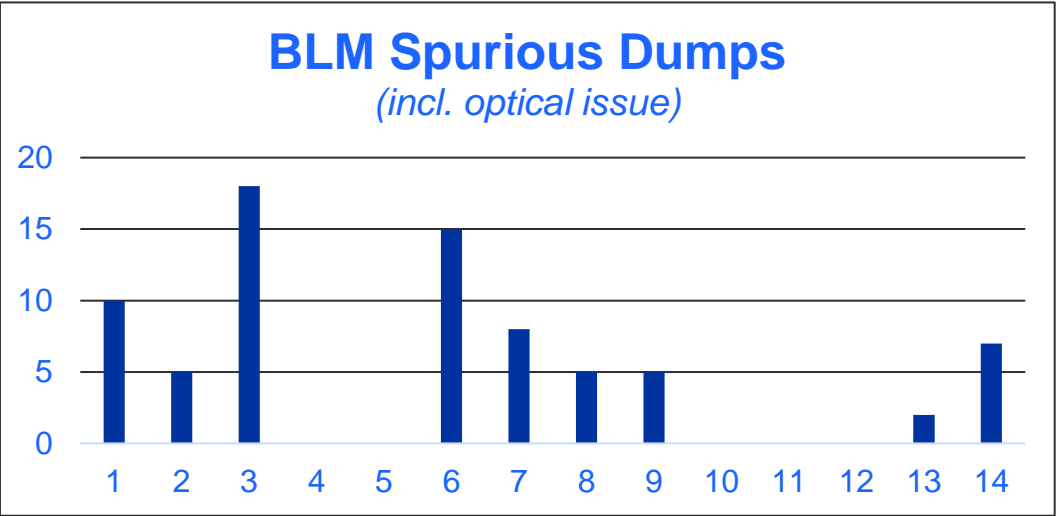
Extract AFT (*approx. numbers)

Spurious Optical Link Errors

This issue may have been present since Run1.

Partially solved by decreasing the rack temperature during Run2.
But the temperature was increased during LS2, and not lowered after.
 → Temperature set back from 23 °C to 16°C on the 24th May 2023.

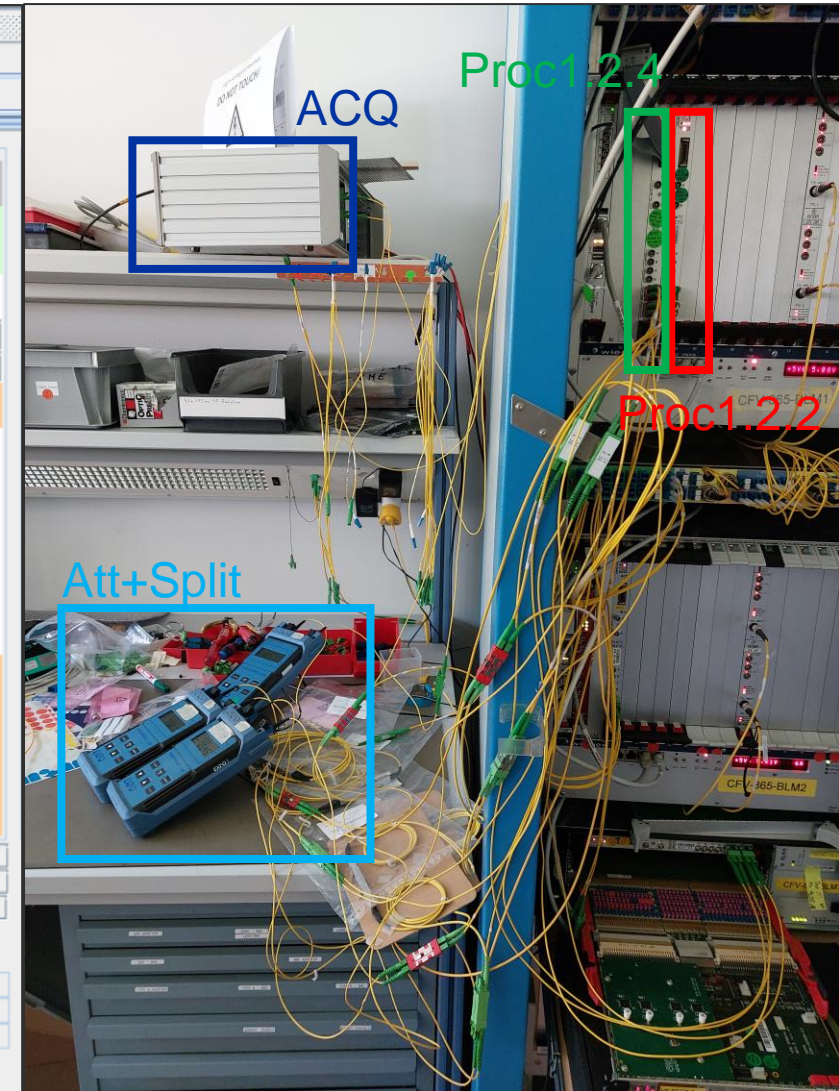
Testbench in the lab

Custom and manual testbench on one board: no more error spurious.

In the lab, 2 BLETCs board running:
 - v1.2.4 corrected FW
 - v1.2.2 current operational FW
