IT.L8 Leak and Repair

LHCC Meeting, 13/09/2023 S. Le Naour

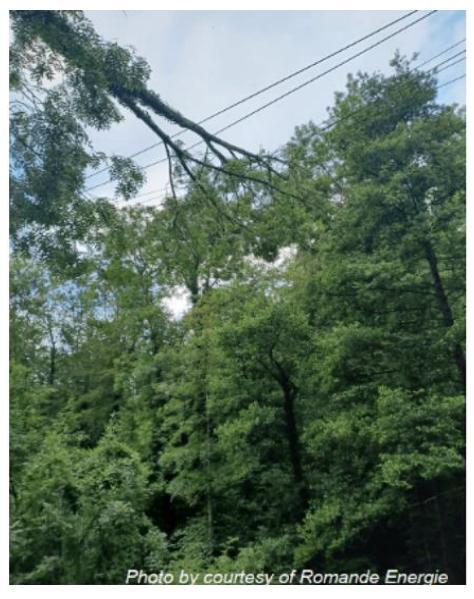
1 am : At stable beam in the LHC since 9 min, an electrical glitch occurred on the RF and magnet circuits, dumping the beam and triggering the protection system of a few LHC circuits, which IT.L8.

Monday, 17 July, 1 a.m.: ROOT CAUSE

The reason for the electrical glitch that caused the safety systems in the LHC to dump the beam and several magnets to quench was found: a tree on the Swiss side (about 55 km from CERN in the Canton of Vaud) fell on the power lines and disrupted the power system.

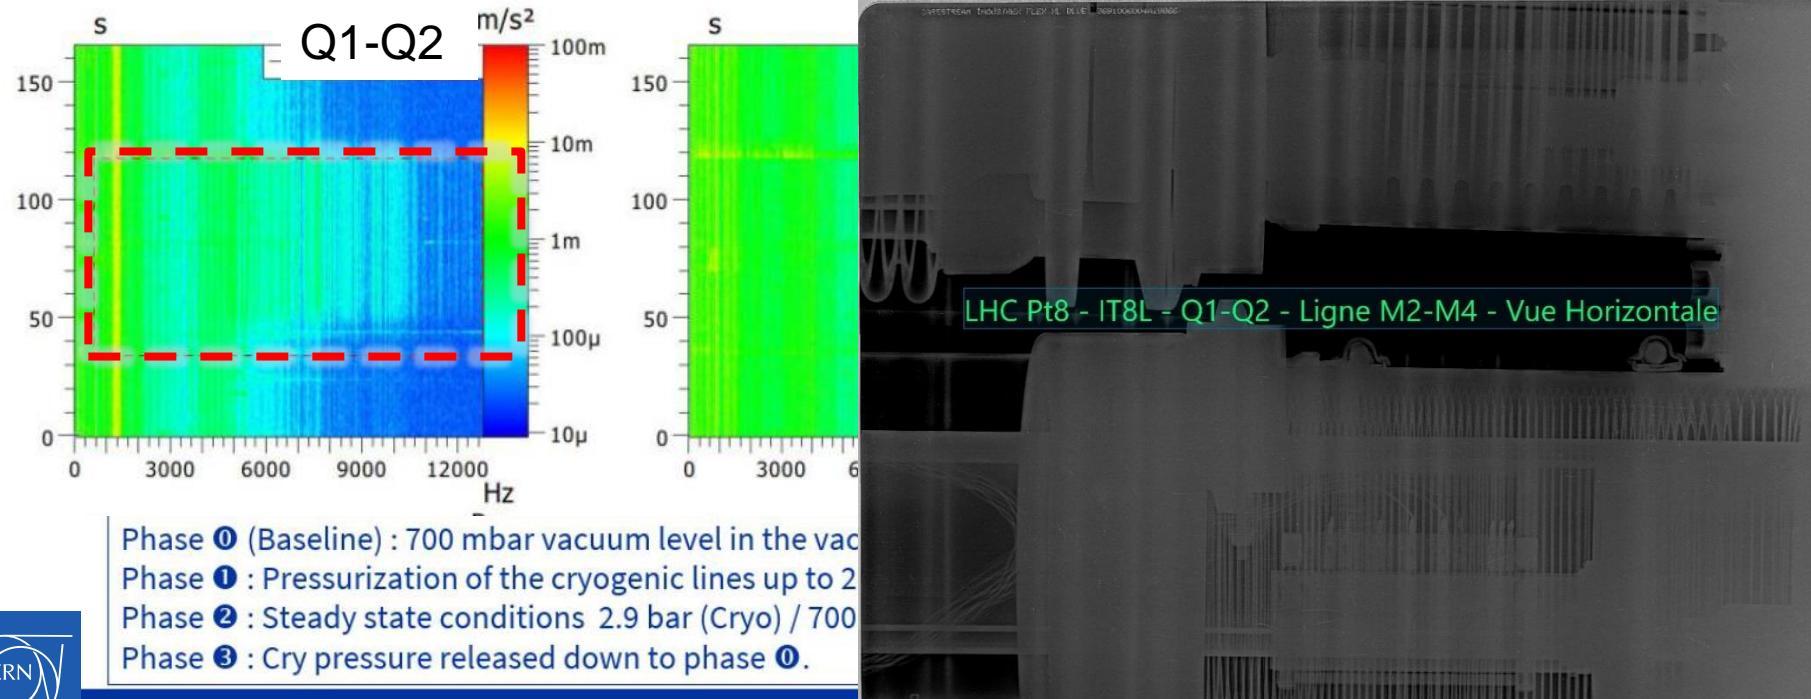
Confirmed in the cold masses volume, the helium leak must be localised over the 40m of the triplet assembly. Microphones and accelerometers were installed below the interconnection bellows.

With the pressurisation of the cold masses, accelerometers in Q1-Q2 interconnection measured significant vibration, indicating a possible position of the leak
